MIFACE INVESTIGATION #05MI051

Subject: Carpenter Dies After He Jumped/Lost Balance From An Unsecured Ladder That Fell Due To A Wind Gust.

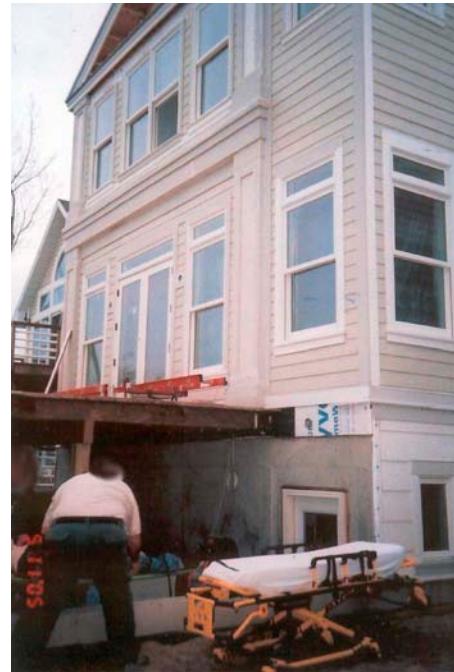
Figure 1. Incident Scene

On Wednesday, May 11, 2005, a 38-year-old male carpenter died after jumping or losing his balance from an unsecured ladder that was falling due to a gust of wind. The company's jobsite foreman instructed the victim and two coworkers to work on the siding on the west side of the house. The victim and one of the coworkers positioned their 30-foot fiberglass extension ladders on a second floor walk out deck. The 16- x 20-foot deck was constructed seven feet above grade and was unguarded on all sides. The victim and his coworker erected their ladders side-by-side and leaned them against the side of the house. Both the victim and his coworker were working approximately 15 feet high on their respective ladders. Both ladders had the ladder feet supported by a piece of plywood adhered to the deck to prevent the ladders from sliding away from the house. At approximately 8:30 a.m., the victim and his coworker were attaching wood nailers for a soffit screen when a gust of wind (~ 45 mph) from an approaching thunderstorm blew the top of the victim's ladder sideways (south) along the fascia board. As the ladder was falling, the victim jumped to the deck approximately 15 feet below and landed at the unguarded deck edge. He then fell ten more feet into a concrete basement well (Figure 1). Coworkers called 911 and the victim was transported to a local hospital where he was pronounced dead.

The coworker and deceased were installing treated lumber for the nailer for the screen soffit inside the soffit. Both workers were working approximately 15 feet high on their ladders. The coworker and deceased had been working approximately one hour. There was a thunderstorm approaching with variable high winds. The deceased had his nailbag on and was handing nails to his coworker when a 45-mile-per-hour gust of wind blew the deceased's ladder sideways along the fascia. The ladder began to fall and the deceased, as he was climbing down the ladder, either jumped from the ladder or lost his balance. The deceased fell between 10 to 15 feet knee-first to the edge of the deck, hit some equipment, and then fell 10 feet face-first into the concrete stairwell below the deck. The ladder landed on the deck.

Although both the deceased's and his coworker's ladders were blocked at the base, the jobsite foreman did not ensure the ladders lashed, per company policy, to prevent displacement. Blocking the ladder at its base did not provide adequate protection from displacement. Lashing a straight ladder as close to an upper support point as possible in addition to blocking will provide more protection against unexpected ladder movement. The employer stated to the MIFACE investigator that employees were instructed to lash the ladder when there was a possibility that the ladder could become displaced. The oncoming storm with the potential high winds raised the possibility that the ladder could become displaced. He stated that training had been given in the correct procedures when erecting and using an extension ladder.

The company was cited under General Rules for the open basement stairwell. The employer did not cover the basement well next to walk-out deck because the well was used as an employee entrance to the home. Although a cover may have been inconvenient, it would have provided protection from a further fall distance when the deceased fell from the deck edge. A MIFACE internet search of options to cover such an opening found transparent solid covers, rectangular grates, and fall arrest netting that could be purchased at a reasonable price to provide worker protection. If the basement well was covered, the deceased would not have fallen the additional distance and the fatality may have been prevented.

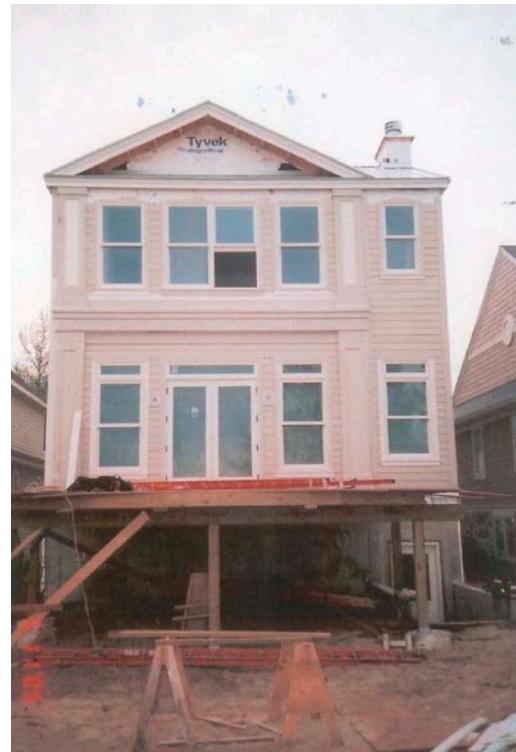
Figure 2. West Side of house

There were four employees on site, three carpenters and one jobsite foreman who had 25 years experience. The company had been working at the site for two months. The three-story home was being built on a 33-foot wide lot, with the west side of the home facing a lake. At the second floor level, there was a 16-foot x 20-foot walkout deck, built 7 feet above grade. The deck had recently been constructed and no guardrails were installed. On the south side of the deck was a basement stairwell entrance. The basement well was 4 feet 8 inches deep by 4 feet wide by 6 feet long. The concrete well floor was approximately 10 feet from the top of deck (Figure 2). There were two entrances for employees to gain access to the interior of the home. One entrance was on the street side and the other entrance was the basement well on the west side.

The victim and a coworker working from another ladder had been working for about a week installing siding. On the day of the incident, the jobsite foreman instructed the deceased and his two coworkers to continue working on the siding on the west side of the house. The deceased and his coworker positioned their 30-foot fiberglass extension ladders side by side on the deck. The third coworker stayed on the ground as a saw man, supplying material to the victim and his coworker. The coworker positioned his ladder that was extended to approximately 16 feet on the north side of the deck (north of the deceased's ladder) against the siding just above the third floor windows. The victim positioned his ladder that was extended to approximately 20 feet against the wood fascia board and drip edge soffit. Plywood "ladder boards" were nailed on the deck to prevent the ladders' safety feet from slipping away from the building. The ladders were not secured at the top. It is unknown if the deceased's ladder complied with the 4 to 1 rule. The 4 to 1 rule recommends that the distance from the bottom of the ladder to the surface it leans against should be a quarter of the ladder's extended height.
