# Fatality Investigation Report

OR 2005-38-1

## Window cleaner killed in fall due to unsecured line

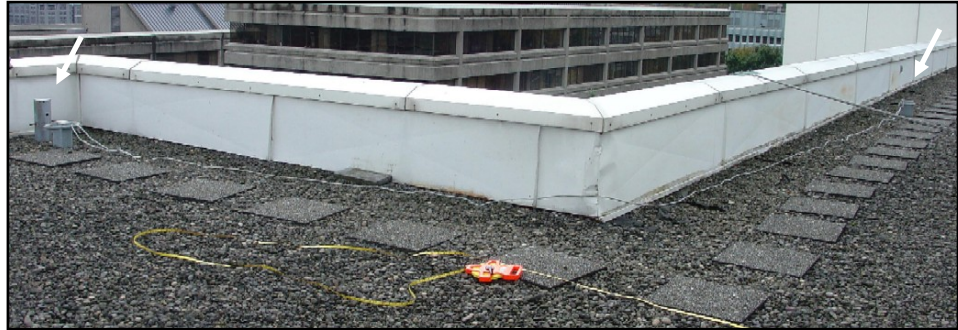
Two certified anchor points are visible here on the roof of the building where the incident occurred. The victim's anchor line was not attached to the left anchor.

The window cleaner connected one end of his wire anchor cable with a D-ring to a fixed roof anchor and stretched the cable around a 90-degree angle of the roof line to a second fixed roof anchor, where he apparently laid the end of the cable next to the anchor without attaching it. The closed D-ring for the anchor was later found 30 ft away from the anchor, apparently unused.

- (a) Building owners must install and regularly test certified anchor points for suspension work, and ensure that window cleaners are aware of their locations. Window cleaners should not use an inappropriate anchor that merely looks strong, such as an air conditioning unit, roof pipe, or balcony rail. Window cleaners should communicate to the building owner any deterioration of an anchor that makes it unsuitable for use.

- (b) A primary line should be attached to a single anchor point. This incident illustrates the increased risk when a line is strung between two anchor points.

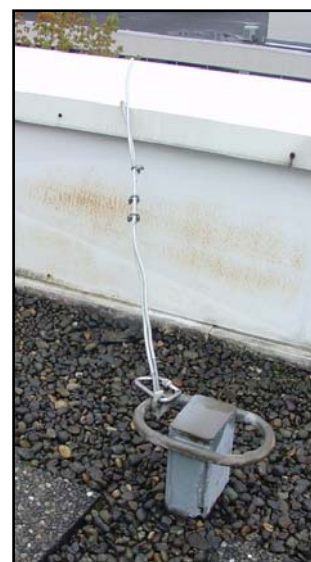
The one secured anchor line dangled over the roof edge following the incident.

Once over the edge, the coworker saw the window cleaner immediately falling. Then he saw one end of the window cleaner's anchor cable come off the top of the building. The victim landed on the concrete below and was instantly killed. The coworker rappelled down to the ground, found the victim unresponsive, and dialed 911 on his cell phone. An off-duty paramedic, who witnessed the event and ran over to help, completed the emergency call. An emergency medical team arrived minutes later.

- (c) A personal lifeline must be worn and secured to a completely independent anchor point.
- (d) Suspension lines should not be strung around corners. An extra corner reduces the load capacity of a line significantly and increases the chance of breaking from sudden force. A roof edge should be padded to prevent damage to the ropes.

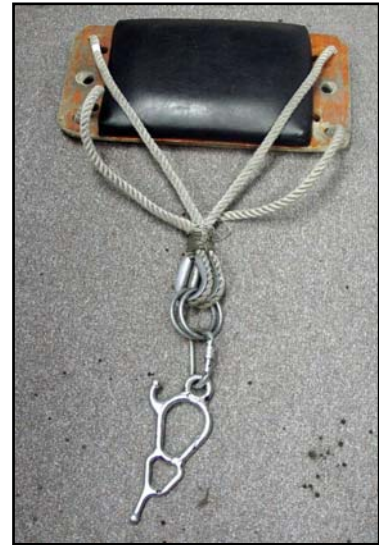
Detail of a boatswain's chair shows attachment to a descender with a screw-type carabiner.

On the victim's equipment, the whipping that secures the lines to the boatswain's chair was found to be frayed and unraveling. Other

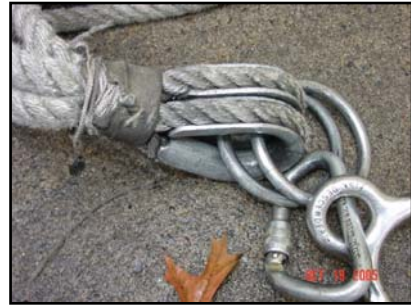
deficiencies in the anchor line included a missing nut on a restraining clip, U-clips placed in the line the wrong way, no weight limits stamped on a D-ring, and cuts and damage to the plastic covering on the line. Lines were not tagged with the date of purchase and length of service.

**REPAIR FLAWS  
IMMEDIATELY!**
