**Case No. 04IA59**

**SUBJECT: 45-Year-Old Cattle Farmer Entangled in Exposed Rotating Conveyor Shaft**

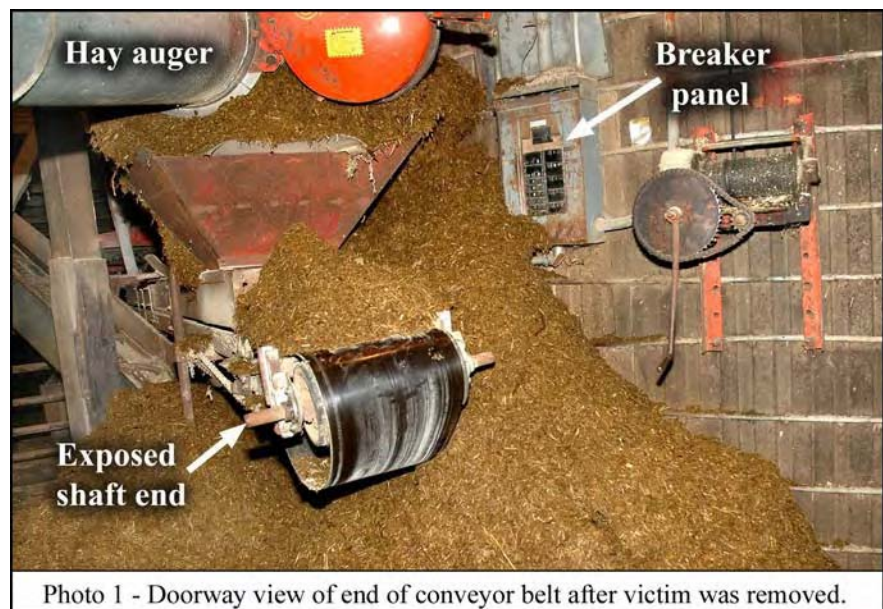
Photo 1 - Doorway view of end of conveyor belt after victim was removed.

controlled from a breaker panel (Photo 1). This panel also controlled the conveyor belt motor. This configuration of switches required the farmer to walk around the exposed end of the conveyor belt at least three times during each feeding cycle. The shaft for the conveyor belt pulley extended about three inches (75 mm) beyond the bearings on each side. A keyway was cut into the length of the 1-inch (25 mm) diameter shaft, and there was no guard around the conveyor belt or the shaft. The injury occurred when the farmer apparently leaned or bent over too close to the shaft. The hood of his nylon jacket became entangled in the exposed shaft end. The hood and arm of his jacket wound up in the shaft strangling him and stalling the conveyor. Silage kept piling up from the silo, and the conveyor motor and drive kept running, eventually burning through the west end of the stalled conveyor belt. The victim was discovered by his wife. He had suffered fatal injuries before rescuers arrived.

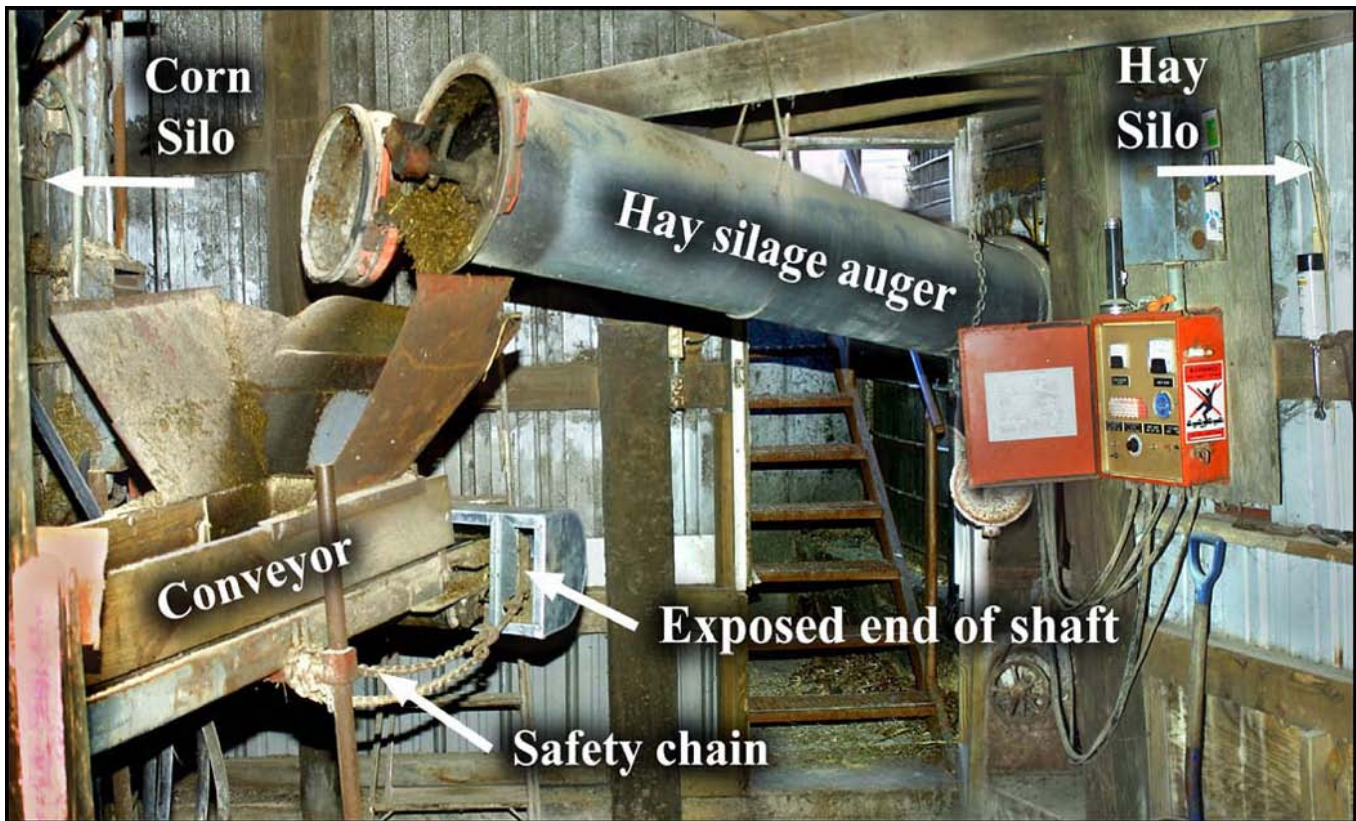
Photo 3 - Composite photograph from the west end of the shed showing both silos, the end of the conveyor belt (now with guard), and the control panel for the hay silo.

The oxygen-limiting hay silo was built in the mid 1980s, and was situated on the south of the shed, with control switches mounted to its wall inside the shed. The corn silo was built in 1977 on the north of the shed. It was controlled from a breaker panel box mounted to its side inside the shed. The free-stall barn extended west from the shed. The motor for the conveyor was positioned at the west end in the barn, and the motor was switched on and off using a breaker switch in the electric panel on the north side of the feed shed.

The east end of the conveyor belt was in the middle of the feed shed and had a 6-inch (15 cm) diameter pulley at its end, rotating on a 1-inch (25 mm) diameter shaft which was approximately 20 inches (50 cm) long. This pulley was spring-loaded to maintain constant tension on the conveyor belt. Safety chains were attached to both sides of the pulley in case the belt should break (Photo 3). The shaft and bearings had been replaced several years ago, and the new shaft was long enough to fit the wider 16-inch (41 cm) conveyor model. This longer shaft left three inches (7.5 cm) of exposed shaft on both sides. The shaft had a keyway cut throughout its length, which left sharp corners at the shaft ends. The ends of this shaft were left exposed, and not cut off. The conveyor was not thought to be a great hazard, since the shaft turned at three revolutions per second (180 rpm); slower than tractor power take-off shafts and many other power shafts used in agriculture. During each feeding cycle, the farmer had to walk around the end of this conveyor 3-4 times to access breaker switches on the side of the corn silo.

Since this farm death, a neighbor, who was a sheet metal worker, constructed a metal box to enclose the end of the conveyor belt (Photo 4). Also, after the investigation, an electrician was scheduled to rewire the switches in the shed, moving all electrical controls to the south wall, adjacent to the existing controls for the hay silo (Photos 3 and 4).
