Two Tow Truck Drivers Killed When Struck in a Highway Breakdown Lane - Massachusetts

Investigation: # 04-MA-005-01

Release Date: May 22, 2006

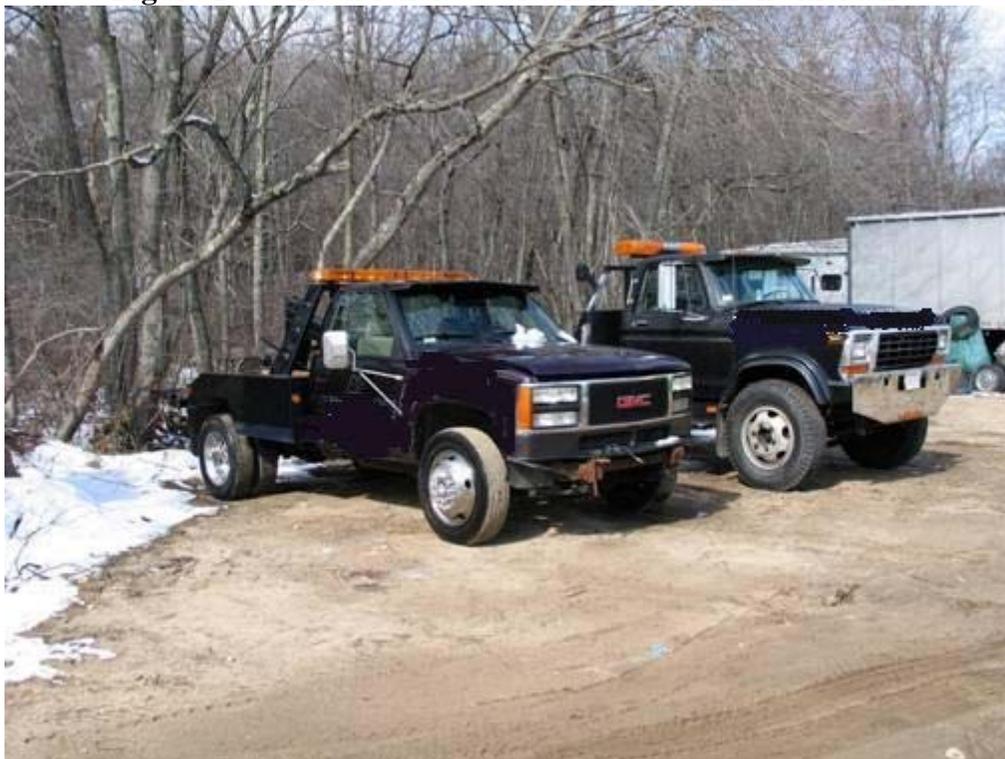
Figure 1 – Conventional tow truck involved in the incident

The trucks involved in the incident were a 1994 conventional tow truck (Figure 1) and a 1999 flatbed tow truck (Figure 2). Victim #1 was returning to the office, via a major interstate highway, after towing a car to a drop off location that was a few towns away. At approximately 3:30 a.m. victim #1 noticed that the conventional tow truck's dashboard alternator warning light came. Victim #1 pulled the conventional tow truck into the shoulder/breakdown lane, angling the front of the truck away from the travel lanes and called the company office, via cell phone, for help. Victim #2 was dispatched by the office to respond to the co-employee's call for assistance. Victim #2 headed out to the location of victim #1 in the flatbed tow truck to bring the broken down conventional tow truck and victim #1 back to the office.

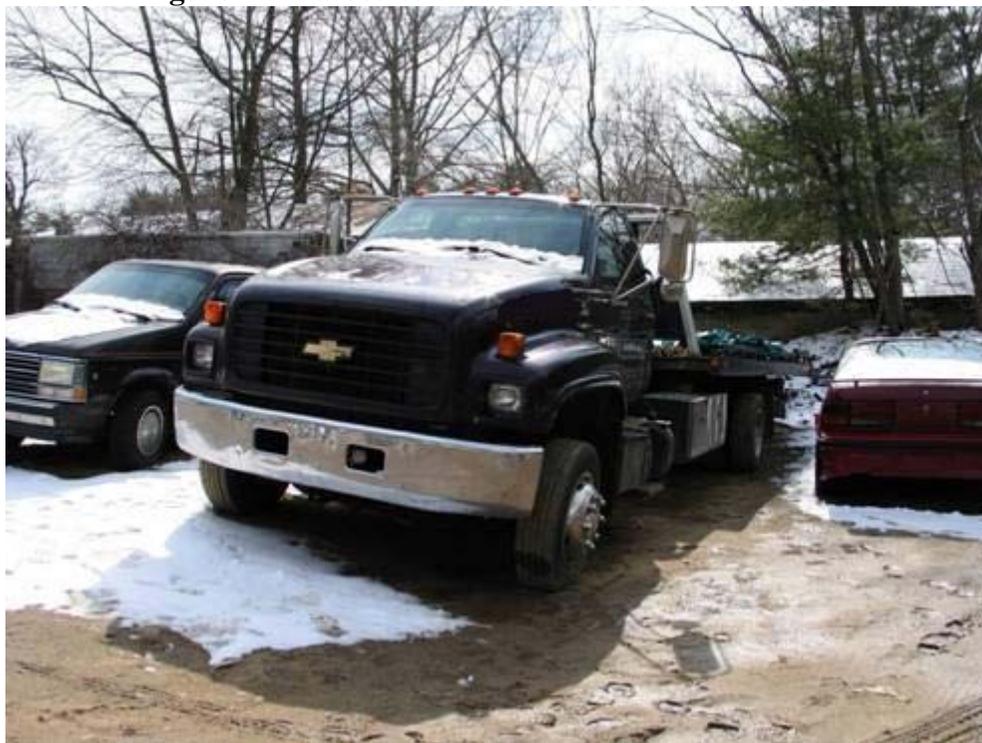
Figure 2 – Flatbed tow truck involved in the incident

At approximately 4:00 a.m., victim #2 arrived at the location where the conventional tow truck had broken down. Victim #2 pulled into the break down lane in front of the conventional tow truck and positioned the flatbed tow truck at an angle in front of the conventional tow truck. The flatbed truck was equipped with reflecting triangles, which were placed behind the disabled tow truck (at unknown distances), and with yellow strobe lights that were on at the time of the incident. The truck also had dual tow equipment control levers for the flatbed tow truck, one set was located on the driver's side and the other set was located on the truck's passenger side.

Discussion: The flatbed tow truck involved in the incident was equipped with tow equipment control levers for the flatbed tow truck on both the driver's and passenger's sides of the truck. In this incident the control levers being used at the time of the incident were the control levers located on the driver's side of the truck, the side closest to oncoming traffic. Employers should ensure that tow truck operators, when feasible, use the control levers located on the side of the truck that are the farthest from approaching traffic.

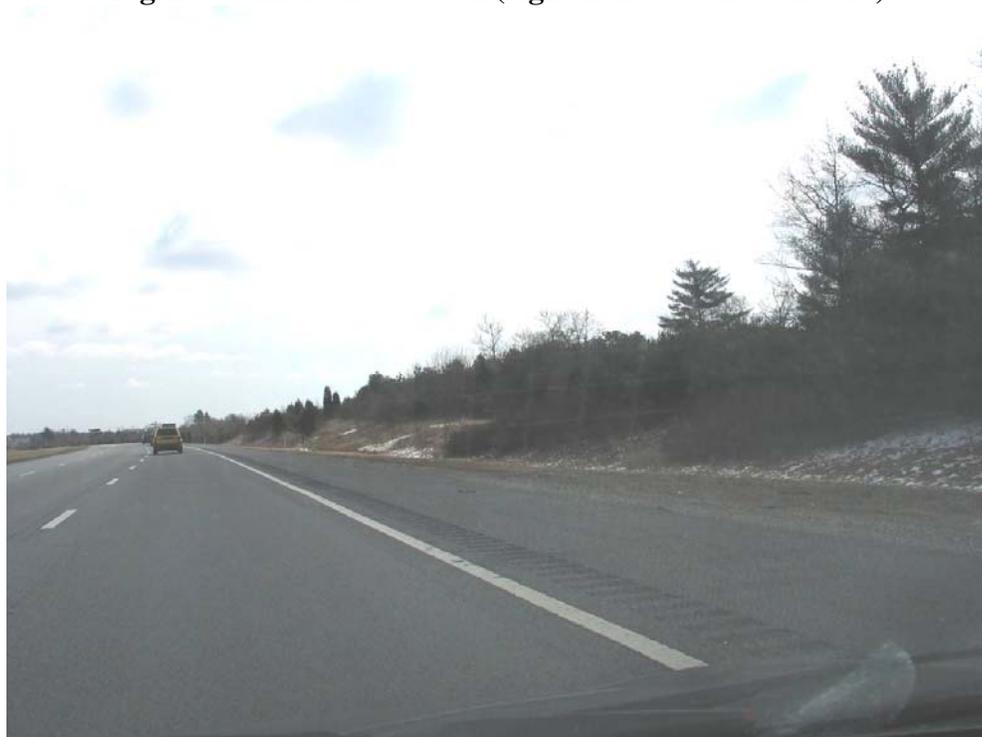
Figure 3 – Incident location (right hand breakdown lane)

The interstate was a six lane asphalt highway with an asphalt shoulder/breakdown lane and a grass median. The section of the interstate where the incident occurred did not have street lights,

but it did have a right hand lane white fog line and a rumble strip inside the left hand side of the breakdown lane parallel to the white fog line. The section of interstate where the incident occurred was level and straight with a slight curve (Figure 3 and 4). At the time of the incident the section of highway was clear and dry.

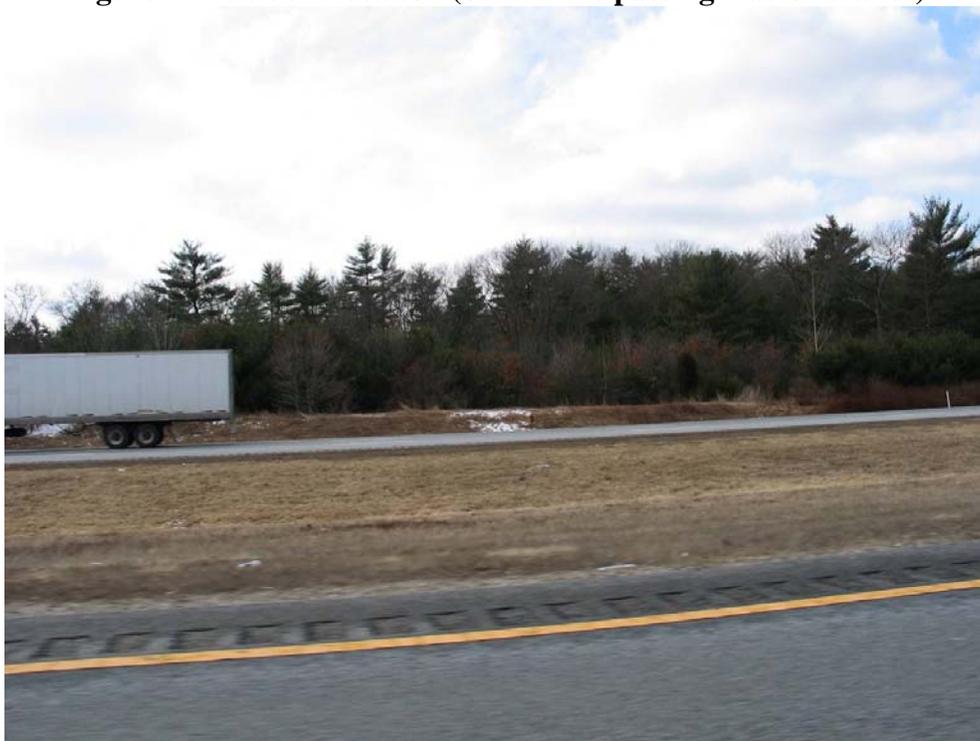
Figure 4 – Incident location (behind the passing tractor-trailer)

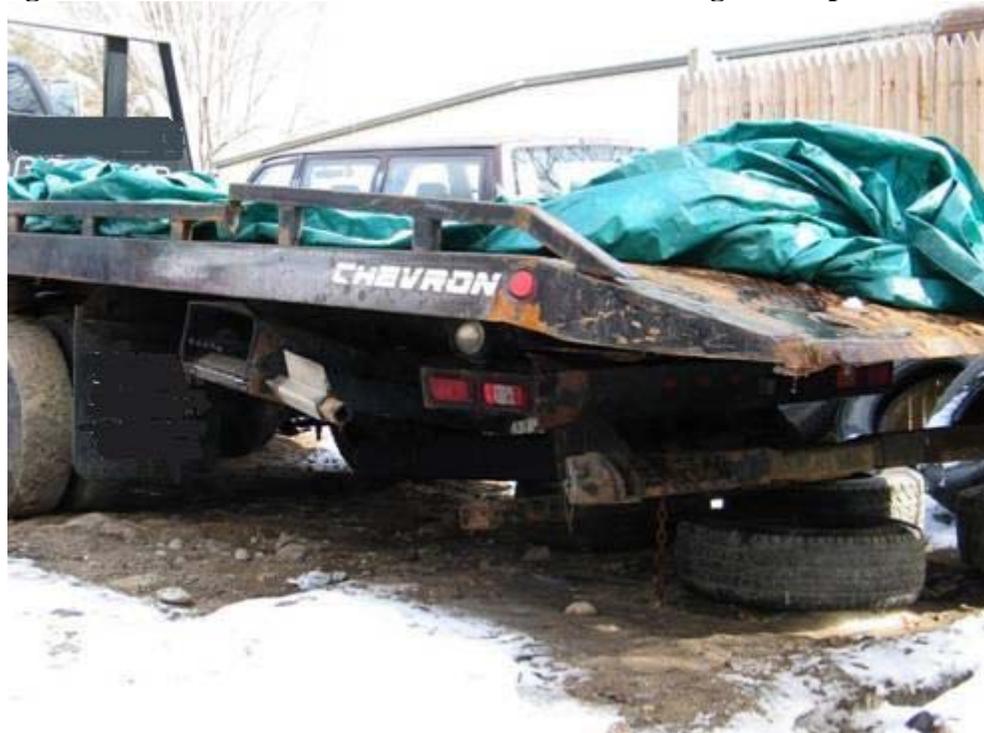
Figure 5 – Location where the victims were standing and impacted of car

The victims were standing on the driver's side (left side) of the trucks while preparing to load the broken down conventional tow truck onto the flatbed tow truck when a car traveling at a high rate of speed crossed into the breakdown lane. The car sideswiped the conventional tow truck and continued in the forward direction striking both victims. The car then struck and became wedged partially under the left rear section of the flatbed tow truck (Figure 5). The incident was reported to Emergency Medical Services (EMS) via cell phones calls from passing motorists. EMS arrived within minutes of the calls. Victim #1 was pronounced dead at the scene and victim #2 was transported to a local hospital where he was pronounced dead later that same day. The operator of the car was transported to a local hospital and sustained non-life treating injuries. At the time of the incident, the operator of the car was allegedly driving the vehicle under the influence of alcohol.
