**FROM: Iowa FACE Program**

**Case No. 04IA60**

**SUBJECT: 53-Year-Old Cattle Farmer Entangled in Exposed Rotating Conveyor Shaft**

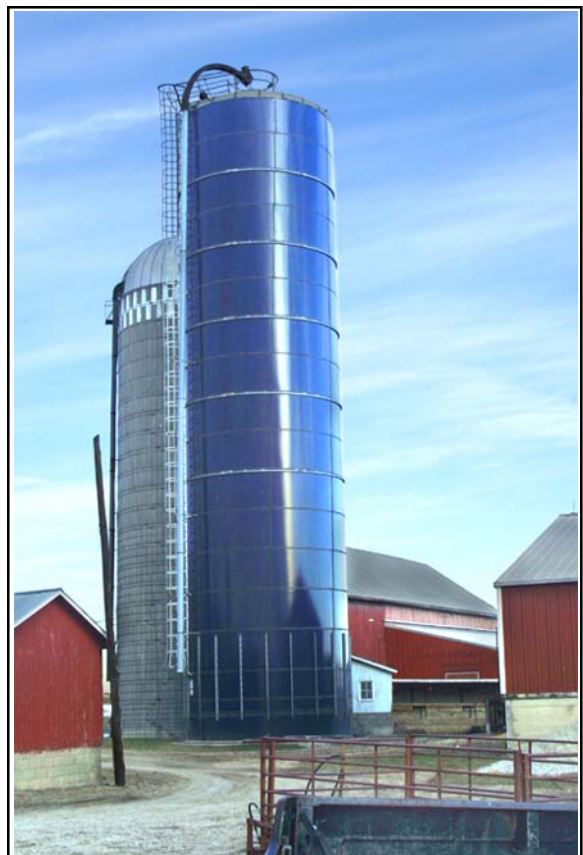
This cattle feeding operation had two silos as seen in photo 2. One was a conventional concrete silo and the other was a larger, oxygen-limiting silo. A feeding control shed was built between the silos from which feed was conveyed to the adjacent feed bunk that extended to the outdoor feedlot area. When the farm was a dairy, the concrete silo was filled with corn silage and the oxygen-limiting silo was filled with hay silage. Since the milk cows were sold 5-6 years ago, the concrete silo was abandoned, and the oxygen-limiting silo was used for ground, high-moisture ear corn. Between the two silos was a feeding control shed containing an auger and two conveyor belts, which were used daily to mix and distribute feed to the feed bunk (Photo 3).

Photo 2 – Outside view of silos showing the attached shed and adjoining feedlot.

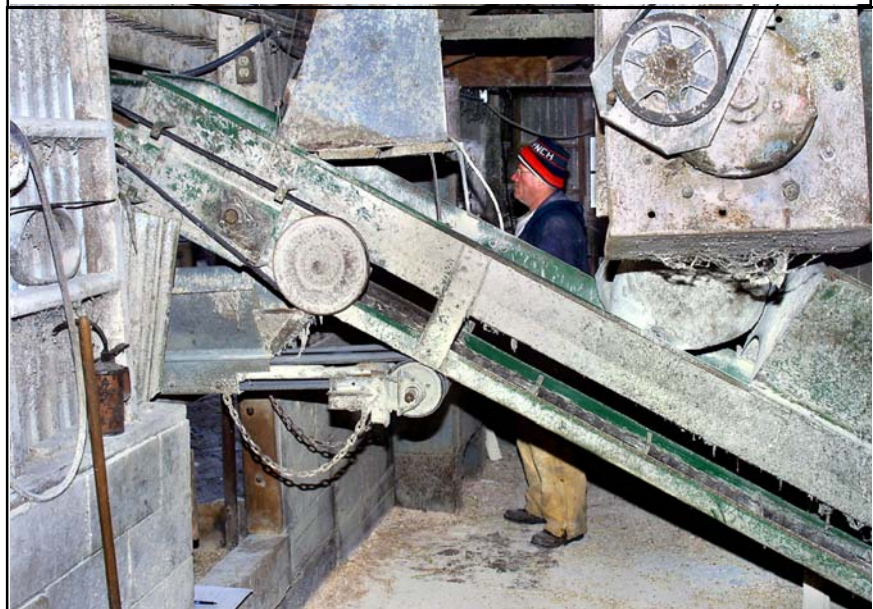
The farmer's normal feeding chores would take about 30 minutes early in the morning. As ground corn was moved from the silo by the auger, he would add cracked corn by bucket from a pile near the doorway of the shed. Photo 4 shows his normal work position at this time to the left of the switch panel. This task required the farmer to crawl under the exposed end of the horizontal conveyor belt a few times each day to access the switches, open and close the oxygen-limiting silo, and add corn to the feed. The farmer had become accustomed to doing this every day.

Photo 4 – View of conveyors from the doorway end of the shed, showing the farmer's normal work position, with the exposed ends of the horizontal conveyor at waist level.

**Discussion:** Conveyors and feeding equipment have many moving and rotating parts. The farmer had to work in close proximity of the conveyor which had several entanglement points. There were many other unguarded belts, pulleys, shafts, and augers in the immediate work area. The end and bottom side of the main bunk conveyor was particularly exposed and the farmer had to duck under it through a three-foot (90cm) space

several times each day, in many cases when the conveyor was running. There are well established standards for agricultural machinery guarding which would apply for properly protecting moving parts in this work area (ANSI/ASAE S493).

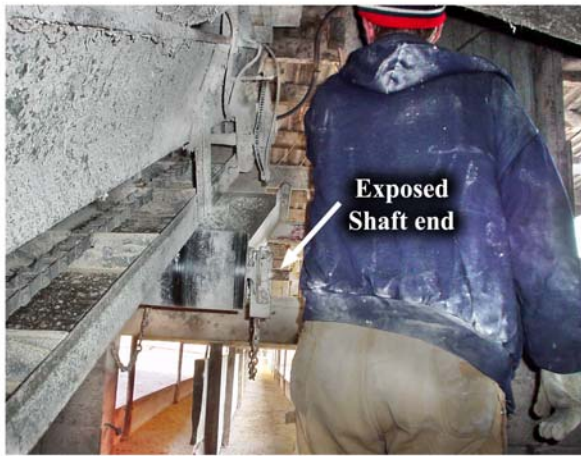
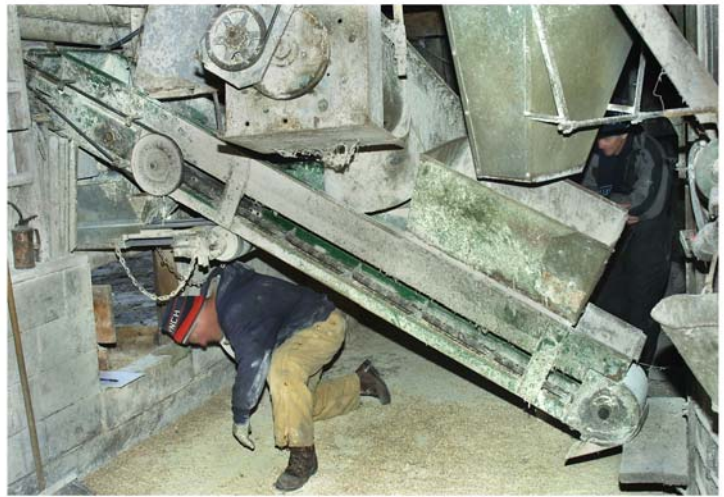
On the day of the incident, the farmer had gotten up early, about 4:30 am. He had been plowing all morning and proceeded to feed cattle about 10:30 am. During feeding, while ducking under the conveyor belt, the collar of his jacket was caught and wound up in the exposed end of the shaft for the horizontal feed bunk conveyor (Photo 5). He was strangled by his clothing and his entangled clothing stalled the conveyor belt.

Photo 5 and 6 - Shows the height and location of the rotating shaft. Photo 6 shows how the farmer had to routinely duck under the conveyor from side to side to access the switch panel.

**Discussion:** The overall layout of the conveyors and augers in this feed shed created unsafe working conditions. The electrical controls for this feeding system were consolidated, but to access them the farmer often had to crawl under the main feed bunk conveyor. For mixing other feeds into the conveyor, he would have to go back to the other side again to manually move corn and/or other supplements to the conveyor. It is difficult to place conveyors, augers, and controls in a feeding system so that there is no need to work close to moving machine parts. However, with careful planning most hazardous work circumstances can be avoided.
