**FROM: Iowa FACE Program**

**Case No. 04IA36**

**SUBJECT: Metalworking Shop Owner Crushed Between Skid Steer and Forklift Attachment**

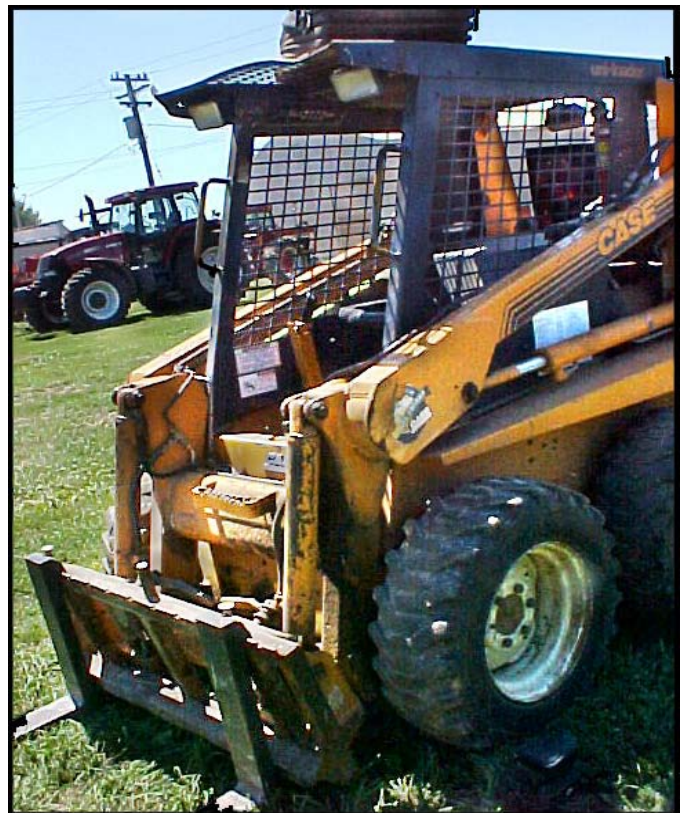
Midsummer 2004 a 52-year-old owner-operator of a metalworking shop was killed in the shop on his rural residential farm site. He was crushed between the front frame of his skid steer loader and the back of the forklift attachment mounted to the machine's lift arms (Photo 1). The machine was being repaired, and the loader's seat, battery cover, and battery were removed from the floor of the operator's station. Hand operated controls had been disconnected from their control rod linkages, which connect them to the valves that govern hydraulic flow to the power lift arms, forklift, and skid steer movement. The lift arms, with mounted forklift attachment, were partially or fully raised. The tall repairman was in the zone bounded by the frame across the lower front of the skid steer loader, the back frame of the raised forklift attachment, and the lift arms extending forward along each side of the protective metal structure around the operator's station. He was leaning forward into the operator's station to accomplish his repair tasks.

Photo 1 - Skid steer loader with forklift attachment on lift arms.

- ***Skid steer loader operators should lower lift arms to the ground before exiting the operator's station. Operator's and those repairing skid steer loaders should always use lift arm locking mechanisms provided by the manufacturer and ensure that they perform properly before exiting or working under any portion of the raised lift arms of the loaders.***

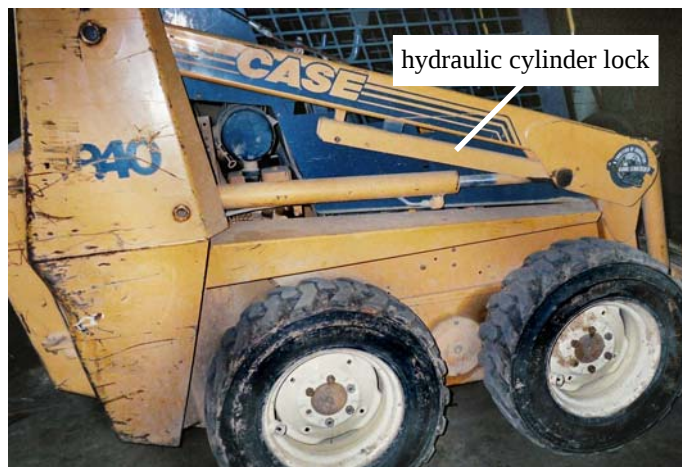
A metal channel lock is provided on the right-hand lift arm cylinder mount (Photo 4). When properly positioned in use over the exposed rod of the hydraulic cylinder, this channel serves as a rigid mechanical means that prevents lift arms held above a height, which is a function of the length of the channel, from lowering under power or by gravity.

Photo 4 - Hydraulic cylinder lock in stowed position.

It is not known why the repairman in this incident did not engage the hydraulic cylinder lock (Photo 4), which can be put into position from the operator's station when the lift arms are raised. This mechanically blocks movement for the lift arms. Movement of the lift arm lowering control rod, and having it stay in the actuated position, allowed the lift arms to fall. The lanky repairman (6' 6", 2.0 m) leaning into the operator's station from the front, had too little time to escape. The lift arms of a representative skid steer fall from full raised height to the ground in about four seconds with the engine off. The time would be less when the lift arms are in a partially raised position before they fall, and with attachments mounted on the lift arm attachment frame.

**Recommendation #1** *Skid steer loader operators should lower lift arms to the ground before exiting the operator's station. Operator's and those repairing skid steer loaders should always use lift arm locking mechanisms provided by the manufacturer and ensure that they perform properly before exiting or working under any portion of the raised lift arms of the loaders.*
