**SUBJECT:** A plumber was killed when a skid-steer loader tipped forward and struck him in the head.

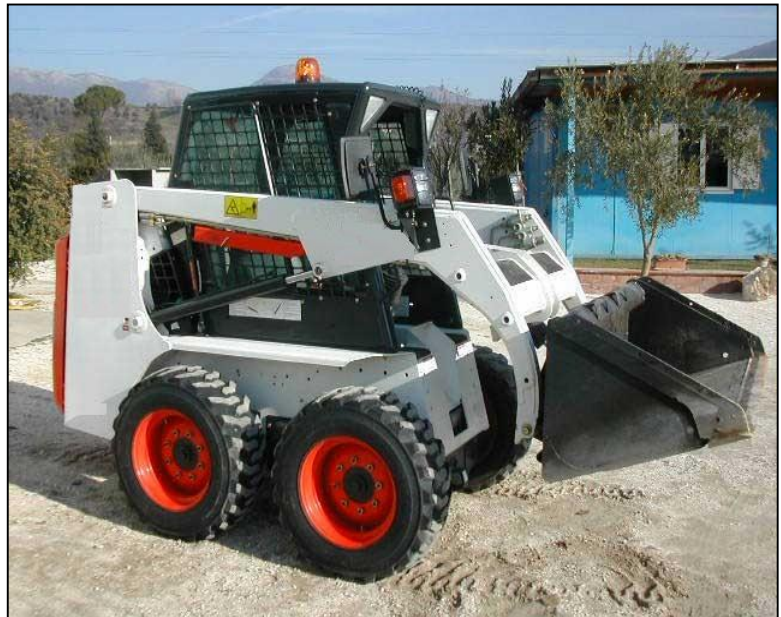
Figure 1. Skid-steer loader similar to the one involved in the incident

The victim was in the trench holding the sleeve over the valve with his right hand, while his coworker used a skid-steer loader (Figure 1) to haul a bucket of sand over to the area and the victim used his left-hand to guide him. The skid-steer loader bucket was filled with sand (Figure 2) and the bucket was elevated higher than the victim's head. As the coworker approached the edge of the trench, the left tire shifted in the damp/wet dirt and the skid-steer loader tipped forward (Figure 3). The victim had a shovel in the trench to place sand around the sleeve, but the pair were attempting to dump the sand directly from the loader. As the skid-steer loader tipped forward, the bucket struck the victim in the head and then pinned his left arm against the wall of the excavation.

Discussion: All mobile machinery operators should be trained based upon written machine-specific procedures and the operator's manual. The written procedures should address the safe operation of mobile machinery including necessary precautions when operating machinery in and around excavations. Movement of heavy machinery can cause soil failure such as cracks, fissures, and undermining of excavation stability. These situations can lead to excavation wall cave-ins and mobile equipment rollovers. The written procedures and operator's manual should be available to operators at all times for review.

Operator's manuals contain important information regarding safety features, limitations of machinery, warning statements, and guidelines for safe operation of machinery. Some warning statements included in the operator's manual for the skid-steer loader involved recommended the operator to carry bucket or attachments as low as possible, do not travel or turn with lift arms up, and load, unload, and turn on flat level ground.

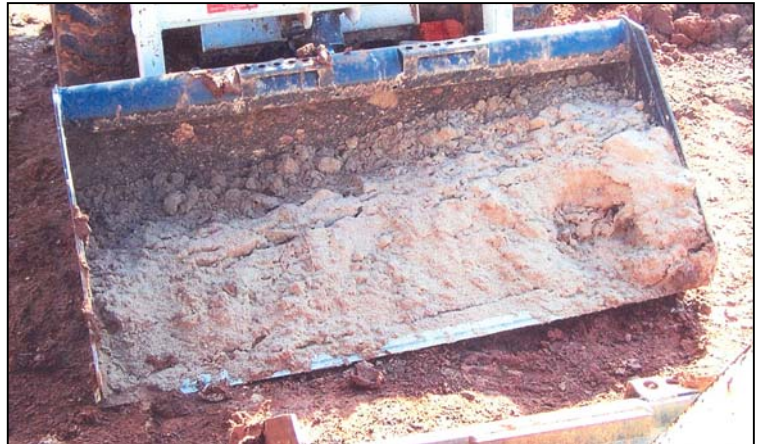
Figure 2. Skid-steer loader bucket of sand (taken after the incident)

Discussion: Employers should ensure that employees are not positioned underneath elevated loads during loading or unloading. Employees positioned under elevated loads can be struck by spillage or falling materials. According to OSHA standards, no employee shall be permitted underneath loads handled by lifting or digging equipment. Backfill material could have been placed into the excavation with the skid-steer loader bucket without the victim standing in the trench. After backfill material had been placed under the water pipe, the victim could have held the PVC sleeve in place while his coworker used the available shovel to finish placing and packing sand around the sleeve and water pipe.

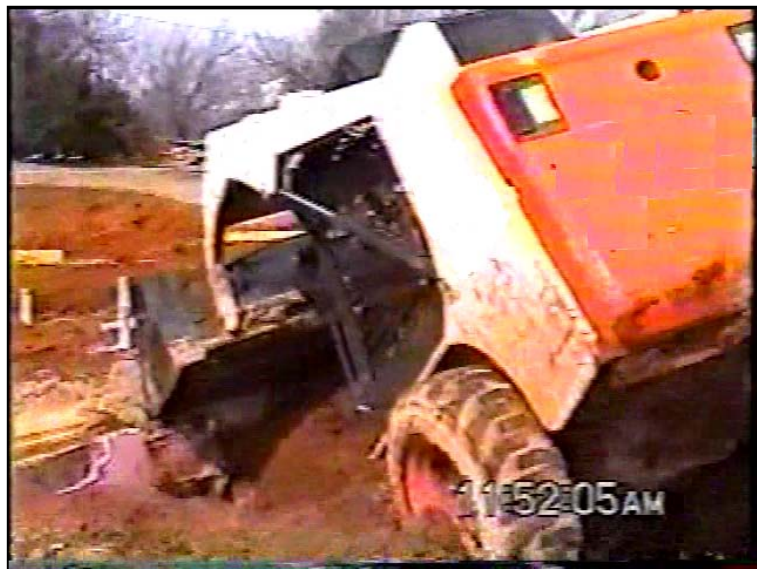
The coworker immediately dismounted the loader, observed the victim's situation, and used a cell phone to dial 911. The local fire department arrived at the scene in less than five minutes. The winch and a cable from the fire department's brush truck was used to stabilize and tip the loader backwards, freeing the victim's arm. The victim was transported by helicopter to the hospital and pronounced dead shortly after arrival to the emergency room.

Figure 3. Skid-steer loader tipped forward (from video filmed after the incident)

According to OSHA standards, employees should be protected from excavated or other materials or equipment that could pose a hazard by falling or rolling into excavations. OSHA standards require that materials or equipment are kept at least 2 feet from the edge of excavations, or retaining devices are provided to prevent materials or equipment from falling or rolling into excavations, or by a combination of both if necessary.
