Case No. 03IA072

SUBJECT: Overturn of a Tractor with ROPS Folded Down Kills Operator

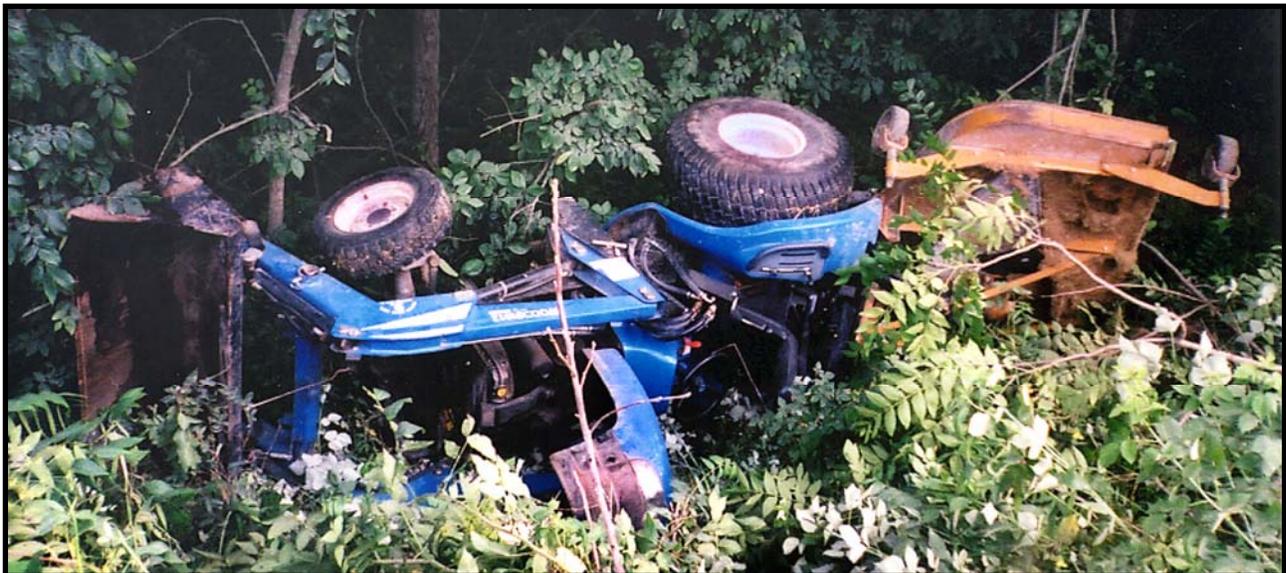
Photo 1 – Side view of the tractor in a roadside ditch after the overturn.

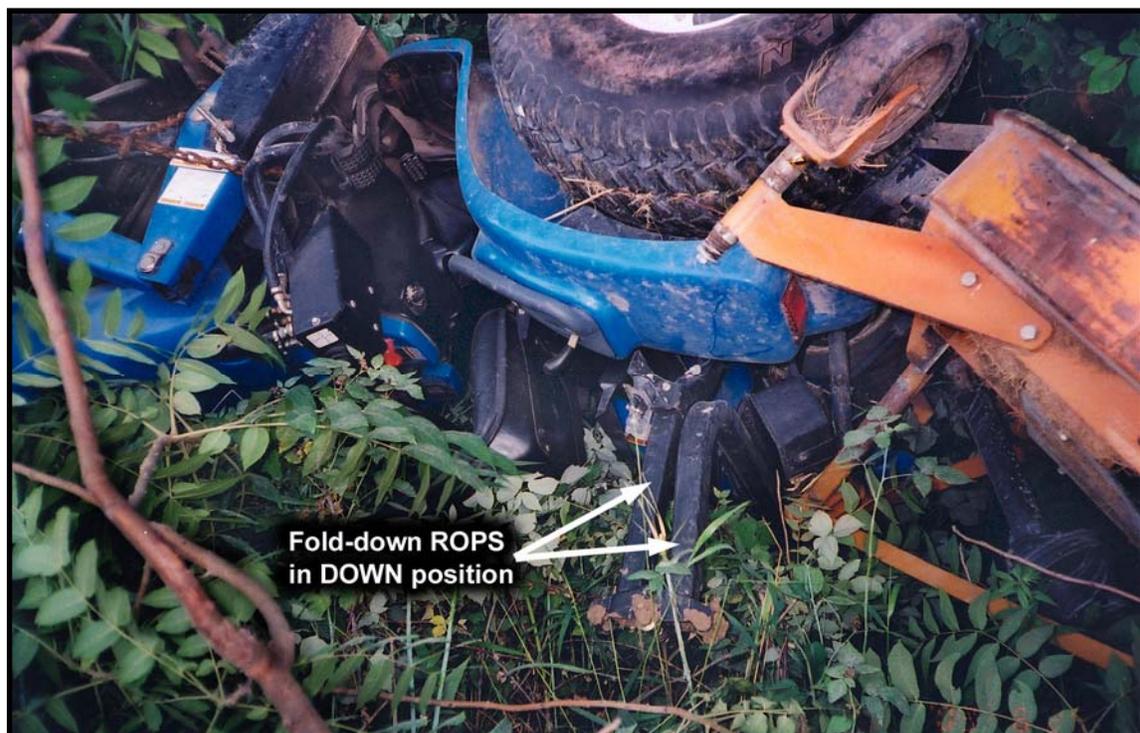
Photo 2 – Upside down tractor in the ditch, with foldable ROPS in the down position.
Notice the mud around the hinge area from digging into the ground during overturn.

Recommendation #1 *Operators should return retractable ROPS (foldable or telescoping) to their upright and locked position immediately upon exiting a low clearance environment where the ROPS must be down.*

Discussion: One of the barriers to increased installation of ROPS has been the complaint that ROPS interfere with using tractors in low clearance situations, such as low buildings and orchards. The manufacturers of tractors and ROPS have responded to this concern by manufacturing fold-down-type ROPS, which are very common in newer open-station tractors. A concern remains that the fold-down ROPS can easily be left in the down position, and seldom, if ever, returned to the upright position. This fatality, to our knowledge, is the first case in Iowa where a folded-down ROPS was involved in a fatal tractor overturn. Owners and operators must be reminded that leaving the fold-down ROPS in the down position renders it ineffective. It must be returned to the upright position after any low clearance work.

There was no reason to have the ROPS in the folded-down position while driving on this road. Employers should ensure that ROPS are kept in the upright position at all times, except when necessary to have them down. It is unclear whether this ROPS was kept down routinely. Employees should be trained not to use tractors outside low clearance environments unless they have ROPS in the upright position and are wearing the seatbelt.

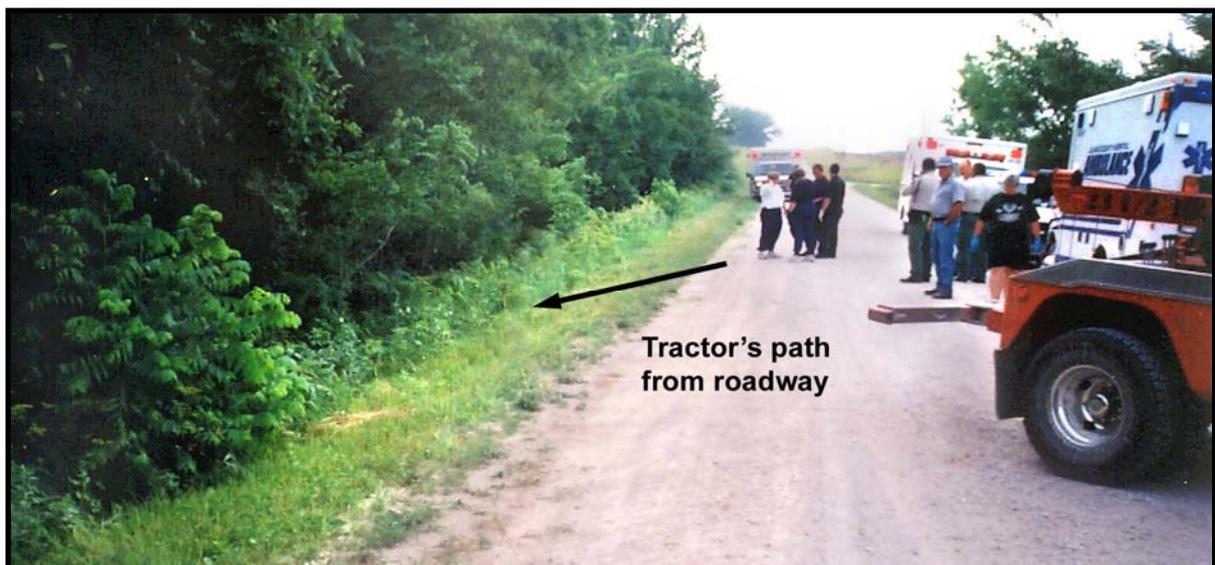
Photo 3 - Incident scene facing east, showing road conditions and path the tractor traveled into the ditch.

At the time of the incident, the victim was in transit from the nursery to the sow confinement facility. He was driving alone, heading west on the gravel road, using a compact utility tractor which he was familiar with. There was no indication of any other traffic on the gravel road at that time. The incident occurred about 6:40 AM., well after sunrise. The victim apparently lost control of the tractor and it veered into the right-hand ditch (Photo 3). He suffered fatal crushing injuries in the overturn. One of the coworkers arrived on site about 7:00 AM and found the victim dead, pinned under the tractor's left rear wheel. He went to tell the supervisor, who called 911. The Iowa State Patrol and ambulance arrived quickly, but the victim was dead at the scene. The rollover incident was not witnessed.
