SUBJECT: A heavy equipment operator was killed when he was crushed between the lift arm and the rollover protection cage of a skid-steer loader.

SUMMARY

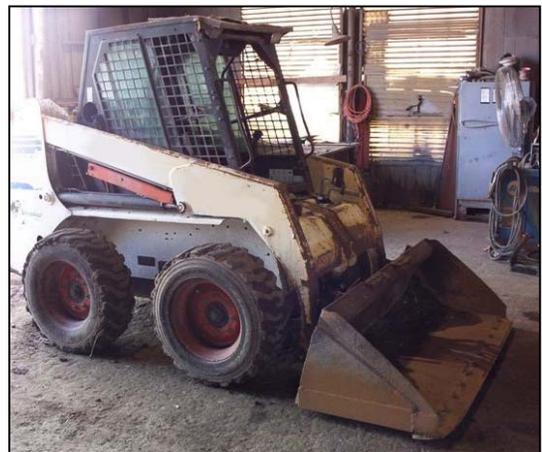
Figure 1. Skid-steer loader involved in the incident

On the day of the incident, July 24, 2004, the victim had been assigned to use a skid-steer loader (Figure 1) to clean crushed rock from underneath a rock conveyor. The material had accumulated there during the week as rock was moved from the crusher to storage piles. After the skid-steer loader had been running for approximately 16 hours, the decedent noticed a pin, which held the bucket to the lift arm, had become loose and slipped out of its seating. The pin (Figure 2) was threaded and it was not uncommon for one to become loose or fall out. However, company policy specified employees should stop using equipment when maintenance was needed. The decedent, who was still considered to be in training, attempted to repair the loose pin.

Recommendation #1: Employers should ensure that skid-steer loader operators do not position themselves outside of the operator's compartment while the machinery is in use.

Discussion: Employers should train employees to follow the safe operating procedures for skid-steer loaders and the accompanying manufacturer's recommendations for operating and servicing. Supervision, testing, and periodic retraining should also be included with proper instruction. Operators should be instructed not to position themselves or any parts of their bodies outside of the operator's compartment while the machinery is running. Furthermore, no one should pass or work under elevated portions of the equipment unless well-maintained lift arm supports are used. Operators should enter the loader only when the bucket or attachments are on the ground or lift arm supports are in place. Supports, other than those provided or recommended by the manufacturer, should not be used because they may not be capable of supporting the load.

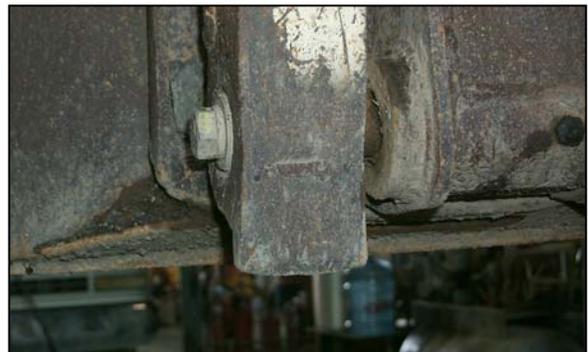
Figure 2. Pin attaching bucket to lift arm

Recommendation #3: Employers should ensure that all equipment is secured before servicing and maintenance are performed and that only authorized employees perform that maintenance.

Discussion: According to OSHA regulations for motor vehicles, mechanized equipment, and marine operations, all controls shall be in the neutral position, with the motors stopped and the brakes set, unless work being performed requires otherwise. Before a skid-steer loader is serviced, the parking brake should be engaged, the bucket or other attachments should be lowered to the ground, the engine should be turned off, and the key should be removed from the ignition switch. In instances where the maintenance cannot be performed with attachments on the ground, appropriate lift arm supports recommended by the manufacturer should be used. Furthermore, there may be instances where the operator's manual requires the engine to be running while maintenance is performed. In these events, the manufacturer's directions should be followed along with all safety recommendations, including having two or more people work on the task.

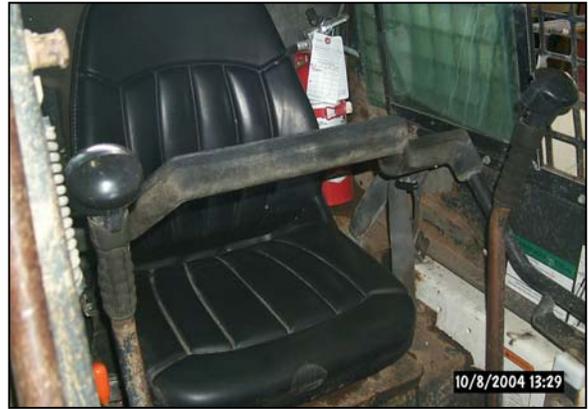
The loader had a safety system in which the operator's seat was equipped with a lap bar (Figure 3) connected to interlocks on the pedals. The machinery could not operate unless this bar was lowered across the lap. Once the bar was lowered, the pedal interlocks were released and the pedals could operate freely. In an attempt to repair the loose pin, the decedent raised the lap bar and stood up with his feet inside the operator's cab. By standing up, his body was extended above and in front of the protective operator's cage. With the engine still running, the victim put the lap bar down on the seat, releasing the interlocks, so that the loader could function despite having no operator in the seat.

Figure 3. Skid-steer loader operator's seat and lap bar

Recommendation #2: Employers should ensure that skid-steer loader operators do not bypass or override safety guards, switches, and devices and properly use seat belts and restraint bars.

Discussion: Employers should train employees on the safety features of the skid-steer loader and the importance of their proper use. Occupational Safety and Health Administration (OSHA) standards state that employees must follow all company procedures and should not disengage, remove, or bypass any switches, guards, or other safety devices. Operators should be instructed not to bypass or modify the safety features, such as in lowering the lap bar without being seated. Interlocked controls rely on the operator being appropriately positioned in the seat in order to function correctly. Interlock controls should also be inspected and maintained regularly to ensure that they are in proper working order. In addition, operators should be instructed to use seat belts. On some skid-steer loader models, the seat belt may be part of the interlock control system. They also protect the operator from being caught or crushed by the lift arms or attachments and from being ejected during a rollover incident.

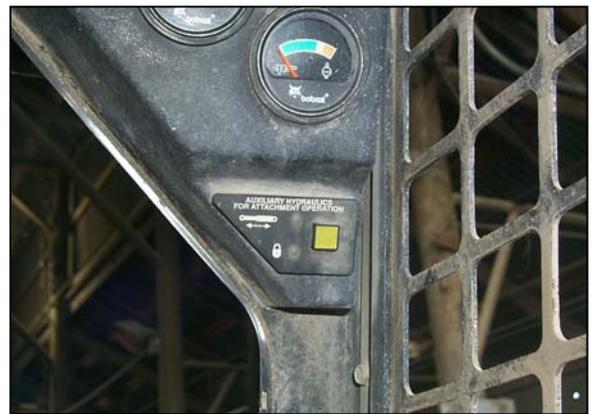
After activating the hydraulics for attachment operation (Figure 4), the decedent bent over and tried to reposition the pin. In the process of maneuvering the lift arm and bucket, the decedent depressed the foot pedal (Figure 5) that tilted the bucket up and back. Unable to stop the lift arm from moving and unable to move out of the way, the victim was pinned between the lift arm and the top edge of the rollover protection cage. There was no one working directly with the decedent; however, a coworker noticed the pinned employee, called for help, and ran to his aid. Coworkers tilted the bucket back down to release the victim, lifted him out of the loader, and started cardiopulmonary resuscitation immediately. Emergency medical services arrived within 20 minutes and transported the victim to a local hospital. The victim was flown by helicopter the next day to a major trauma center where he died on August 6, 2004, nearly two weeks after his injuries.

Figure 4. Button to control attachment operation hydraulics inside the operator's cab

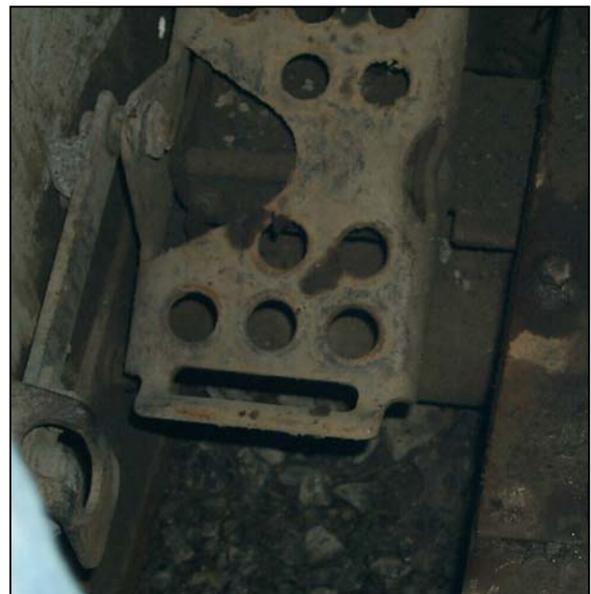
Figure 5. Pedal that was depressed to raise bucket
