NJ FACE
INVESTIGATION
REPORT

FACE 05-NJ-003

WORKER KILLED IN A FALL IN A BAKERY FERMENTATION TANK

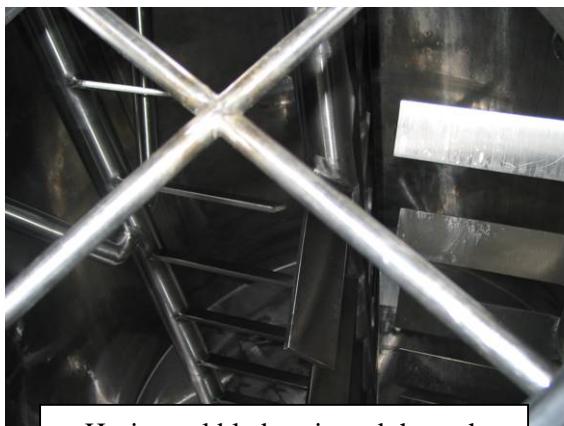
Horizontal blades viewed through
newly-installed bars across hatch

The interior of the tank contained two stationary vertical rods at the walls of the tank with attached horizontal blades, each of which was fixed at an angle of approximately 30 degrees. In the center of the tank was an agitation device with attached horizontal blades that rotated at 8 revolutions per minute to prevent settling of the contents of the tank.

The top of the tank was approximately 36 inches above the platform and the worker was 5 feet, 4 inches, tall. It is unlikely that he could have tripped and fallen into the 19-inch opening on top of the domed tank. Although emptied of bakery product, there was fluid at the bottom and product residue on the sides and blades of the tank. Since the incident, the company management has evaluated the area for hazards and retrofitted the tank with two stainless steel rods that were welded to form a cross across the tank opening. Other similar tanks have also been retrofitted.

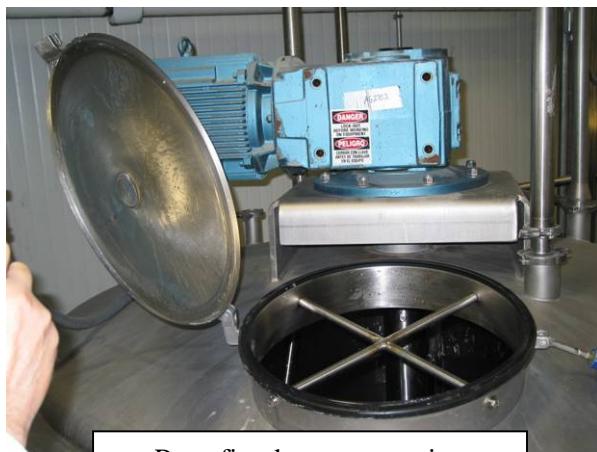
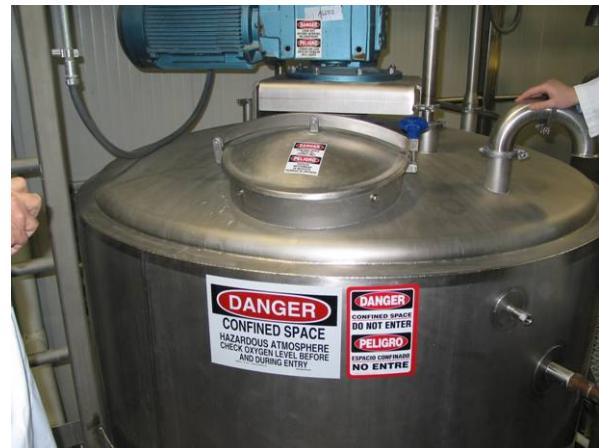
The company has also attached "Danger: Confined Space" signs on the tanks, in English and Spanish, to alert workers that no one should attempt to enter the tanks. Federal OSHA issued no citations to the company for violations of OSHA standards regarding this fatal injury.

Recommendation #1: Existing tanks should be retrofitted with devices that prevent entry into the tanks.
