**DATE:** February 22, 2006

**FROM:** Minnesota Fatality Assessment and Control Evaluation (MN FACE) Program  
Minnesota Department of Health

**SUBJECT:** MN FACE Investigation 05MN040  
Farmer Dies After Being Engulfed In Corn Inside A Steel Grain Bin

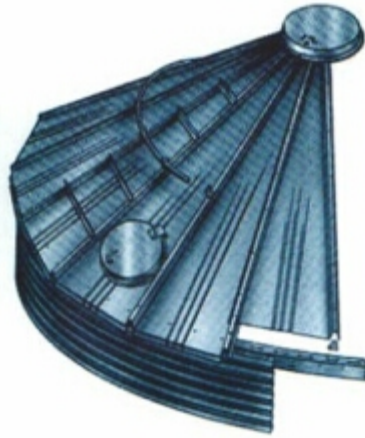
The bin was built in 1989, had a diameter of 24 feet and sides that were 18 feet high. It had a storage capacity of 7000 bushels and was full of corn at the time of the incident. The roof of the bin was sloped upward from the sides of the bin and was typical (Figure 1) of the roof on steel storage bins. The inverted cone design of the roof allowed the bin to be filled such that the surface of the corn was higher in the center of the bin than at the outer edges of it. This is commonly done when a bin is filled and results in a limited space between the surface of the stored grain and the inside surface of the bin roof. This limited space between the corn and the bin roof results in a situation where if a worker enters a bin when it is full or nearly full, the worker will not be able to stand upright inside the bin.

The bin had one access hatch located near the edge of the roof that was accessible by an exterior ladder attached to the side of the bin. The bin also had a center cover at the peak of the bin roof. The access hatch cover and the cover at the bin of the roof were opened before the victim and his father started to remove corn from the bin. Both covers were opened to allow dust that was generated inside the bin while it was emptied to escape through the roof openings. If bin access hatch and roof covers are left closed while bins are emptied, grain dust may accumulate inside a bin and possibly create a very hazardous environment inside the bin due to the explosive nature of airborne grain dust.

Figure1. Typical Steel Bin Roof with Access Hatch and Center Opening Cover

As indicated earlier in this report, the design of the bin roof allowed the bin to be filled such that the surface of the corn was higher in the center of the bin than at the outer edges of it. This resulted in a limited space between the surface of the corn and the inside surface of the bin roof. This limited space created in a situation where the victim would not have been able to stand upright inside the bin. After entering the bin, the victim probably was in a crawl position with his head toward the center of the bin. This may have resulted in him being pulled under the grain with his head below the rest of his body, a position in which he would have almost immediately become unable to do anything to prevent himself from becoming completely submerged including making a call for help.
