DATE: January 24, 2006

FROM: Minnesota Fatality Assessment and Control Evaluation (MN FACE) Program
Minnesota Department of Health

SUBJECT: MN FACE Investigation 05MN046
Farmer Dies After Being Injured While Attempting To Pull A Machine From A
Wet Field

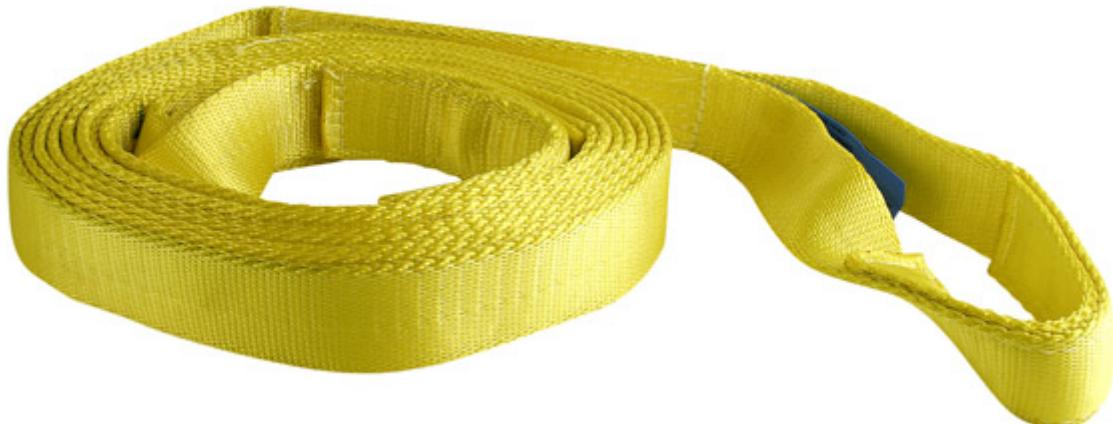
After the operator of the chopper notified the victim that the chopper was stuck in the field, the victim drove a large four-wheel drive tractor to the field to attempt to pull the chopper from the area where it was stuck. The victim hooked one end of a 3-4 inch wide strong flexible fabric tow strap commonly called a “snap strap” (Figure 1) to the forage chopper and the other end of the strap to the four-wheel drive tractor. A tow strap is a strong flexible fabric band that is several inches wide and typically varies in length up to 30 feet or more. The strength of “new” tow straps, commonly referred to as minimum breaking strength (MBS) depends on the width of the straps and the ply or number of layers and can range from around 20,000 pounds for a 2 inch wide 2 ply strap to over 50,000 pounds for a 4 inch wide 4 ply strap. In addition, the strength of a strap depends on its condition and may be significantly less if a strap has been damaged in any way during prior use. A U-shaped clevis (Figure 2) was used at each end of the tow strap to connect it to the tractor and the chopper. Each U-shaped clevis used a steel pin to connect the clevis to the chopper and the tractor. The clevis shown in Figure 2 has a locking clip which is a light weight clip that is used to prevent the pin from inadvertently being thrown or dislodged from the clevis. In this incident, it was not known whether or not the clevis pins were fitted with locking clips.

Figure 1. Typical Flexible Tow or “Snap Strap”.

Recommendation #1: Workers should only use towing components such as chains, clevises and snap straps that can withstand the forces exerted by towing units to which they are connected.

Discussion: Whenever workers use towing components such as chains, clevises, tow or "snap straps", etc. they should only use those that can withstand the forces exerted by the tractor or other towing unit to which they are connected. Modern farm tractors such as the four-wheel drive tractor associated with this incident typically are rated from 200 to over 400 horsepower and are much more powerful than older two-wheel drive tractors. In this incident, the clevis pin that coupled the snap strap to the chopper began to bend when the victim tried to pull the chopper from the field. The bending of the clevis pin indicates that the pin was not of sufficient strength to withstand the forces to which it was exposed by the large four-wheel drive tractor. Whenever farmers and other farm workers are using large horsepower tractors to pull or tow items, they should never use any tools or equipment that was originally designed for use with smaller farm tractors. If workers are in doubt as to whether items can be safely used with large tractors, they should consult with tractor and equipment manufacturers and dealers. After seeking advice from knowledgeable equipment representatives, they need to purchase and use only items of sufficient strength that have been designed for use with tractors of similar size to

those with which they intend to use the item. Tow straps such as the one used in this incident are often stamped with the “minimum breaking strength” (for example: 30,000 MBS) when new however, this stamped rating may not remain clearly visible over time if the strap becomes dirty or the stamp is worn off during use. If only items of appropriate strength are used with large horsepower tractors, the risk of items failing during use will be reduced along with a reduction in the risk of workers being injured in the event of a component failure as happened in this case.

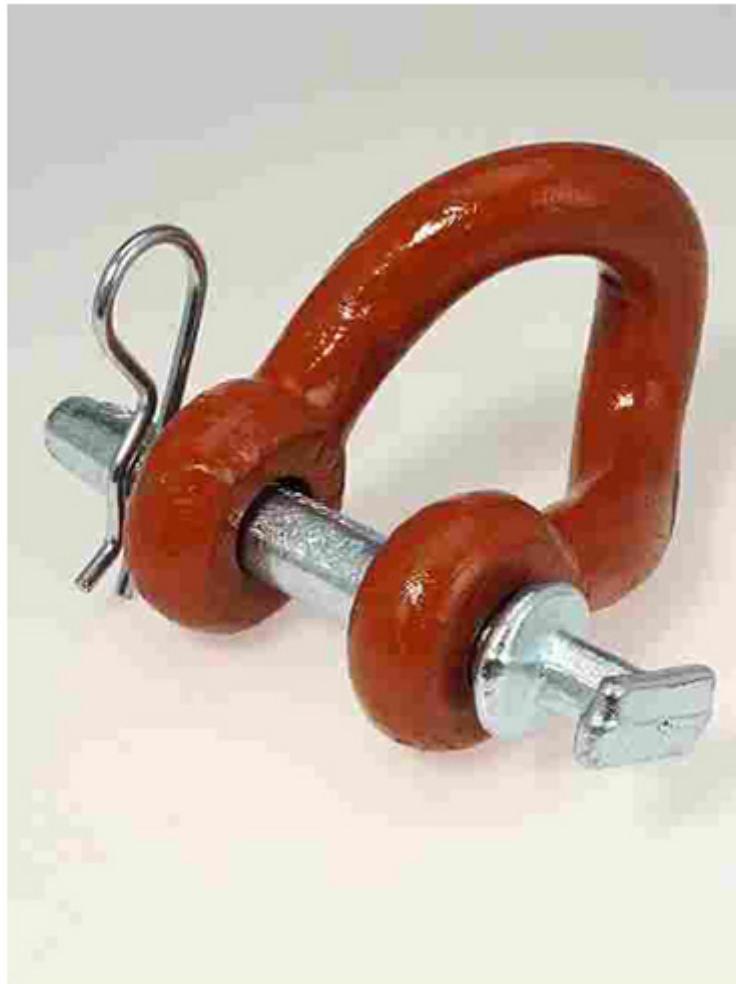
Figure 2. Typical Clevis with Pin and Locking Clip.

While the victim tried to pull the stuck chopper free, the pin in the clevis hooked to the chopper started to bend. As the pin bent, the U-shaped clevis spread apart and suddenly unhooked from the chopper. It could not be determined if the clevis pin associated with this incident was secured with a locking clip as shown in Figure 2. However, even if a locking clip had been used, the lightweight clip would not have been of sufficient strength to prevent the clevis from unhooking from the chopper. Due to the energy stored in the tow or "snap strap" while it was under tension, the clevis was propelled toward the tractor and the victim seated in the enclosed cab. The clevis shattered the rear window of the cab, struck the victim and caused him to lose control of the tractor.
