**SUBJECT:** A supervisor dies when crushed by a machine that manufactures concrete blocks.

**SUMMARY**  
**California FACE Report #05CA006**

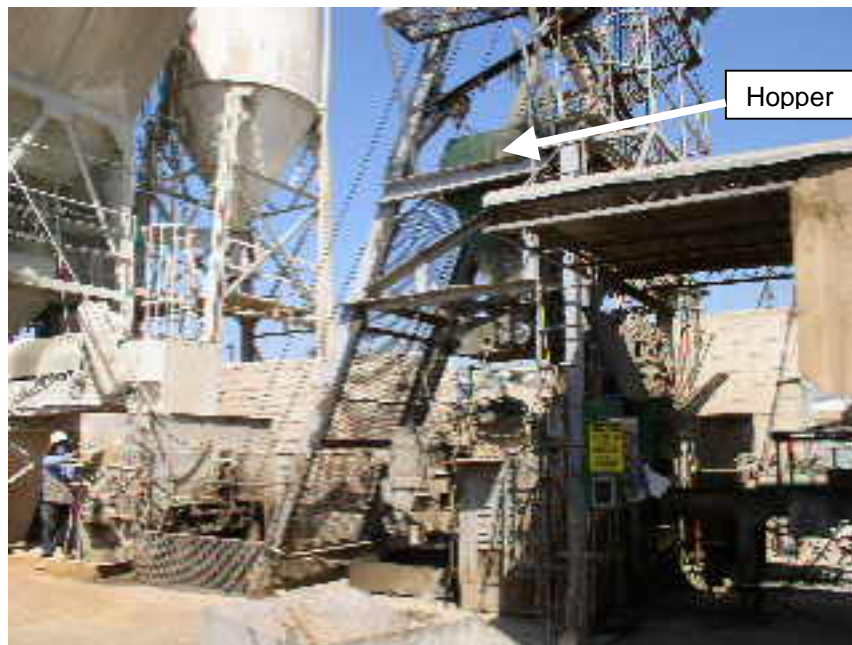
Exhibit 1: The automated machine that made concrete blocks.

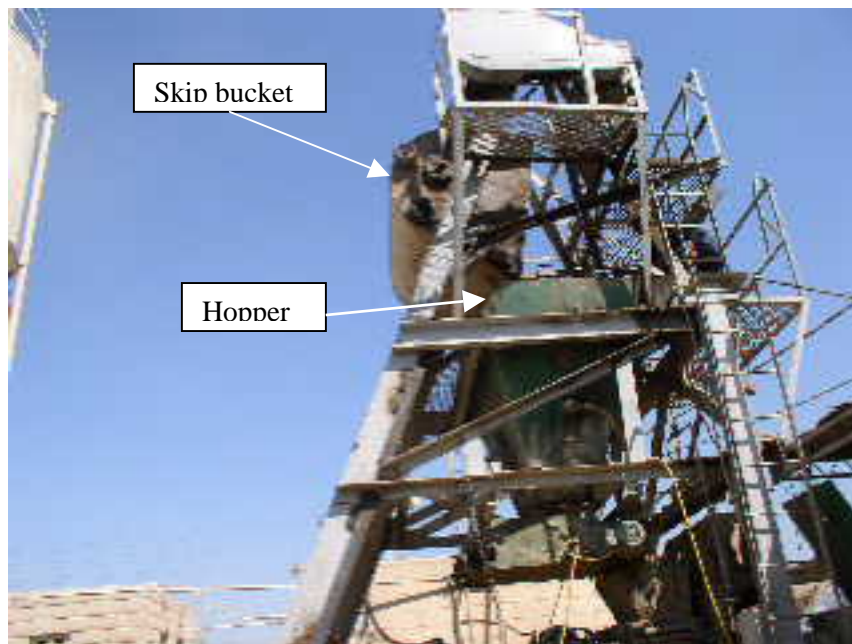
Exhibit 2: The portion of the machine the victim climbed onto.

Discussion: Since the contents of the hopper did not always smoothly feed into the concrete block-making machine, a vibrator was sometimes used to ensure the concrete mixture flowed at a constant rate through the hopper opening. A worker was required to climb up onto the machine to connect an airline to turn on the vibrator every time it was used. If an air hose connection, valve, or service switch had been run down to the control panel, then workers could have turned on the vibrator remotely, eliminating the need to climb onto the machine.

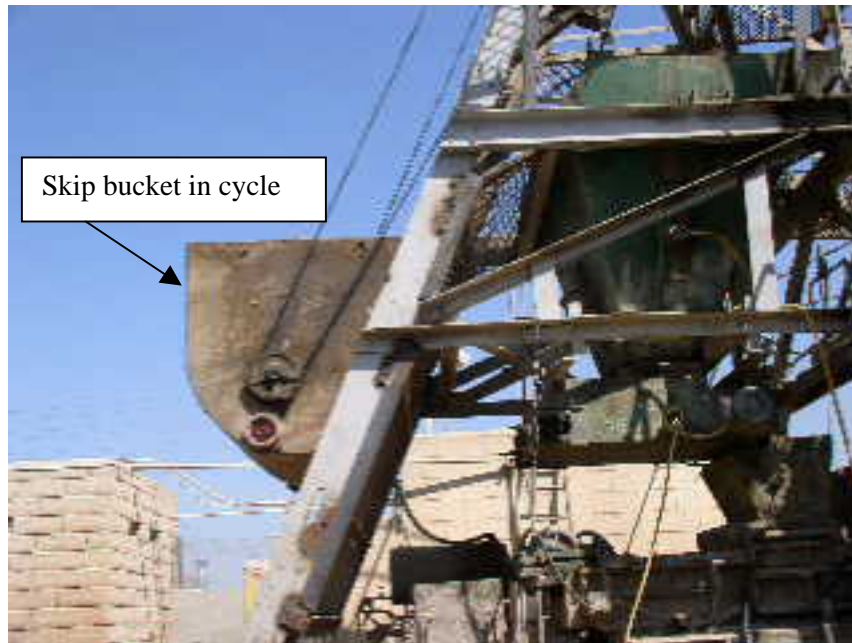
No one witnessed the victim climb up onto the machine while it was running, but the machine operator saw the victim being dragged between the frame of the machine and the skip loader which was on a down cycle. The victim then dropped onto the machine mechanism below. The operator immediately shut off the machine and went to get help. Paramedics responded and treated the victim, and then transported him to a local hospital where he died from his injuries.

Exhibit 3: The place on the machine where the victim was dragged by the skip bucket.

Discussion: Because of the ever-present danger of entanglement when working near moving machinery components, employers should continually strive to protect employees by providing machine guarding in the areas where work is actually performed. Employers should ensure that hazardous areas are sufficiently guarded against personnel entry by physical barriers or locked gates. Advances in engineering technology may be such that machine guarding may be applicable to this particular machine. Employers should contact machine manufacturers and retrofit the machine, if applicable, with guards and barricades that prevent any part of the body from contacting the machine's moving parts. Another consideration would be to install interlocking mechanisms designed to deactivate the machine when the gate or guard is opened or moved. A gate or guard with a by-pass switch wired to the emergency stop button could stop the machine's movements instantly when the gate is opened. Employers can ensure that employees do not climb on running, unguarded machines through enhanced programs of task-specific training, supervision, safe work recognition, and progressive disciplinary measures.

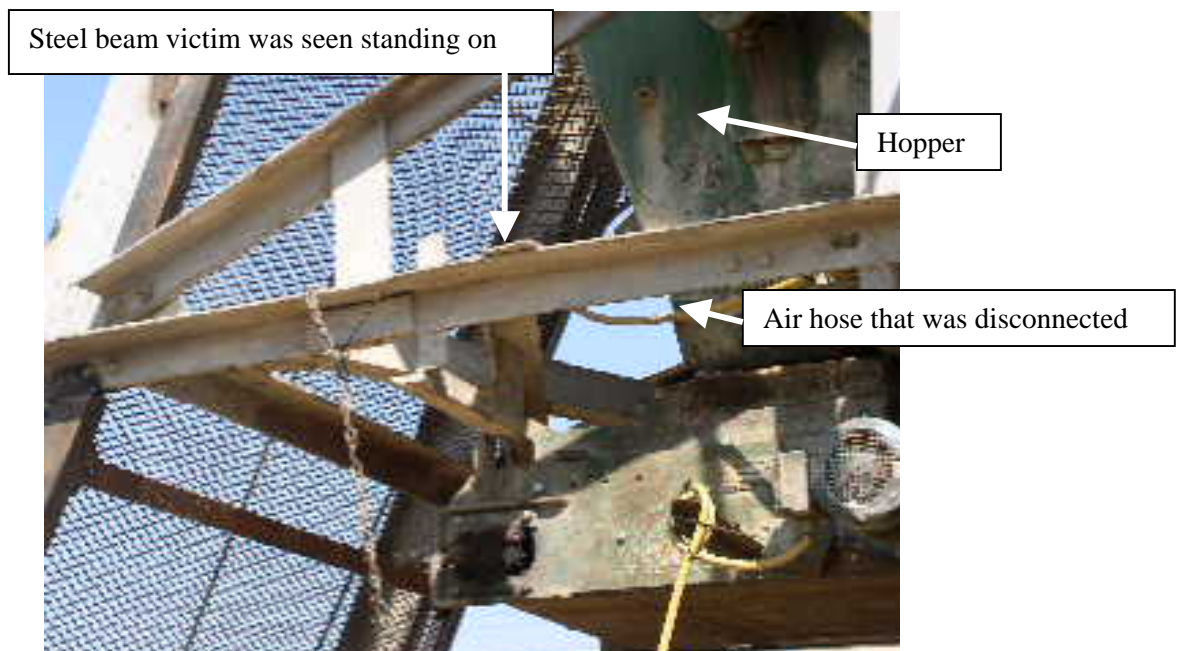
On June 10, 2005, at approximately 7:20 a.m., a 52-year-old Hispanic supervisor was crushed between the structural frame and skip hoist of a machine that makes concrete blocks. The CA/FACE investigator learned of this incident on June 23, 2005, through the Legal Unit of the Division of Occupational Safety and Health (Cal/OSHA). Contact with the victim's employer was made on June 26, 2005. On July 26, 2005, the CA/FACE investigator traveled to the facility where the incident occurred and interviewed the plant manager and employees. The machine involved in the incident was photographed, and the area where the incident took place was examined.

Exhibit 4: The portion of the machine frame the victim was dragged between by the skip bucket.

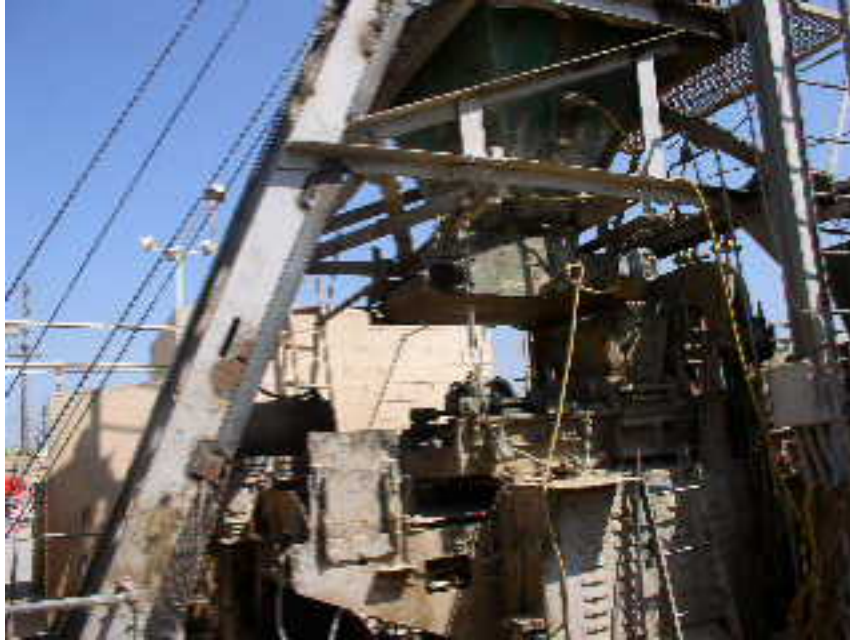
Exhibit 5: The portion of the machine the victim fell to after he was crushed by the skip bucket and machine frame.
