MIFACE INVESTIGATION: #04MI160

SUBJECT: Carpenter Dies When Eight-foot Trench Wall Collapses During Sewer Pipe Replacement

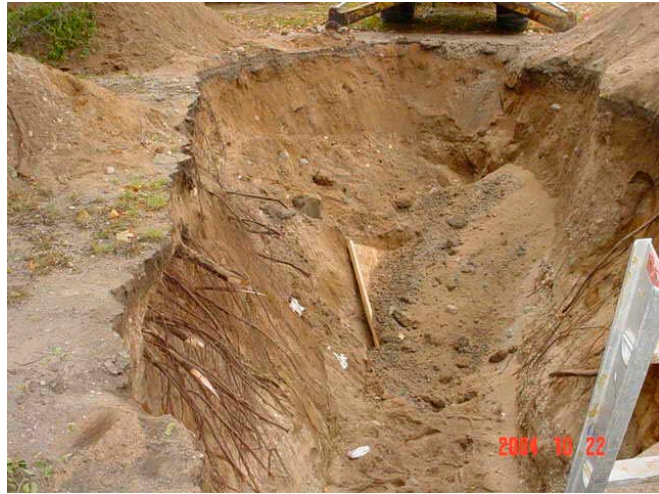
On October 21, 2004, a 22-year-old male carpenter died when the walls of an eight-foot excavation he was working in collapsed and completely covered him (See Figure 1). A homeowner hired his employer to replace the six-inch clay tile sewer pipe leading from his home to the alley behind the home and garage. The firm was “threading” a new four-inch PVC pipe through the deteriorating existing clay six-inch pipe, and leaving the existing six-inch pipe in place. Prior to the victim’s arrival, the employer excavated an approximately eight-foot-deep trench from the home’s basement to the homeowner’s garage. Once beyond the garage the employer dug another eight-foot excavation from the garage to the alley where the sewer connection was located. The soil conditions in the second excavation were sand/gravel and the angle of repose (maximum permissible slope) for the excavation sides varied from 60-80 degrees. To determine how far away the four-inch PVC pipe was from the sewer line, the victim either knelt or laid down at the bottom of the excavation. The victim was either still kneeling or lying on the ground when the south side of the excavation collapsed, completely burying him and burying his coworker up to his waist. 911 was called, and at the same time all employees jumped into the excavation to rescue the individuals in the trench. Emergency personnel arrived within minutes, removed the victim and transported him to a local hospital where he died the next day.

Figure 1. Picture of Trench after cave-in

- Employers should ensure when employees are working in excavations that require a supporting system that a supporting system is implemented in accordance with MIOSHA standard requirements.

The selection of preventative measures is based on this evaluation. Methods such as angle of repose, sloping and benching, tight sheeting/sheet piling, or trench boxes and shields may be used to protect personnel in the excavation. Sloping involves positioning the soil away from an excavation trench at an angle that would prevent the soil from caving into the trench. Shoring systems are structures, such as a metal hydraulic, mechanical or timber that provide support to the walls of the trench and prevents cave-ins. If either adequate sloping or shoring had been used in this incident, this fatality may have been prevented.

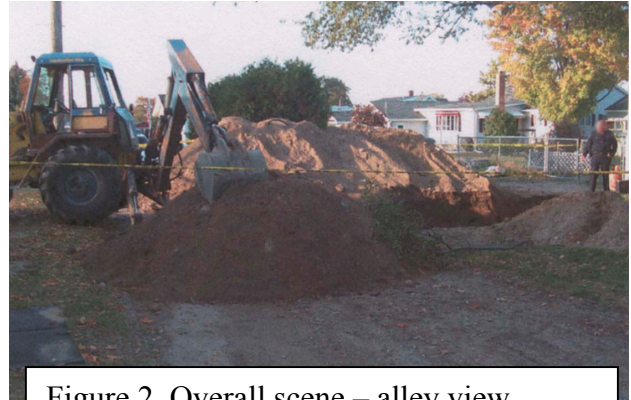
The residential property where the company was performing the sewer replacement had fairly narrow lots. The company owner stated that the lots were only 50 feet wide, and the sewer taps were very close to the property line. In this case, there was only six feet of room between their work area and the adjacent property line, making it difficult to cut the trench to the proper angle of repose for the soil conditions (See Figure 2).

Figure 2. Overall scene – alley view

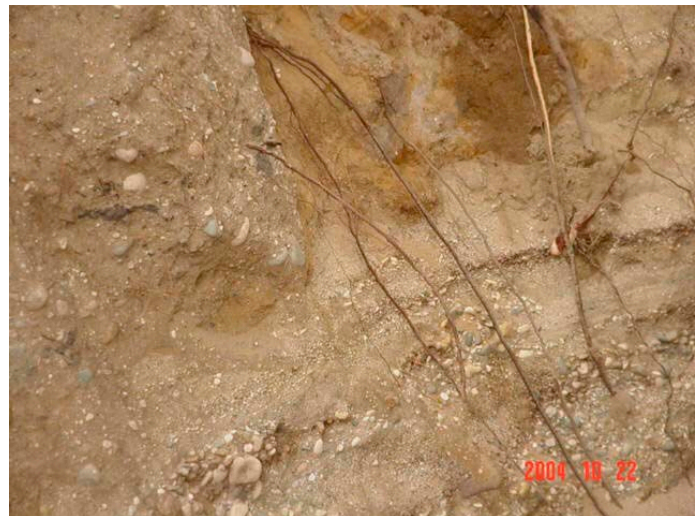
Figure 3. Soil composition and tree roots

alley. The soil conditions in this excavation were sand/gravel (See Figure 3). The owner states that at the time of the wall collapse, the backhoe was located approximately six feet from the edge of the trench and was not idling. The company blocked off the alley throughway so there was no vibration from the alley traffic.
