SUBJECT: A backhoe operator died when his backhoe pinned him against a retaining wall.

California FACE Report #05CA001

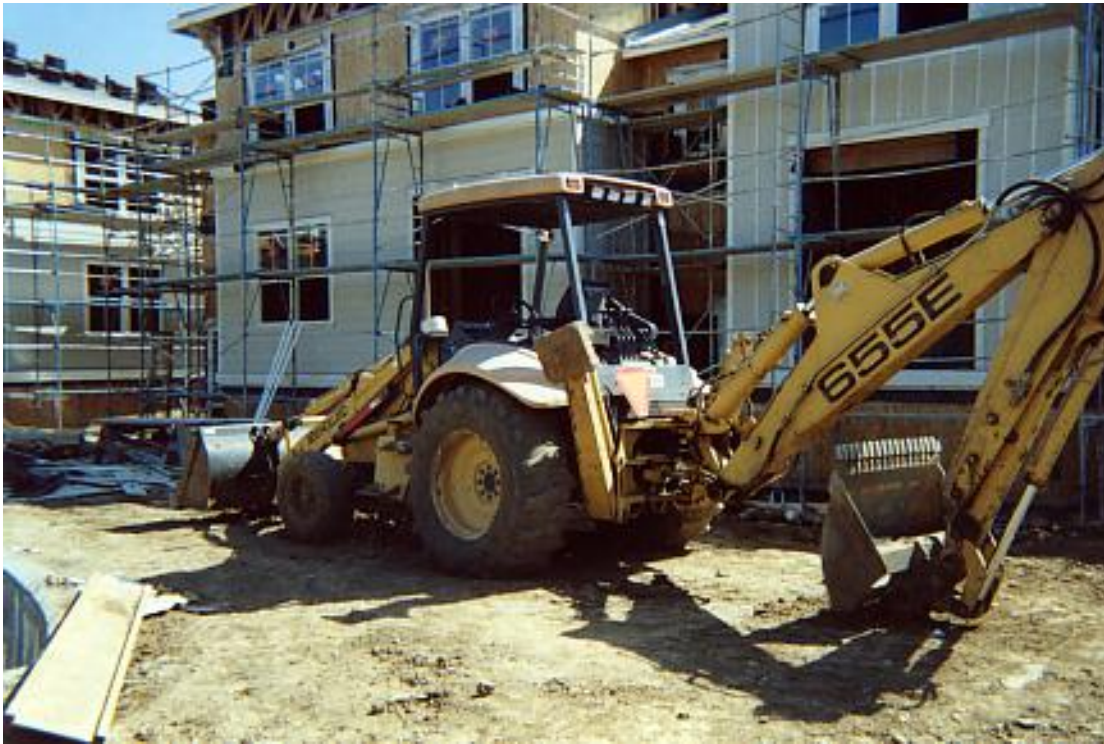
The victim, who was the operator of the backhoe, was bringing rock and gravel to be unloaded in the trench. He drove the backhoe to the trench and then parked it so the front bucket was at the end of the trench. The backhoe was on an incline that measured approximately 20 degrees. As the victim got off the backhoe, he left the front bucket that was full of rocks and gravel elevated, and set the parking brake. The victim and a co-worker used shovels to scoop the gravel and rock out of the bucket and then spread it over the pipe in the trench. The victim then began to lay down the landscaping fabric over the gravel and rock. He was bent over directly in front of the backhoe bucket when the backhoe started rolling forward and pinned the victim against the retaining wall. Another worker got on the backhoe and moved it in reverse to release the victim. This worker told the police that the backhoe's parking brake was engaged and the gear shifter was in 1st gear. A check of the parking brake showed that it was operational. The victim's supervisor was in the area but not within visual distance of the incident when it occurred. The paramedics were called and they treated the victim at the scene, and then transported him to a local hospital where he died from his injuries.

Exhibit 1. The backhoe involved in the incident.

Recommendation #1: Ensure employees lower the loader and backhoe buckets to the ground when parking a backhoe unattended on an incline.

Recommendation #2: Ensure employees block and/or chock the backhoe wheels when parked unattended on an incline.

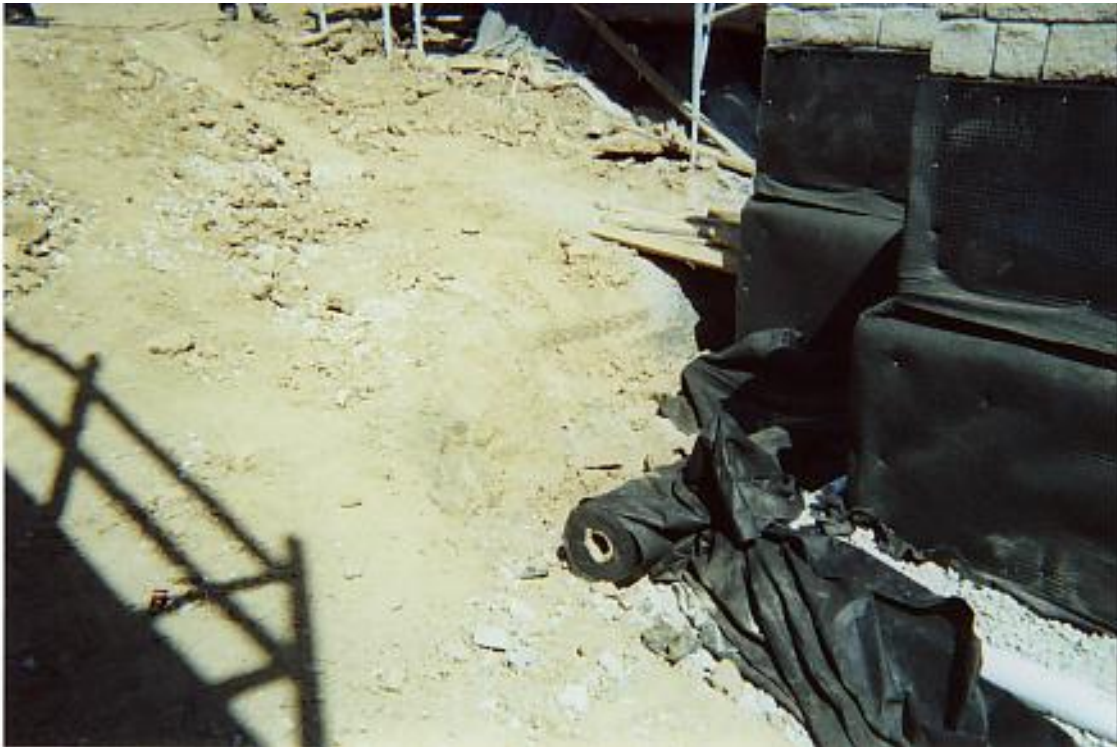
Exhibit 2. The area where the incident took place, depicting the angle of the slope the backhoe was parked on.

Discussion: When parking a backhoe, it is recommended that the operator select level ground whenever possible, engage the parking brake, lower the loader and backhoe buckets, shift all controls to neutral, idle then shut off the engine, remove ignition key, and block and/or chock the wheels. When the backhoe has to be parked on an incline, then every effective mechanical

means to prevent the backhoe from moving downward must be taken. The lowering of the loader and backhoe buckets is one way to effectively prevent the backhoe from moving. When the buckets are lowered to the ground, they act like a barricade because the weight of the buckets creates drag to help prevent the backhoe from moving, even on an incline. When backhoe operators perform this precautionary function each and every time they get off their tractor, incidents such as this one could be prevented. Employers can enhance worker compliance with safe work practices through programs of task specific training, supervision, recognition, and progressive disciplinary measures.

Discussion: Even when the parking brake is applied, equipment can move if there is not enough pressure applied. The manufacturer of the backhoe stated in its operators' manual that the parking brake was not designed to hold the backhoe in place when parked unattended on an incline. When equipment parked on inclines has the wheels chocked and the parking brake set, it is prevented from moving by effective mechanical means. Had the victim chocked the backhoe wheels, it would have prevented it from moving forward on the incline and this incident might have been prevented.

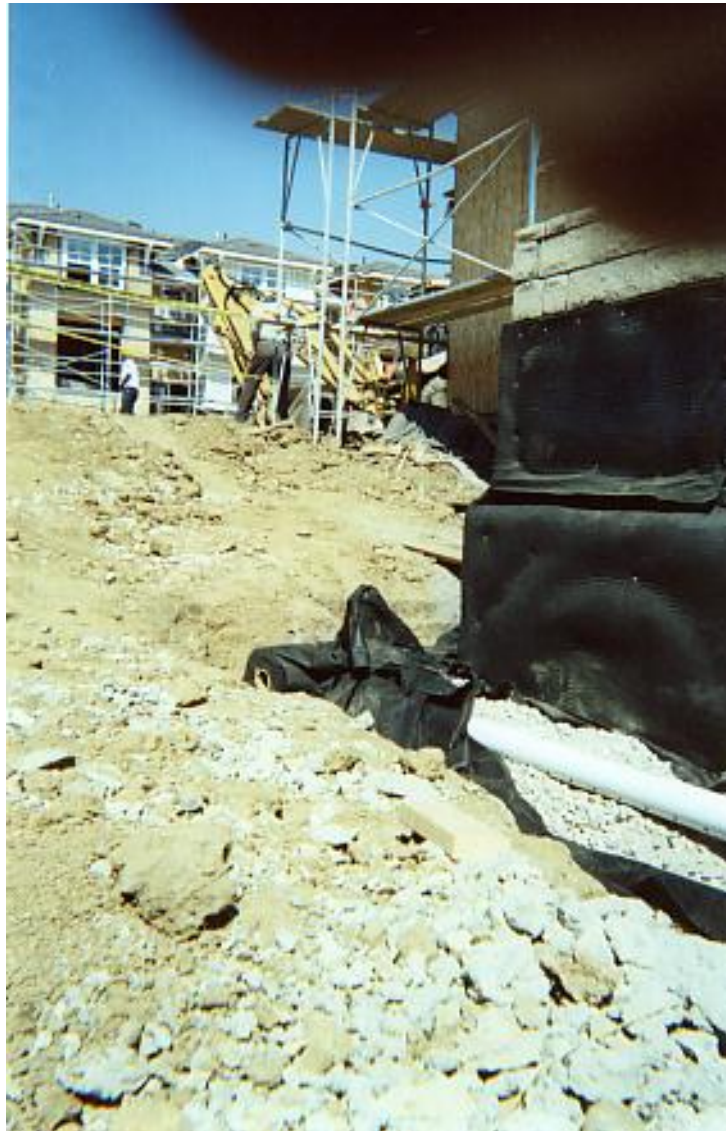
The site of the incident was a construction site of a housing complex. Behind a building under construction was a retaining wall which was 6½ feet high. At the bottom of the wall was a two-foot drainage ditch with a pipe that was to be covered with gravel and rock and then wrapped with landscaping fabric and backfilled. The machine involved in the incident was a backhoe tractor that was 24 feet long and weighed more than 14,000 pounds. The backhoe was equipped with a 1.3 cubic yard loader bucket, and a 24-inch heavy duty backhoe bucket. The parking brake was a disc on the transmission output shaft that was mechanically activated with a hand lever located on the right side of the operator's seat.

Exhibit 3. A view of the retaining wall and the slope of the surface where the backhoe was parked when the incident occurred.
