Logging Site Heavy Equipment Operator Dies After Being Pinned by the Dozer he was Operating in West Virginia

Case: 03WV022-01

Release Date: October 23, 2003

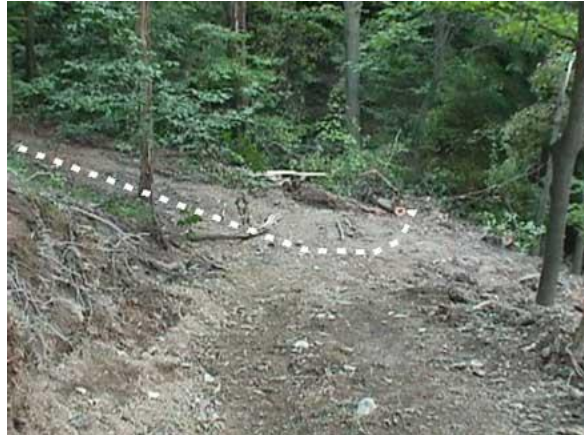
Figure 1. From left to right is the path the bulldozer followed while backing out of the newly constructed skid road. The end of the dotted line on the right depicts the nearly vertical drop-off.

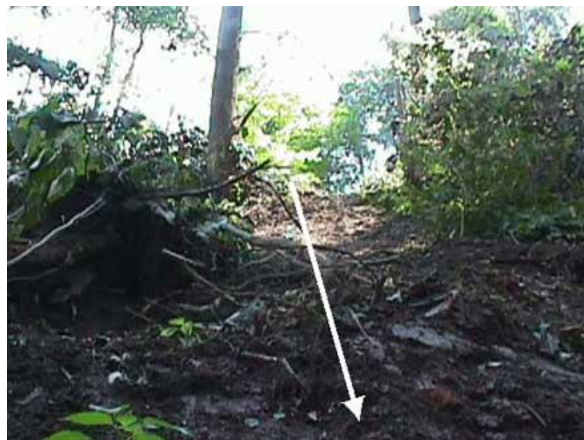
Figure 2. This photo shows the steep bank the dozer began to slide down backwards before rolling over. The white arrow represents the path of the sliding dozer.

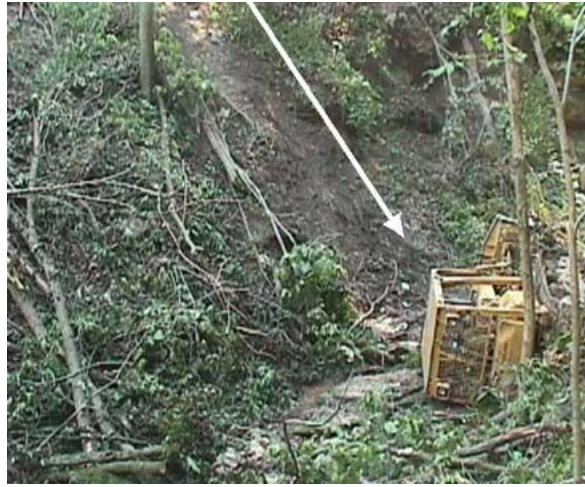
Figure 3. This photo shows the section of bank where the rollover occurred and the dozer's final resting place.

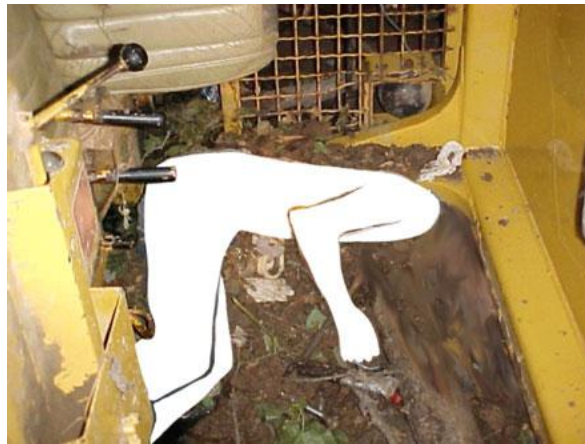
Figure 4. The victim's position after the rollover.

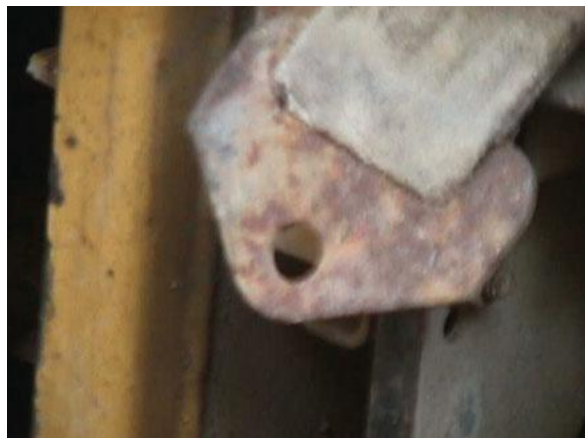
Discussion: The dozer's seat belt was rusted and in a state of disrepair (see [Figure 5](#)). Evidence suggests that the belt had not been recently used. Equipment should be inspected as it arrives on site and defects or damage repaired or the unserviceable machines should not be operated. It is important to realize that a machine with a defective safety device is considered to be unserviceable. The OSHA Logging Standard CFR 1910.266 (f)(1)(i) requires that the employer assure that each machine, including any machine provided by an employee, is maintained in serviceable condition.² Furthermore, 1910.266 (d)(3)(ii) & (iii) requires the use of an available seat belt while the machine is being operated in order to restrain the employee in the machine's cab.² It is unknown whether the operator would have used the belt had it been functional. However, it is the employer's responsibility to ensure such use if it is functional or remove the machine from service. Had the defective seat belt been identified and repaired prior to allowing the victim to operate the equipment and had the employer made seat belt use a condition of employment, the seat belt would have kept the victim within the safety zone provided by the cab's ROPS, and the fatal incident may have been avoided.

Figure 5. This photo shows the condition of the operator's restraint system.

Recommendation #1: Employers should ensure that machines , including those provided by employees, are maintained in serviceable condition and that available safety devices are used while the equipment is being operated.
