# Farmer Dies Following a Tractor Rollover in West Virginia

Case: 03WV001-01

Release Date: July 8, 2003

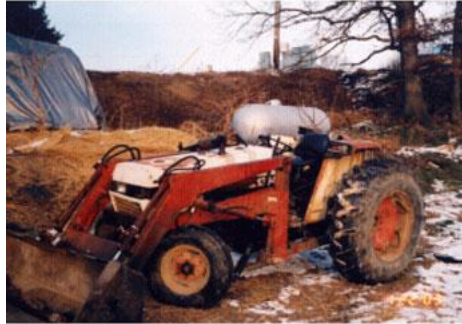
Figure 1. 1982 Case Model 1394. Photo was taken shortly after the incident.

On January 18, 2003, a 73-year-old male farmer (victim) died of injuries sustained when the tractor he was driving over turned after sliding sideways down a soft shale bank adjacent to his snow covered work area. The victim was using a 1982 Case Model 1394 tractor, which was equipped with a front end loader (see [Figure 1](#)). Just prior to the incident, the victim was loading large round bales of straw onto a flat bed trailer. Due to a recent snow, and his concerns about being able to pull a loaded trailer up-hill from the usual loading area, he had established a temporary loading area. The temporary work area was actually a farm-related dirt road that had been widened with shale within the past year or so and therefore its edge was fairly soft (see [Figure 2](#)). Although the victim had performed loading operations often, it was reported that the loading had never been done in this particular area. The victim had just loaded a large round bale on a flat bed trailer and was returning to the bale storage area when his left front and left rear wheels came too close to bank's edge (see [Figure 3](#)). The soft snow covered bank gave way causing the tractor to slide then roll sideways down the hill (see [Figure 4](#)). The tractor landed upside down pinning the victim (see [Figure 5](#)). The tractor did not have a ROPS or seat belt. The victim's wife came out to the work zone to check on the victim and found him pinned under the tractor. She called EMS which arrived within minutes and found no signs of life. The body was extricated and transported to the local funeral home.

Discussion: Preventing death and serious injury to tractor operators during rollovers requires the use of ROPS and a seat belt. These structures, either a roll-bar frame or an enclosed roll-protective cab, are designed to withstand the dynamic forces during a rollover. In addition, seat belt use is necessary to ensure that the operator remains within the "zone of protection" provided by the ROPS. OSHA regulations require that all tractors built after October 25, 1976, and used by employees of a farm which employs 11 or more must be equipped with ROPS and a seat belt.<sup>1</sup> In West Virginia, many tractors are in use on family farms with fewer than 11 employees and therefore do not fall under OSHA regulations. Given the uneven terrain and environmental conditions in West Virginia, all farmers should voluntarily have their older tractors retrofit with a properly designed ROPS and seat belt system. A ROPS was and still is available for the tractor involved in this incident (1982 Case 1394). If the tractor had been equipped with a ROPS and seat belt had been used, this fatality might have been prevented.

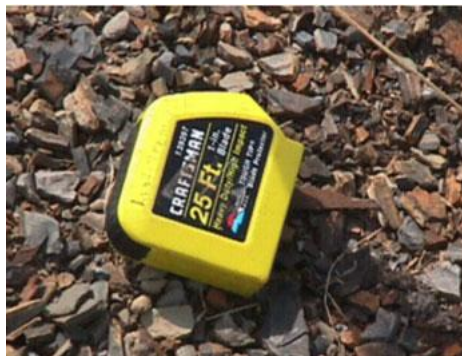
Figure 2. Photo shows the nature of the aggregate which was used to widen the road.

Discussion: Hilly terrain which has been graded usually will result in a steep bank or drop-off. In addition, recently graded terrain, especially near the edge of a bank, will yield a surface which provides little support for equipment. Sudden shifts in a tractor's center of gravity (CG), due to soft terrain near edges, has often resulted in overturn. In this incident, the tractor's front left and rear wheels came too close to a soft edge causing a slide and CG shift which resulted in an overturn. Farmers should realize that operating equipment within close proximity to a bank's edge is dangerous. Changes in the environment, equipment, and the operator's judgment or any combination there of is always possible. Therefore, bank edges near barns, storage areas and other work zones need additional consideration. Simply demarcating the edge with section of fence will provide the equipment operator with a visual warning and an established work zone boundary. Greater operator protection can be achieved by barricading the edge with a series of large boulders or large diameter logs that are sufficient to prevent equipment from getting too close to the edge. Had this edge been demarcated and/or barricaded in some manner, this incident may have been prevented.

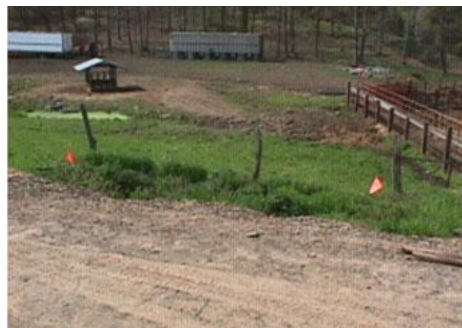
Figure 3. The far side of the white line depicts part of the area that had been widened. The orange flags indicate where the left front and left rear wheels began to slide. The arrow indicates the intended direction of travel.

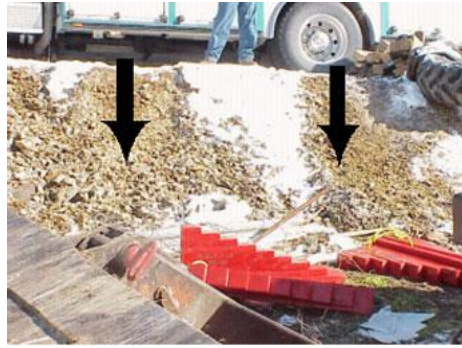
**Figure 4.** The black arrows indicate the slide marks which were made by the front left and rear wheels. The point of the arrows indicate the approximate position of the wheels when the tractor began to roll. This photo was taken over the bottom of the overturned tractor. In the foreground is the end loader bucket. From this perspective, the front of the tractor is on your left.

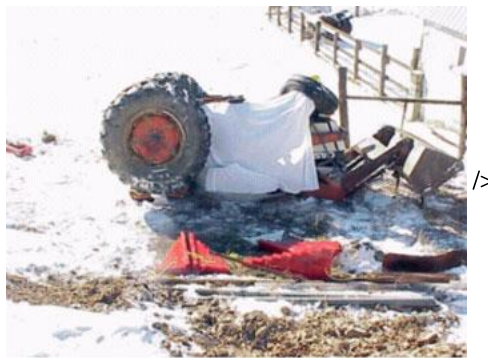
**Figure 5.** The tractor's final resting place. Photo was taken from the bank's edge.
