Worker Dies After Being Run Over by the Skidder He was Operating in West Virginia

Case: 02WV007-01

Release Date: June 18, 2002

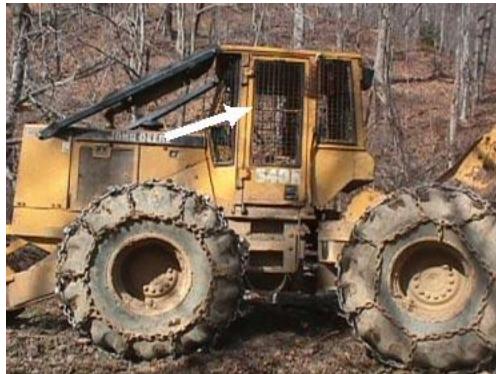
Figure 1. This is the skidder which ran over the victim. The arrow points to one of two doors which were not present the day of the incident.

Recommendation #1: Employers should ensure that machines are maintained in a safe and serviceable condition.

Discussion: Equipment owners should realize the correlation between defective equipment and risk-taking. The skidder's cab doors were in a state of disrepair and removed by the owner. The owner had inappropriately allowed the machine to be operated without the doors. Operating skidders without the doors or with the doors tied open are unsafe practices, especially when operators are not wearing their seat belts. Equipment should be inspected regularly and defects or damage repaired or the unserviceable machines should be pulled from service or replaced. The OSHA Logging Standard CFR 1910.266 (f)(1)(ii) requires that defects or damage shall be repaired or the unserviceable machine shall be replaced before work is commenced.²

Had this skidder's cab doors been present and latched the operator would likely have remained inside the cab and would not have been run over by the machine and its load.

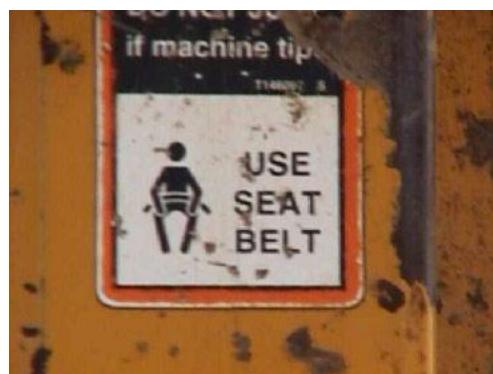
Figure 2. Warning sign located inside of the cab.

Recommendation #2: Machine operators should always wear their seatbelt while operating machines.

Discussion: The owner reported that during the first day of employment the victim had received on-the-job observation by the owner himself to verify his knowledge and skills concerning skidder operation. The owner stated that during this observation period, the victim consistently wore his seatbelt, complying with the warning sign within the skidder cab. Shortly before the incident, the operator either forgot or made the conscious decision not to wear his seat belt which directly violates the manufacturer's recommendations. The OSHA Logging Standard CFR 1910.266 (f)(1)(iii) requires that each machine operator comply with the operating instructions.² The value of wearing a seat belt will be realized when the operator least expects it. Had the operator continued his normal practice of using his seatbelt, he would have remained within the cab and the fatal incident would have been avoided.

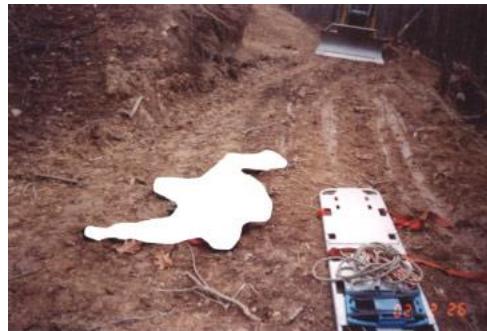
Figure 3. This is where the victim was found lying in the road.

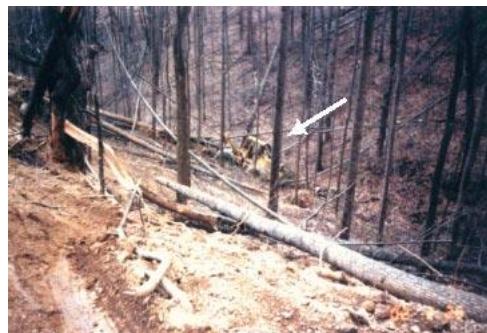
Figure 4. The arrow points to the skidder's final resting place.
