Rental Property General Laborer Dies Following a Tractor Roll Over in West Virginia.

SUMMARY

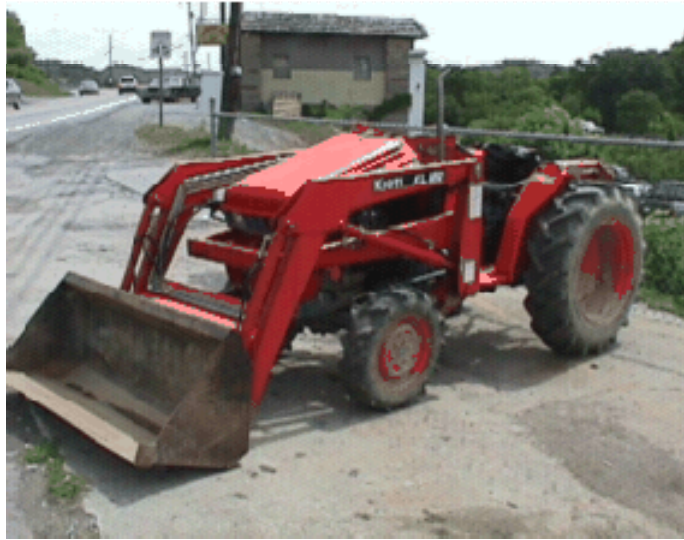
Figure 1. This photograph shows the tractor involved in the fatal incident.

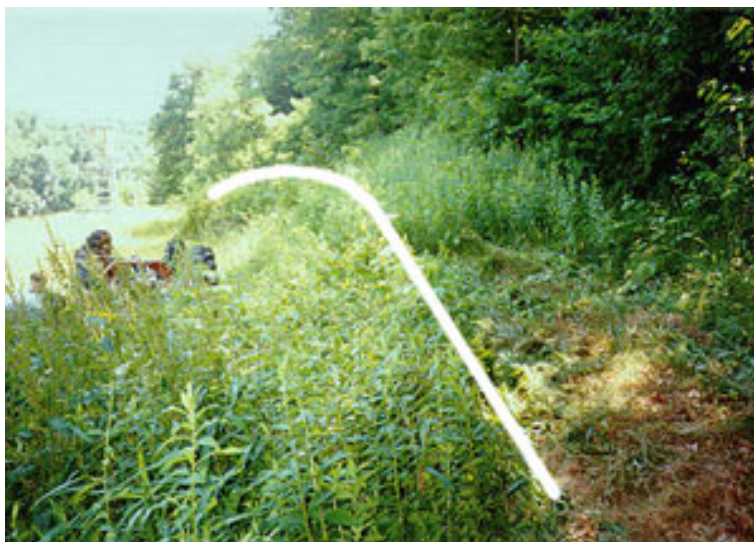
**Figure 2. This photo shows the level area on the left which was to be mowed.
The white line indicates the location of the ledge.
The ridge along the tree line on the right was to be string trimmed.
The photo also shows the actual mowed path and the inverted tractor.**

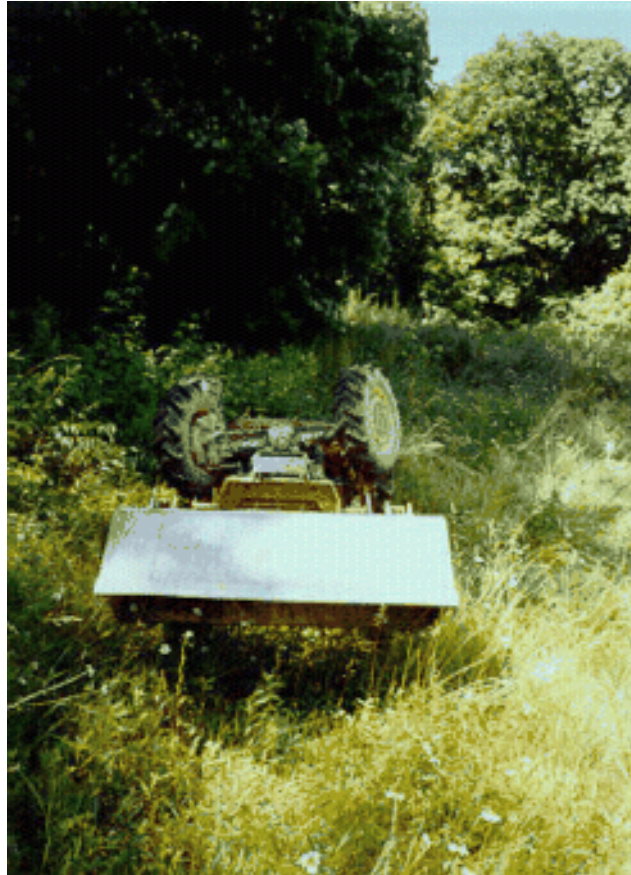
Figure 3. This photo shows the tractor's final inverted resting place.

necessary to ensure that the operator remains within the "zone of protection" provided by the ROPS. Usual set-up for the tractor involved in this incident included installing the ROPS, which had to be taken off in order to store the tractor. It was reported by the property's tenants and neighboring towing service employees that usual operation of the tractor included the ROPS being present. If the tractor involved in this incident had been fitted with its ROPS and the seat belt had been in use, this fatality might have been prevented.
