STATE OF NEW YORK DEPARTMENT OF HEALTH

FATALITY ASSESSMENT AND CONTROL EVALUATION

Teenage Farm Worker Dies during Silage Defacer Entanglement Case Report: 05NY001

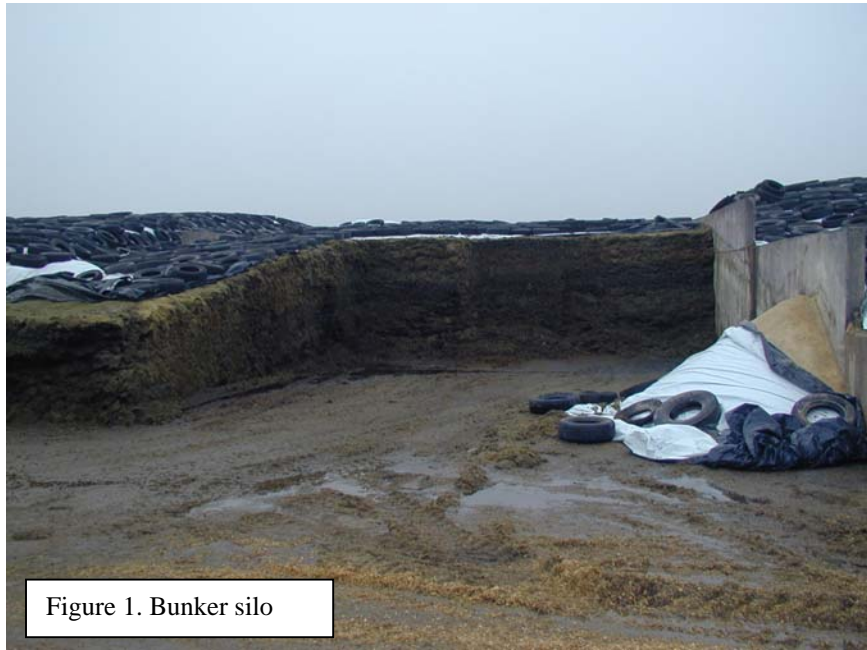
Figure 1. Bunker silo

A bunker silo is a concrete structure that is set horizontally in the ground and has a concrete base and walls with an open top. Silage is placed and packed in this bunker, then covered with plastic until it is used. As it is used, the material is removed from the front of the silage bunker towards the back. The cover on the top of the bunker is moved back to the removal level of the silage (Figure 1). A payloader or a front-end loader on a tractor is commonly used on dairy farms to scoop up silage from the silage face and place it in a feed mixing wagon. A newer technology that farms have begun to use is a piece of equipment called a silage defacer. This unit attaches to either the front of a payloader or an agricultural tractor. Lift arms allow the defacing unit to be moved vertically up and down. The unit has large rotating wheels with teeth on them that remove a slice of silage. Typically, these teeth remove about 6 inches of material from the face vertically each time (Figure 2). The unit is placed in the uppermost position and shaves off a section of the silage face allowing the material to fall to the base of the silage bunker. A payloader then scoops the silage and places it in a feed mixing wagon. A defacer is used to allow a clean slice to be removed and a uniform face to be maintained, which prevents additional spoilage by reducing the surface area of silage exposed to the elements. Additionally, this reduces the potential for overhangs and unstable silage faces to form, which have been known to collapse and entrap workers.

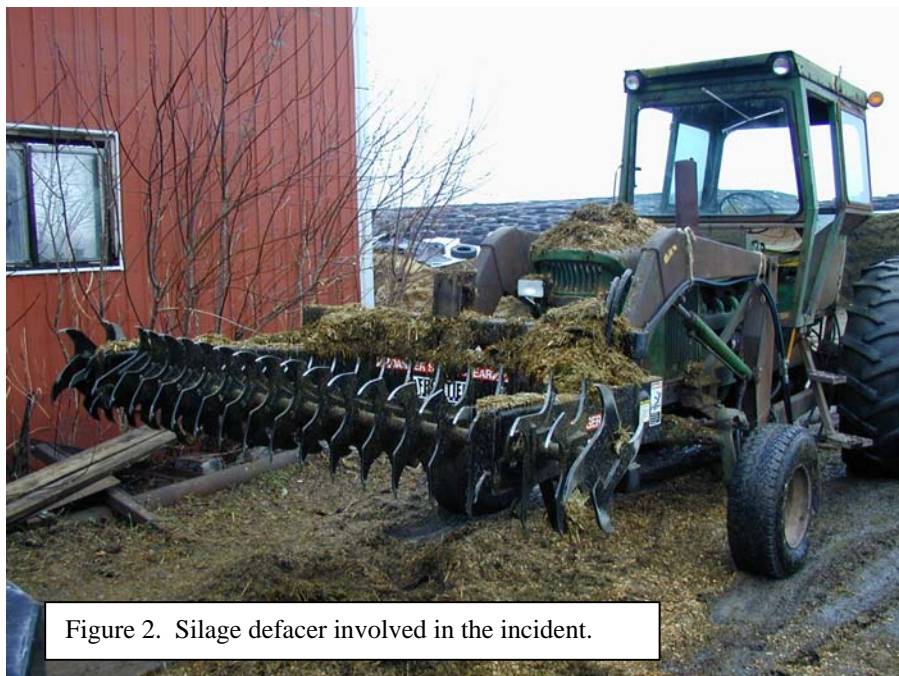
Figure 2. Silage defacer involved in the incident.

As the young worker began his chores on the morning of the incident, he started a John Deere 4020 tractor that had the front-end loader arms attached and a silage defacer mounted on the arms. The silage defacer was manufactured by Frontier Equipment Company and was approximately four years old. The farm had no previous safety or operational problems with this defacer, and it was properly marked with warning signs, warning operators to stand clear of the equipment (Figure 3).

As the tractor engine was warming up and the defacer unit was running, the victim dismounted the tractor and walked around in front of the unit. As he was going around the front right hand corner of the unit, the outside defacer wheel caught the right hand shoulder material of his jacket. When the teeth on the wheels caught the jacket material, the victim became entangled around the rotating defacer unit. The victim rotated around the unit and struck both the ground and the front fender of a Mac Aerodyne truck that was parked in front of the defacer unit.

Discussion: This particular piece of equipment has very aggressive blades similar to a circular saw blade that has large protruding metal teeth. This is necessary for the equipment to remove silage from a compacted state. Entanglement zones of this type should be avoided. The silage defacer involved in the incident had clear warning signs very visibly placed on the unit communicating to workers that they should stay clear of the unit.

Discussion: In this scenario, the victim had energized the unit, dismounted from the tractor, and then walked around the front of the defacer while the defacer's wheels were spinning. The victim then made inadvertent contact with an end wheel resulting in entanglement. The defacing wheels on this particular unit were painted black, a non-visual color when in motion. If the end wheels were painted red (or in combination with yellow striping) the color combination would be more visible when rotating, thereby making the equipment stand out and increasing the likelihood that it will be seen by workers.
