# STATE OF NEW YORK DEPARTMENT OF HEALTH

## FATALITY ASSESSMENT AND CONTROL EVALUATION

### City Engineer Killed in Landfill Manhole When Retrieving Flow Meter Case Report: 03NY027

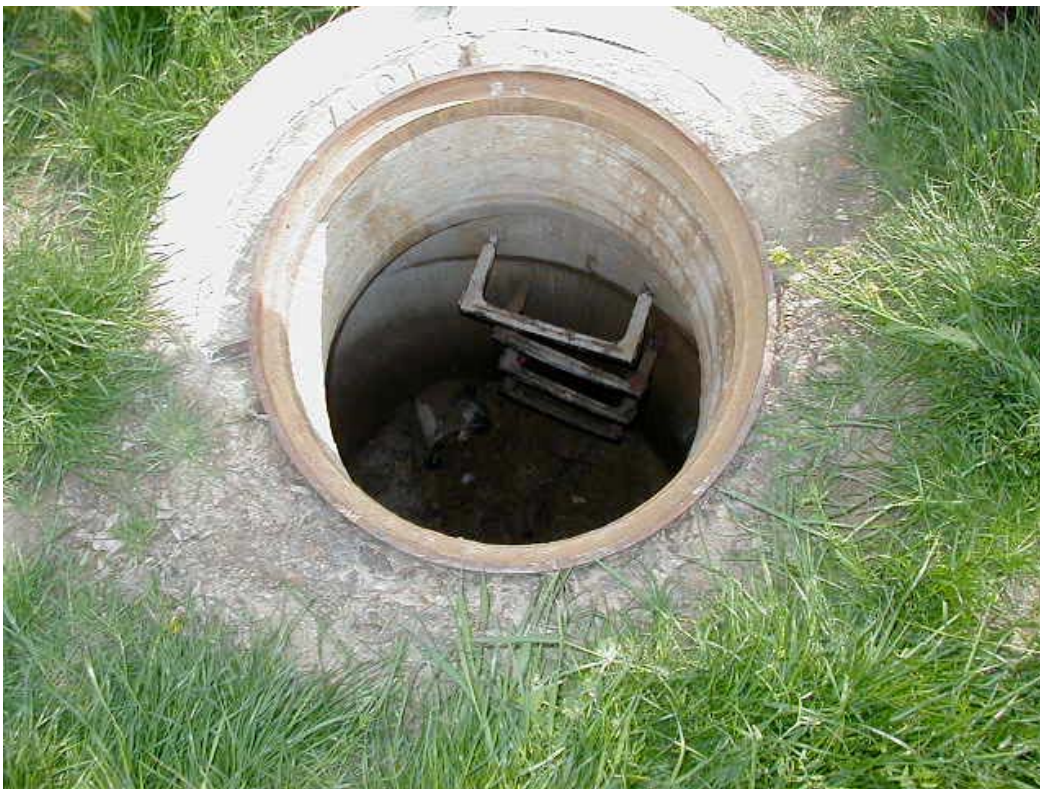
The manhole was 7'4" deep and its inner diameter was 24" (Figure 1). It looked dry at the time of the incident according to the witnesses. There were four iron rungs mounted into the cement wall of the manhole to form a ladder. The flow meter (Figure 2), weighing approximately 15 pounds, was attached to the top rung (34 inches below the manhole opening) by means of a "U" shaped spring loaded handle. A string was looped and tied around the handle of the flow meter.

**Figure 1.** The landfill manhole where the fatality occurred.

**Discussion:** The employer should evaluate and modify the flow monitoring procedure to reduce the risk by implementing feasible engineering controls. For example, the flow meter may be placed outside a manhole to avoid confined space entry; and downloading data and battery replacement may be performed at the same time, instead of on different days. At the time of the incident, the victim used a regular pickaxe to open the cover of the manhole where the flammable gas and vapor concentration exceeded 60% of LEL. Spark proof tools should be used for manhole cover removal and inside the manhole to reduce the fire and explosion hazard. Proper sturdy tools should be used to retrieve the flow meters. When installing the engineering controls, the confined space entry procedures should be strictly followed.

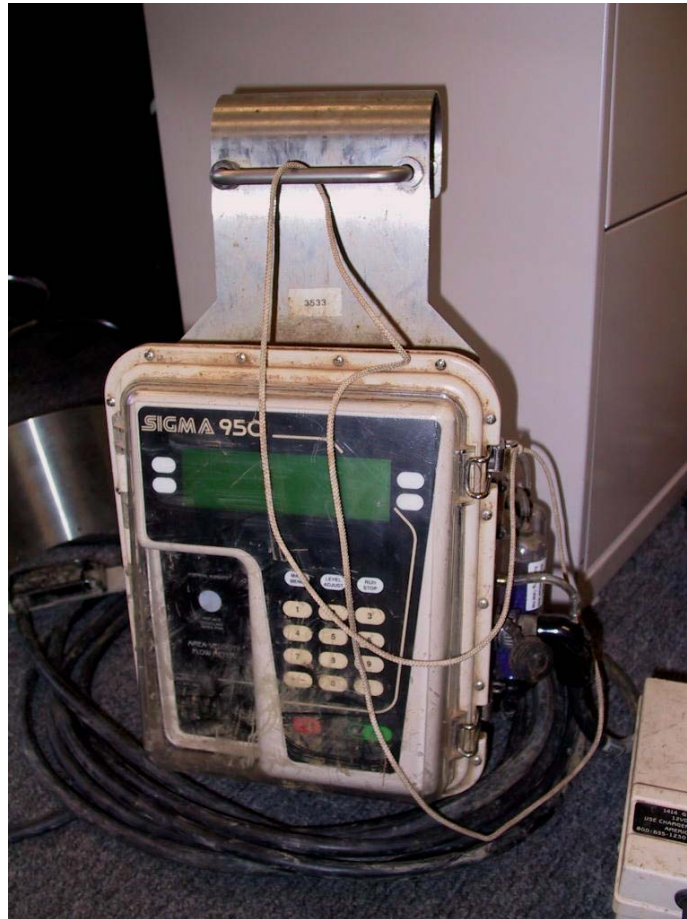
**Figure 2.** The flow meter that was used to measure the flow rate in the manhole.
