FATALITY ASSESSMENT AND CONTROL EVALUATION

Feed Mill Worker Dies in Grain Bin
Case Report: 02NY012

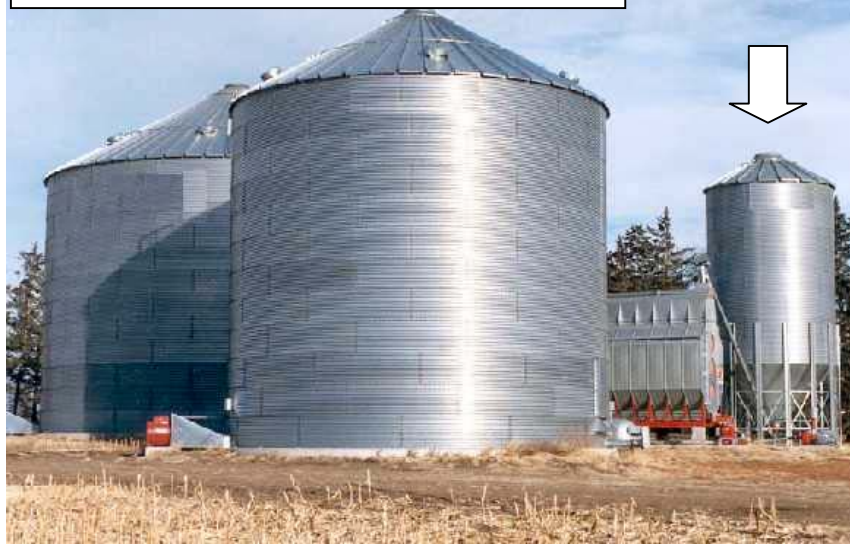
Figure 1. Example of a Hopper Bottom Bin on Farm

On this particular day, corn had been steam flaked and sent through the grain handling system to be stored in a gravity flow hopper bottom grain bin. This feed mill employs a central bucket elevator that carries the feed material up in a vertical direction where it reaches a dividing head that allows the material to gravity flow down into the appropriate bin. This dividing head is controlled electro-mechanically so the material can be remotely placed in whatever bin is desired. The flaked corn on this day was allowed to gravity feed into a round steel hopper bottom grain bin that was approximately 22 feet (approximately 5 “rings”) high and 9 feet in diameter with a 22 ton capacity. This gravity flow bin was located outside of the mill building, and was set up so that the material entered the top of the bin through a gravity drop chute from the bucket elevator. The bottom of the hopper then unloaded into an auger that would carry the material horizontally towards the mixing chamber at the feed mill (see Figure 1).

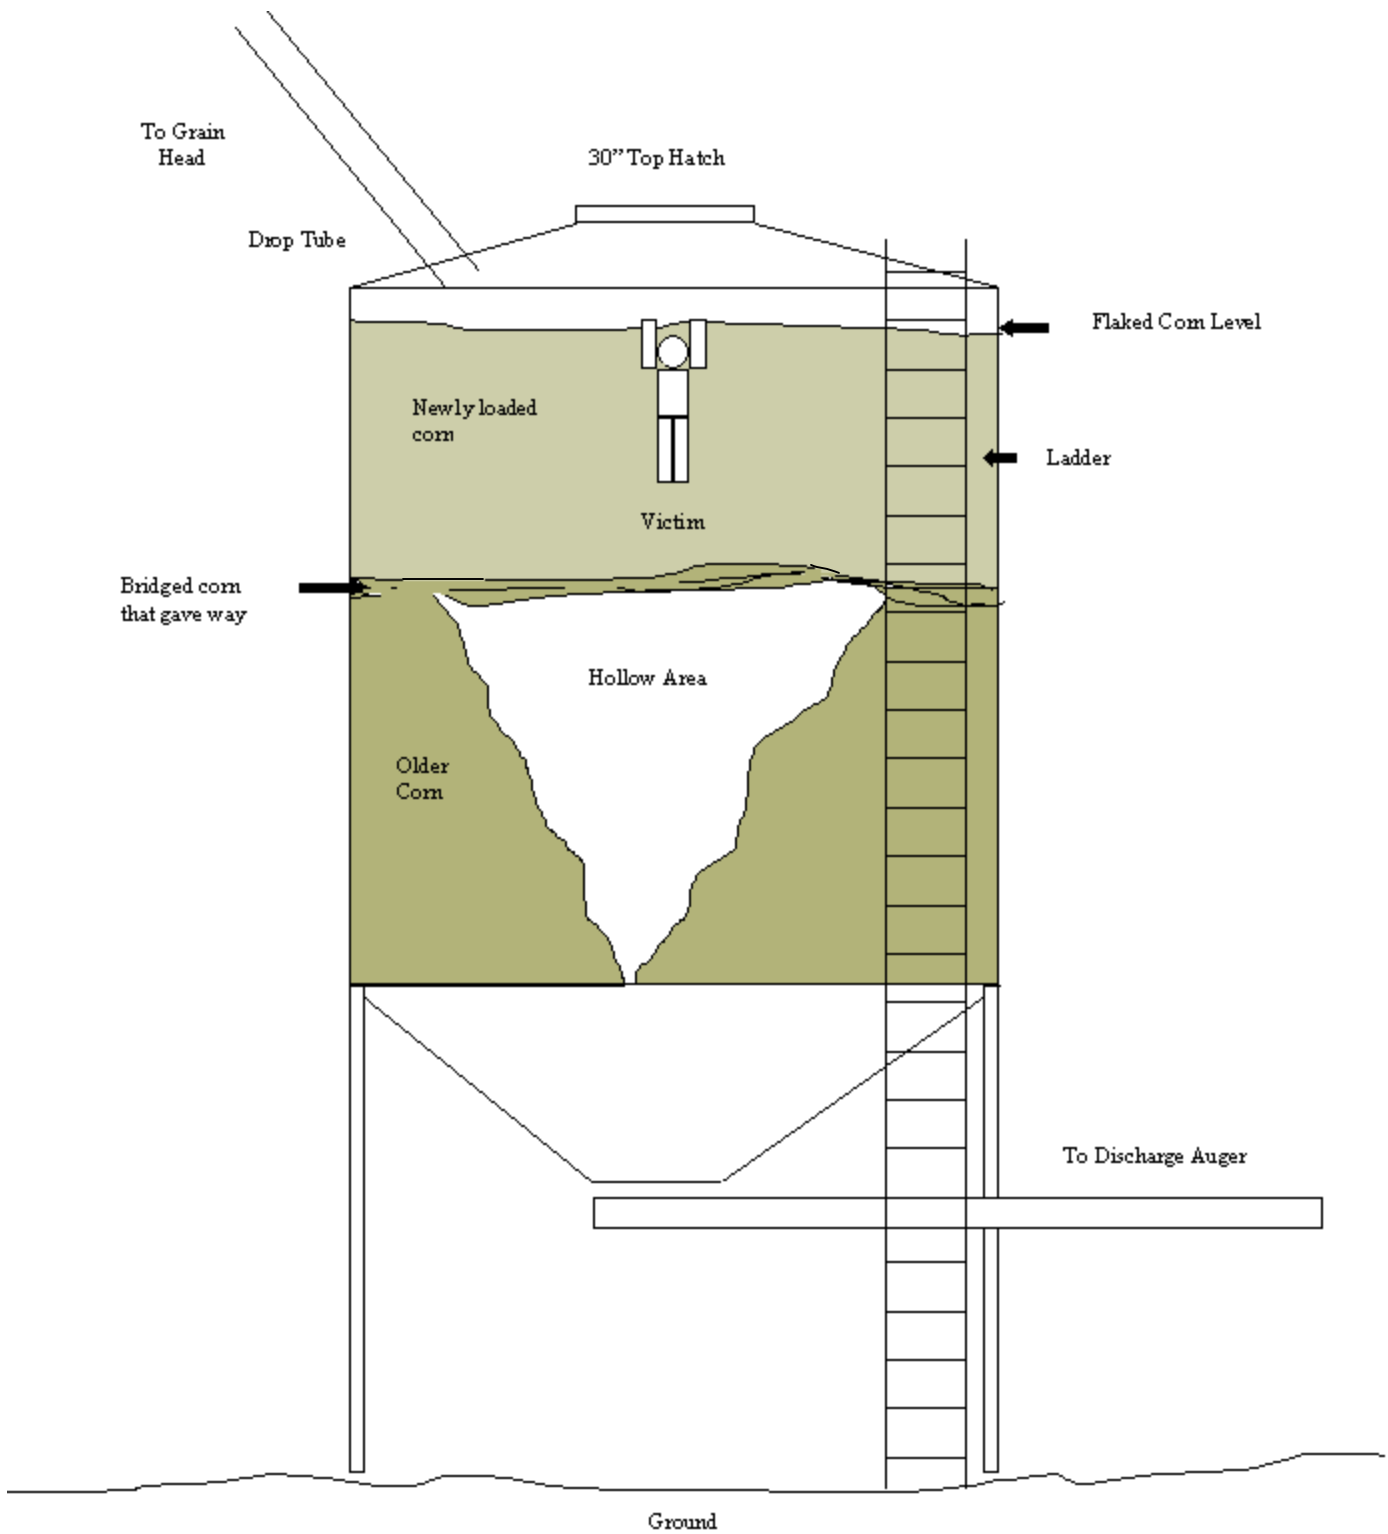
Figure 2. Gravity Flow Grain Bin (Hopper Bottom)—drawing not to scale

On this particular Friday at approximately 3:00 pm, the feed mill worker had been monitoring the transfer of the steam flaked corn from the mill into the hopper bottom grain bin. In reconstructing the incidents of the day, it is believed that as the worker monitored the filling of the bin, he noticed that the bin was full even though approximately one ton of material remained to go into the bin. The worker climbed the exterior ladder to the top of the grain bin where the 30-inch diameter opening hatch was located. He entered the bin and stood on top of the flaked corn that was only a few feet below the opening at the top. It is believed that he was leveling out the mounded corn in an effort to make room at the top of the bin for the last of the remaining material to be stored in the bin. When material is loaded into a bin from the top, the material creates a cone shaped mound. The remaining side space can be utilized for storage if this mound is leveled off and then the remaining corn can be loaded into the bin at the top. It is believed that as the worker was standing on the surface of the flaked corn, a bridged area underneath the center part of the grain bin collapsed. This caused flaked corn to flow down the center of the bin, engulfing the worker and pulling him down into the grain. The victim was pulled below the surface of the grain (Figure 2).

The bridging of grain in a storage bin can occur when the grain is wet and freezes together or also can occur under spoilage conditions that allow the individual grains to adhere together. If this adhesion occurs and then material is removed beneath this layer, a hollow area is created within the bin, leaving a false layer or "bridge" across the top of the grain. On the day of the incident, there was actually some freezing rain. Since steamed flaked corn has a high moisture content, the cold weather could have allowed any stored flaked corn from the previous day to freeze at the upper level, the crust level, where the flaked corn would be exposed to outside air temperatures. This bridging could have occurred from the freezing of the previous days' corn. Then, when the new flaked corn was added on top of the existing material, it would have created this unstable bridge.
