# Fatality Investigation Report

OR 2004-10-1

## Forklift crushes operator working underneath on starter

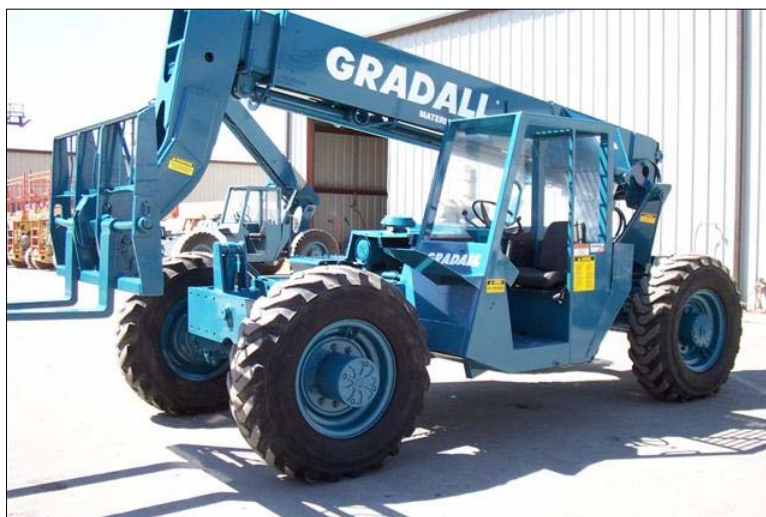
ignition switch while in gear. The contractor was apparently unaware of this safety feature. He checked the batteries, and then crawled underneath the cab area and reached up into the engine compartment with a screwdriver. The screwdriver made contact between the two terminals on the starter, effectively jump-starting the engine and bypassing the safety mechanism that prevented ignition while in gear. The Gradall started and moved forward. The parking brake was not set. The back left tire rolled over the contractor.

- **Powered industrial forklifts should only be operated by knowledgeable and experienced individuals certified by the employer, with proficiency demonstrated through operator training.**
- **Before exiting any powered industrial truck, even briefly, completely shut down power, place controls in neutral and apply parking brake.**
- **Do not start equipment by overriding safety features.**
