NJ FACE INVESTIGATION REPORT

FACE 04-NJ-074

Maintenance Supervisor Crushed Under a Falling Gantry Crane

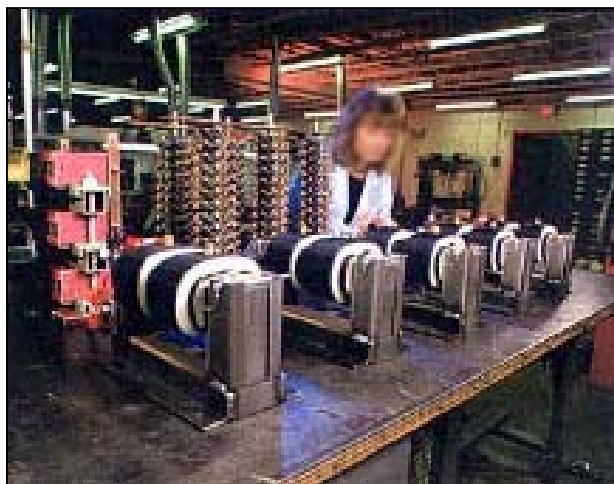
Photo 1
Transformer manufacturing
(Company website photo)

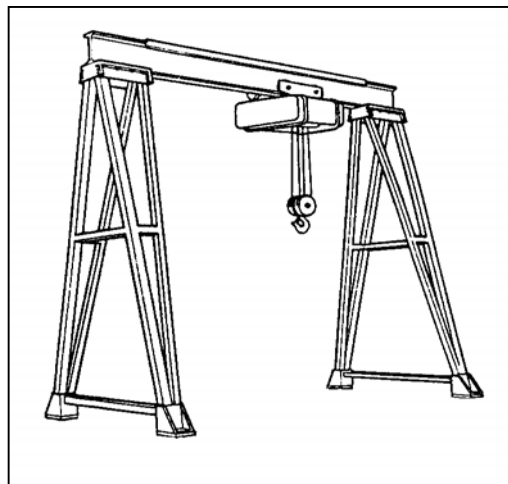
Illustration 1
Typical gantry crane
(Unidentified website graphic)

Much of the work at the plant was done manually, including the handling and stacking of hundreds of steel plates to make the cores. Due to the weight of the materials and products, the plant utilized a number of small gantry cranes to move these materials at the workstations. The gantry crane involved in the incident was made up of an electric hoist that moved along the length of a horizontal steel I-beam. Steel posts supported the ends of the I-beam, with each post terminating in an A-frame mounting that was secured to the concrete floor. The crane used an electric hoist with a 1,000-pound rating that was operated with a pendulum controller. The crane's dimensions were 10 feet high by 28 feet long, with a 62-inch base. The OSHA Compliance Officer calculated that the crane weighted 1,058 pounds, and the hoist weighted 150 pounds.

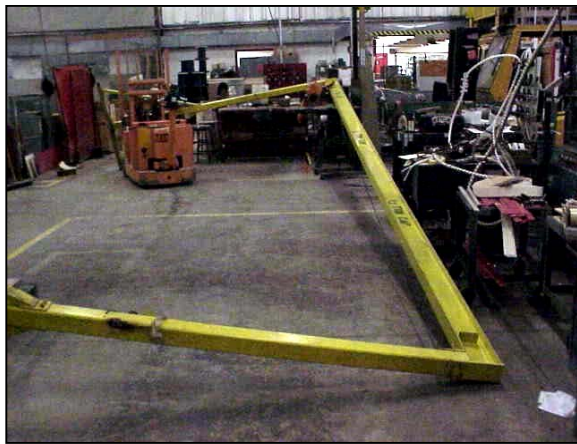
Photo 2
Collapsed gantry crane
(Company photo)

The incident occurred on Tuesday, August 24, 2004. After arriving for work in the morning, the victim met with his maintenance worker, who was to operate the forklift truck. A young laborer who had worked at the plant for six weeks was assigned to assist them. Under the victim's direction, they planned to move the crane with a forklift and a wheeled dolly. First, they secured the 150-pound hoist with beam clamps to prevent it from moving on the I-beam. After unbolting the crane from the floor, they used a small, walk-behind forklift to raise one end of the crane. This was done by positioning the forks between the crane's A-frame, using pieces of 4-by-4 inch wood blocks (cribbing) to fill the space between the forks and the frame. Once raised, the frame was lowered onto an industrial wheeled dolly, and the forklift was removed. The crew then took the forklift to the other end of the crane, planning to lift it in the same manner. As the crew was placing the cribbing into the crane's A-frame, the plant's safety manager stopped the operation to make a correction to the blocks in order to make them more stable. The crew immediately made the change, and lifted the end of the crane up about five inches with the forklift. At 10:20 a.m., the forklift (which was positioned in the inside of the crane under the horizontal beam) was moved forward, and the victim and laborer stood at either side of the A-frame supported by the dolly. As the forklift slowly started to make a turn to the left, the crane became unbalanced on the forks and started to tip to the right. The victim moved in and tried to grab the steel support at his end, apparently in an attempt to right the crane or to keep it from striking the laborer who was helping him. His effort failed, and the crane continued to topple over, striking the victim across his back. The other two workers were under the falling crane, which passed over their heads as it fell. The laborer received minor injuries when the crane caught and ripped his pants,

Discussion: In this case, it appears that a number of improvisations and shortcuts were used to move this crane. These include not disassembling the unit, not removing the hoist, and using the forklift and dolly to move the crane in one piece. NJ FACE recommends following the manufacturers instructions for safely servicing and moving the cranes. If the directions are not

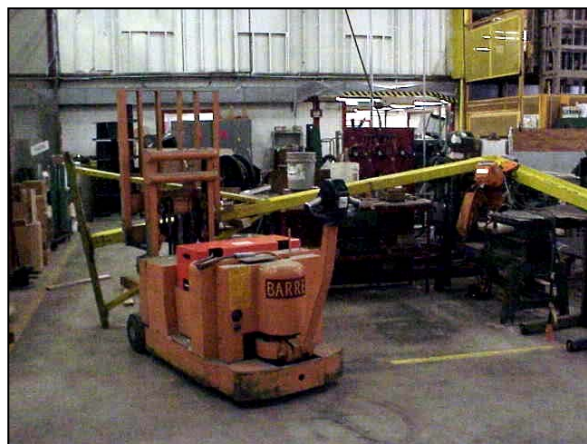
Photo 3
Forklift & A-frame
(Company photo)
