# A 61-year-old Salesman Dies After Falling 10 Feet From an Operator-up High Lift Truck

**Investigation: # 00-MA-70-01**

**Release Date: June 3, 2002**

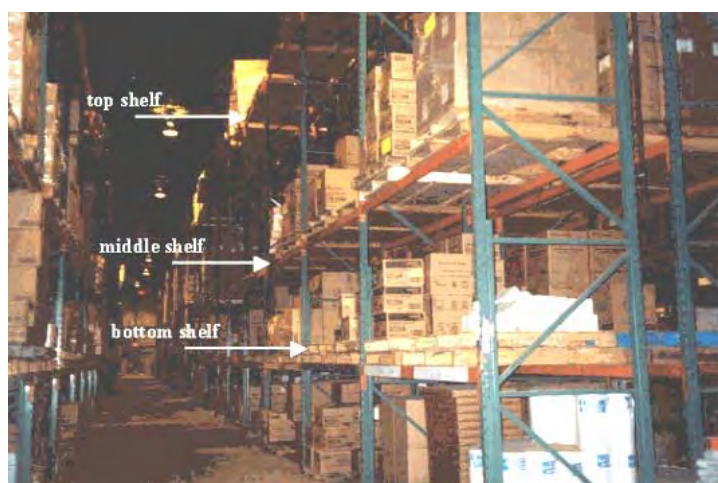
**Figure 1 – Warehouse shelving, location where victim fell.**

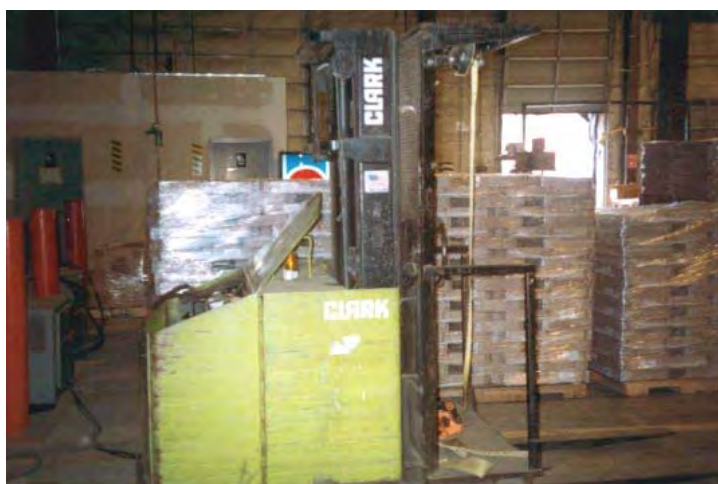
Approximately seven teams of employees were performing the year-end inventory; each team consisted of two or three workers. A team of two had been assigned to the order picker; one employee counted the boxes of product stored on the shelves while the second employee, the victim, wrote down the product number and quantity. The victim's team member, who was counting the product, was also located inside the order picker operator's area operating the order picker. The order picker operator area is fixed to the height of the order picker tines, therefore as the order picker tines are raised or lowered so is the operator area.

**Figure 2 – Operator-up High Lift Truck (Order picker) involved in the incident.**

In this case, conducting a hazard analysis might have revealed that the guardrail system was not structurally secured to the pallet and that the order picker manufacturer had a warning sticker adhered to the order picker, which stated that it was not to be used for lifting personnel.

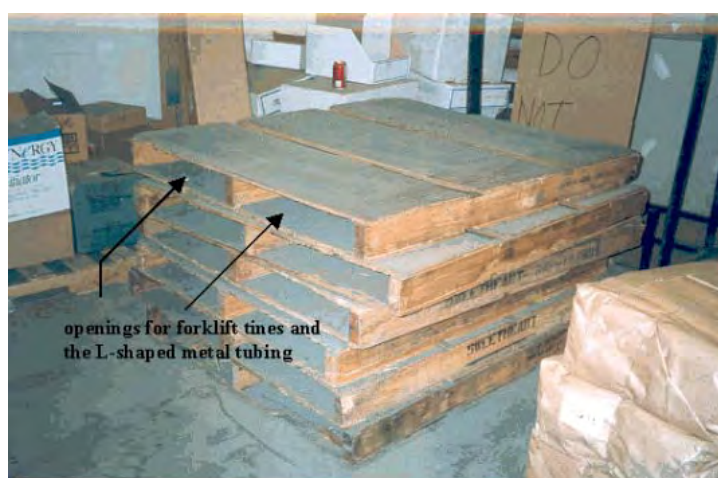
All five platforms appeared to be "homemade". The platform involved in the fatality consisted of a wooden pallet measuring 51½ inches long by 44 inches wide by 4½ inches thick. The pallet deck was comprised of three strips of plywood 16 inches wide and ½ inch thick ([Figure 3](#)). The platform guardrail system was three sided. The back section of the platform was unguarded, except for a chain gate that appeared nonfunctional. The guardrail system consisted of three horizontal rails: The bottom rail was a flat thin piece of metal 4 inches wide and located 4 inches above the pallet deck. The middle rail was metal tubing with an external diameter of 1¼ inches located 44 inches above the pallet deck. The top rail was made of the same metal tubing as the middle rail and was located 52 inches above the

**Figure 3 – Same style pallet the guardrail system was connected to.**

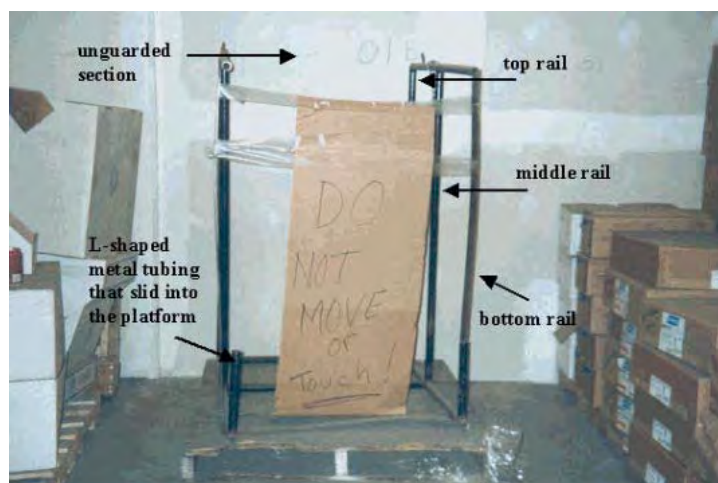
At the time of the incident, the victim was standing on the platform deck, which was raised to the second shelf, 10 feet from the floor level. The victim's team member was standing up in the metal storage rack when he heard a cracking sound. He jumped back to the operators area turned around and saw the victim and the guardrail system fall to the concrete floor below. Evidence indicates that the victim leaned against the already unstable guardrail system and that the weight of the victim's body caused the guardrail system to tip pulling the eyebolts from the pallet. This caused the guardrail to become unattached from the platform.

**Figure 4 – Guardrail system unattached from the pallet and positioned on one end.**

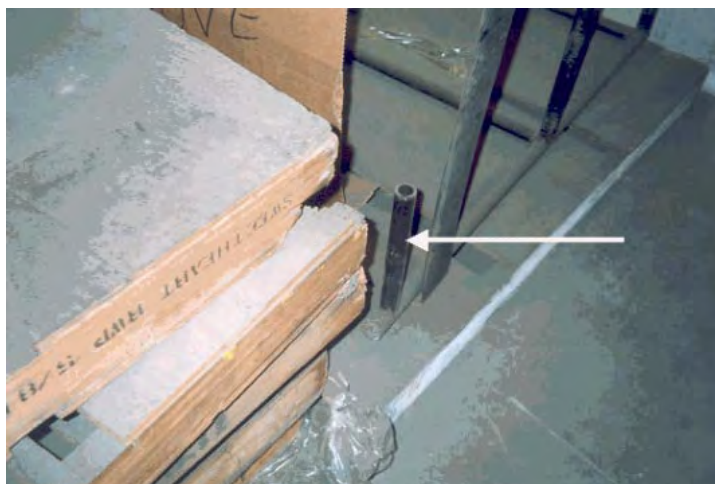
pallet deck ([Figure 4](#)). Two L-shaped pieces of metal tubing were designed to slide under the deck of the pallet, in the same slots for the forklift tines. These L-shaped pieces of metal tubing connected the guardrail system to the pallet ([Figure 5](#)). In addition, eyebolt type hardware was used to help fasten the guardrail system to the pallet. The threaded section of the eyebolt was screwed into the pallet deck. The eye section of the eyebolt was bent slightly open allowing the bottom section of the guardrail system to slide into the eyebolt and re-bent closed ([Figure 6](#)).

**Figure 5 – L-shaped metal tubing that slid into the same opening in the pallet as the order picker tines connecting the guardrail to the pallet.**

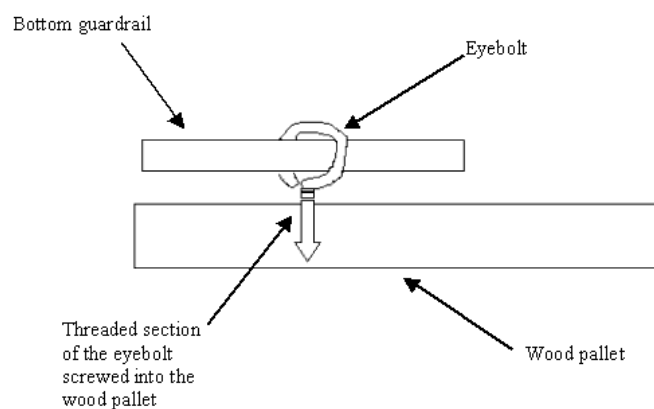
**Figure 6 – Diagram of how the eyebolt was used to fasten the guardrail system to the pallet.**
