Construction Laborer Killed After A Backhoe Slid into an ExcavationMassachusetts

Investigation: # 00-MA-55-01

Release Date: May 20, 2002

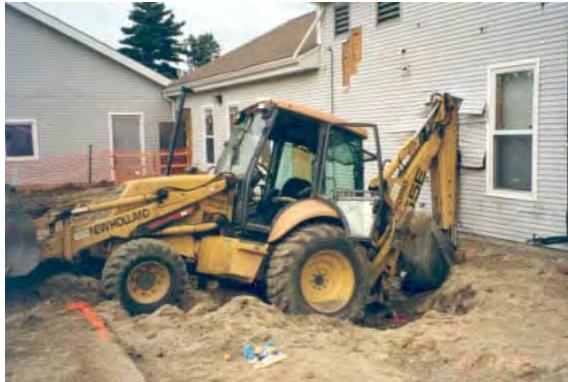
On the day of the incident, the onsite construction crew consisted of three employees from the victim's employer, one employee from the general contractor, and one employee from the excavation subcontractor. The same configuration of workers were located inside the excavation spreading the fill as described above for the day before. The backhoe operator was positioning the backhoe near the excavation edge in preparation to empty a load of new fill into the excavation. It had been reported that the operator had stopped the backhoe after the rear wheels passed over the protruding section of old foundation, did not put down the stabilizers and did not engage the parking brake.

Figure 1 – Backhoe inside the excavation

Recommendation #1: Employers should ensure employees are not inside excavations while construction equipment is in close range to the excavation edge.

In this case, workers were located inside an excavation while the backhoe, positioned at the excavation edge, was dumping fill inside the excavation. Removing workers from the excavation before the backhoe drove up to and started to dump fill inside the excavation would have eliminated the risk of serious or fatal injuries to the victim when the backhoe fell into the trench.

In this case, it was reported that the backhoe's parking brake was not engaged and the stabilizers were not lowered to the ground. Following the above steps and the manufacturer's recommendations for the proper procedure to follow when stopping a backhoe would have reduced the possibility of the backhoe falling unexpectedly into the excavation.

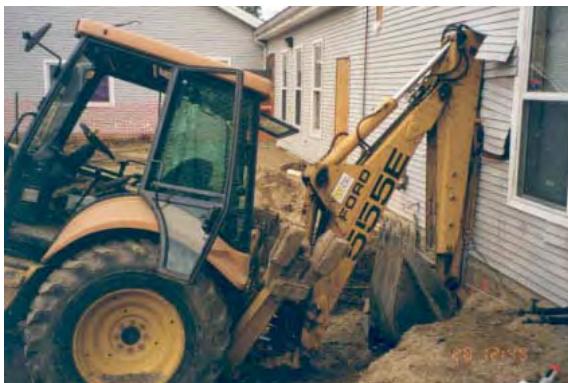
Occupants of the existing building heard the commotion and placed a call for emergency assistance. The construction crew members with help from the building occupants began to dig the victim out from underneath the bucket. Emergency medical personnel arrived within minutes of the call and immediately administered first aid and CPR (cardiopulmonary resuscitation). The victim was pronounced dead at the construction site.

Figure 2 – Backhoe buck that struck the victim
