# Police Officer Killed When Struck By Motorist While Directing Traffic At Roadway Work Zone

**Investigation: # 00-MA-54-01**  
**Date: December 20, 2001**

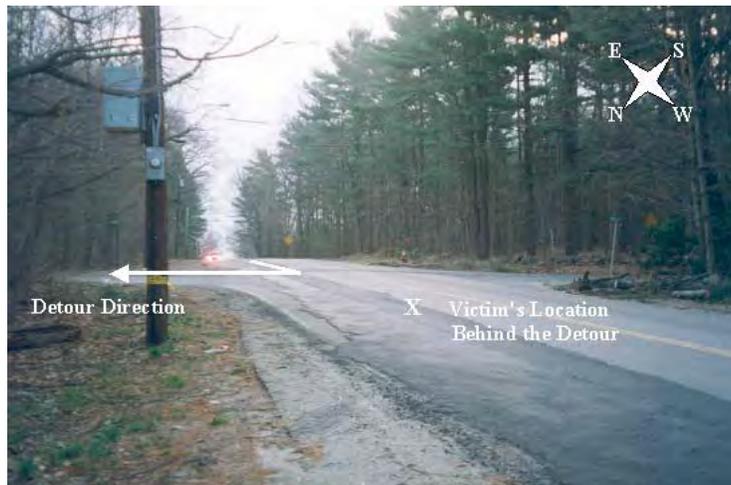
**Figure 1 – The arrow indicates the detour direction. This is the same direction the motorist was traveling (west) prior to striking the victim. Note the crest of the hill, which would obstruct the driver's view.**

The incident occurred at a four-way intersection involving a main roadway on the outskirts of a suburban town. The roadway under construction was asphalt, and approximately 27 feet wide. It consisted of two lanes, which ran east and west. The pavement markings consisted of solid double center yellow line and white fog lines. The road had a no drivable shoulder, and had a few feet of grass and underbrush on each edge before larger trees took over. At the four-way intersection, where the incident took place, traffic was being detoured onto a perpendicular road, which ran north and south. This road was smaller and less traveled than the main road. A hill crested approximately 300 feet east of the detour, on the main road, and the hill continued to decline past the detour turning point. When traveling on the main road heading west, the hill obscured the detour entrance (see attached [figures](#)).

In this case, a hill crested approximately 300 feet east of the four-way intersection and detour. Portable rumble strips could have been placed on the road prior to, during, and after the crest of the hill giving motorists plenty of secondary warning to observe the detour turnoff if they missed the previous signs posted in the advanced warning area.

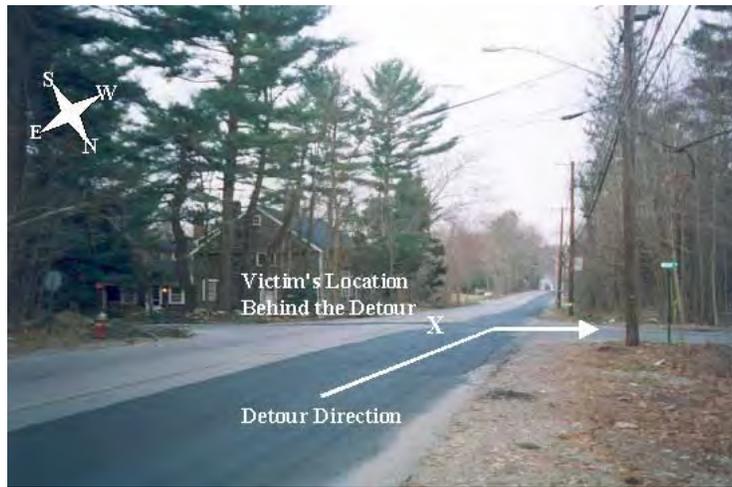
**Figure 2 – This shows the road from the perspective of a motorist traveling west. The arrow indicates the detour direction.**

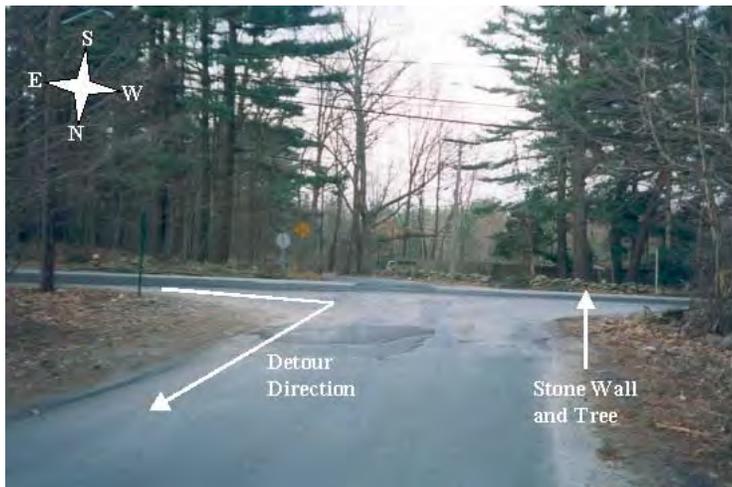
**Figure 3 – Smaller cross road that the traffic flow was detoured onto.**

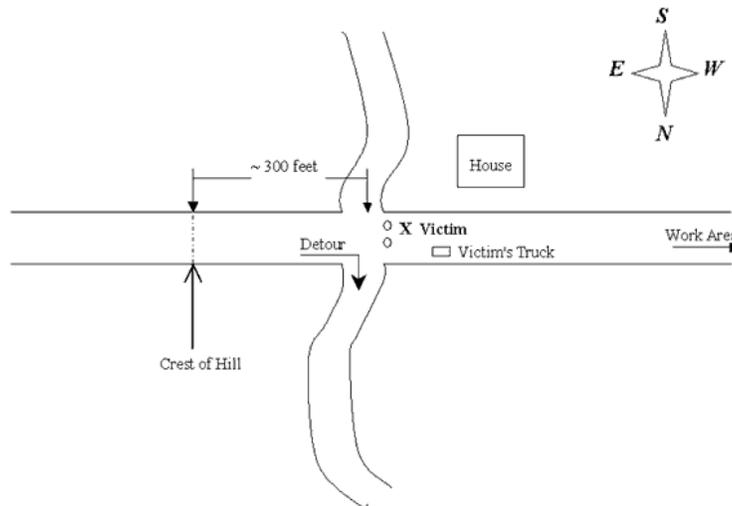
**Figure 4 – Diagram of the incident site.**

On the day of the incident, the victim drove his personal truck to the construction site and parked inside the work zone. The detour had been setup at its usual time, approximately 7:00am. In addition to the construction activities that morning, an evacuation of the surrounding houses was underway because of a gas main leak, caused by the construction work (see [Figure 4](#)).
