Massachusetts Self-Employed Farmer Killed When a Corn Chopper Head Attachment For a Forage Harvester Falls Onto Him

Massachusetts FACE 00-MA-014

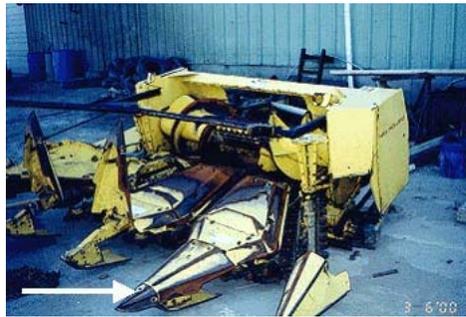
The machinery involved in the incident was a corn chopper attachment ([figure 1](#)) for a self-propelled forage harvester. The corn chopper head was used for cutting corn stocks during harvesting and was attached to the front of a forage harvester. One end of the corn chopper head attachment had five triangle-shaped tongs. The pointed ends of the tongs faced forward creating four locations for four corn stock rows to enter. The tongs, which were hinged, also acted as covers for the skids and could be swung up to reveal the skids. The corn chopper head slid across the ground partially on the skids.

Figure 1 – Corn Chopper Head Disconnected from Forage Harvester
(The arrow points to a tong. The tong to the left of the arrow is raised exposing the skid.)

Recommendation #1: Farmers, including self-employed, should attempt to leave forage harvester attachments (such as corn chopper heads), connected to the forage harvester during minor repairs.

Discussion: Many maintenance procedures that a corn chopper head requires, such as welding a skid, can be performed while attached to the forage harvester. Leaving the corn chopper head attached to the forage harvester would eliminate the hazard of positioning the corn chopper head in a stable position and location once detached from the harvester.

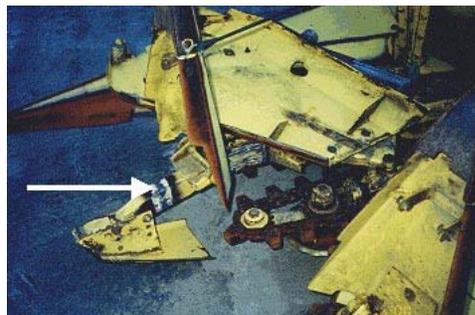
During the weekend of March 5, 2000, the victim was working alone (at the construction company's garage) repairing his corn chopper head attachment. The repair involved spot welding some of the skids.

Figure 2 – Welded Skid of the Corn Chopper Head
(The arrow points to the weld on a skid.)

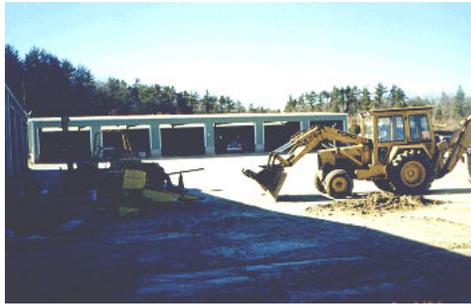
It appeared that the victim was finished welding and was going to move the corn chopper head out of the garage using a backhoe, which belonged to the construction company. He had cleared away the tools used to perform the repair, and positioned the front-end loader bucket of a backhoe inside the garage near the front of the corn chopper head. The bucket of the loader was tilted down and raised approximately 5 feet from the ground. A chain was placed around the bucket in preparation to move the corn chopper head out of the garage. Although un-witnessed, evidence indicates that the corn chopper head may have tipped over (towards the incline of the garage floor by the entryway to the garage door) and struck the victim in the back causing him to fall to the floor. The corn chopper head struck the grille of the backhoe as it fell onto the victim.

Figure 3 – Backhoe Used to Lift Corn Chopper Head

Recommendation #2: Farmers, including self-employed, should ensure that proper equipment is used to stabilize machine parts during repair procedures and that the center of gravity of the parts to be repaired is taken into account.

Discussion: When moving and working on, a large piece of equipment, such as a corn chopper that is detached from the forage harvester, consideration should be given to the center of gravity of that object. Positioning an object without considering the center of gravity might cause it to be unstable. Once consideration is given to the center of gravity and the object is moved, appropriate physical supports should be implemented to further minimize unexpected movement including tipping.

Appropriate equipment for stabilizing a corn chopper head while unattached from the forage harvester would include large jack stands that could support the weight and handle the size of the corn chopper head. In addition, braces and physical supports made of wood or metal should be used to ensure the stability of the corn chopper. The braces should be kept in place until the corn chopper head is reattached to the forage harvester or is placed securely on the ground.
