Massachusetts Inventory Control Clerk Dies after Falling from a High Lift Order Picker Truck

Investigation: # 99-MA-058-01

Release Date: May 4, 2000

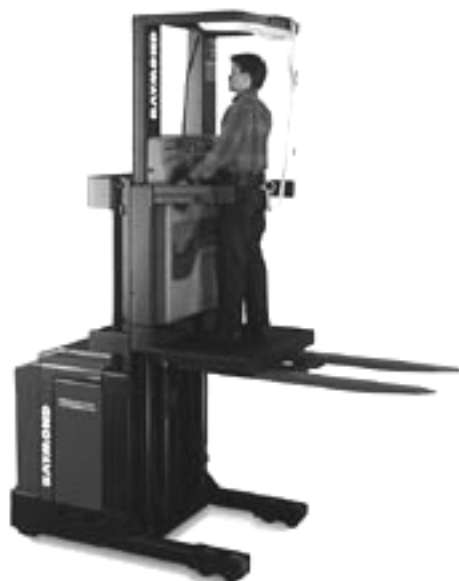
Figure 1 - High Lift Order Picker

Discussion: Any company that has high lift order picker trucks (see Figure 1) or similar equipment in use should adopt a mandatory tie-off/no unhook policy. The operator's platform of the order picker truck is raised with the lift forks creating a fall hazard for the operator. A policy should state that at all times when using a order picker truck the operator must be tied off to the order picker truck and under no circumstances will the operator unhook the lanyard from the anchor point when the lift is in the raised position. The policy should also prohibit stepping off the order picker truck onto shelved boxes of product. In this case, if the victim's lanyard had been connected to the truck's anchor point, the fall would have been arrested and the injuries would have been minimized.

The new electric four-wheeled high lift order picker truck involved in the incident had been recently purchased. The operator's platform of this particular style order picker truck raises and lowers along with the forks so an employee can gather boxes of product from shelves for an order and place them on a pallet for shipment (see figure 1). When the order picker truck is moving in the forward direction the lift's forks are behind the operator. The truck's maximum lifting height was 20 feet and its maximum forward speed with forks and platform lowered was 6.5 miles per hour. Safety features include a lower maximum forward speed while the forks and platform are in the raised position and a built in anchor point for attachment of a fall-protection lanyard. The anchor point is located above the operator's head keeping the lanyard out of the operator's way for maximum mobility. All of the company's powered trucks including the order

Discussion: The operator's platform of the high lift order picker truck in this incident, is raised along with the forks of the lift so the operator can gather selected boxes of products. The manufacturer designed an overhead anchor point on the lift for the use of a lanyard, however in this incident it was not used. A system could be designed that prohibits the forklift from being raised if the operator's lanyard was unconnected from either themselves or the forklift anchor point. The system could be electronically designed so that if the operator were to unhook either end of the lanyard while the lift was raised it would activate audible and visual alarms alerting the operator and other employees of the safety hazard. This type of warning system in conjunction with a strictly enforced mandatory tie-off/no unhook policy may have prevented the victim from unhooking or using the order picker truck with out the fall arrest system.
