FROM: Iowa FACE Program

Case No. 3IA56

SUBJECT: Farmer Killed in Tractor Rollover While Setting a Fence Post

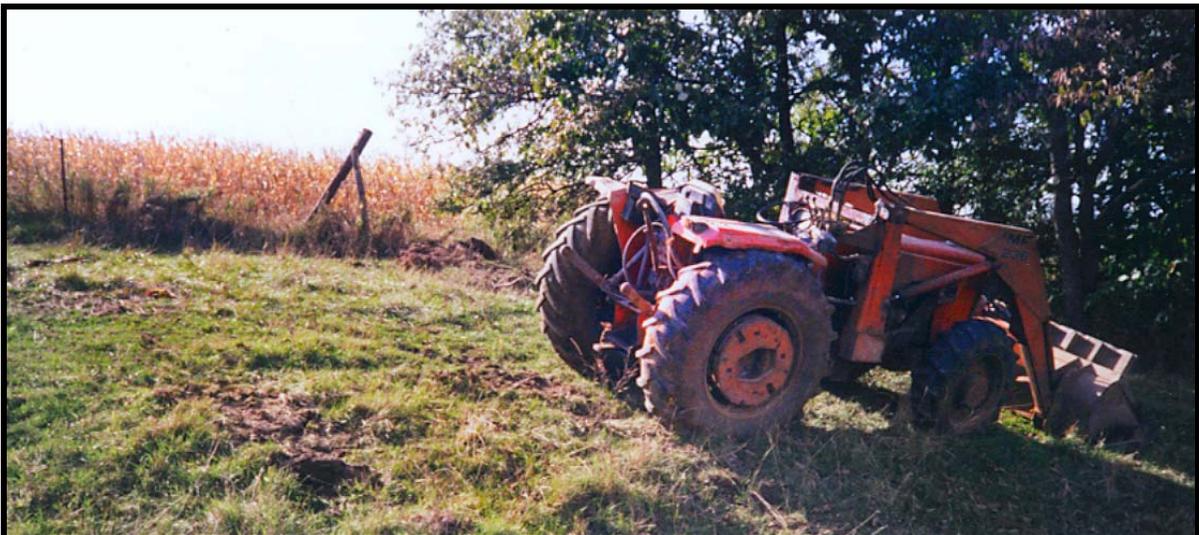
Photo 1 – View of the scene showing the fence being repaired, the sloping pasture, and the up-righted tractor.

The farmer partially filled the front bucket with dirt, then, positioned the tractor to put in the fence post, working in a pasture area, which sloped slightly to the right (see Photos 1, 2). As usual, the farmer was operating the tractor, while his son assisted by positioning the fence post. The middle of the front bucket was placed on top of the post, then, the post was pushed or rammed into the ground. But the soil in the area was rather dry that day, and the post could penetrate no more than six inches.

- *All tractors should be equipped with Roll Over Protective Structures.*
- *Factory installed Roll-Over Protective Structures (ROPS) should not be removed from tractors.*
- *Alternate methods of installing fence posts should be considered.*

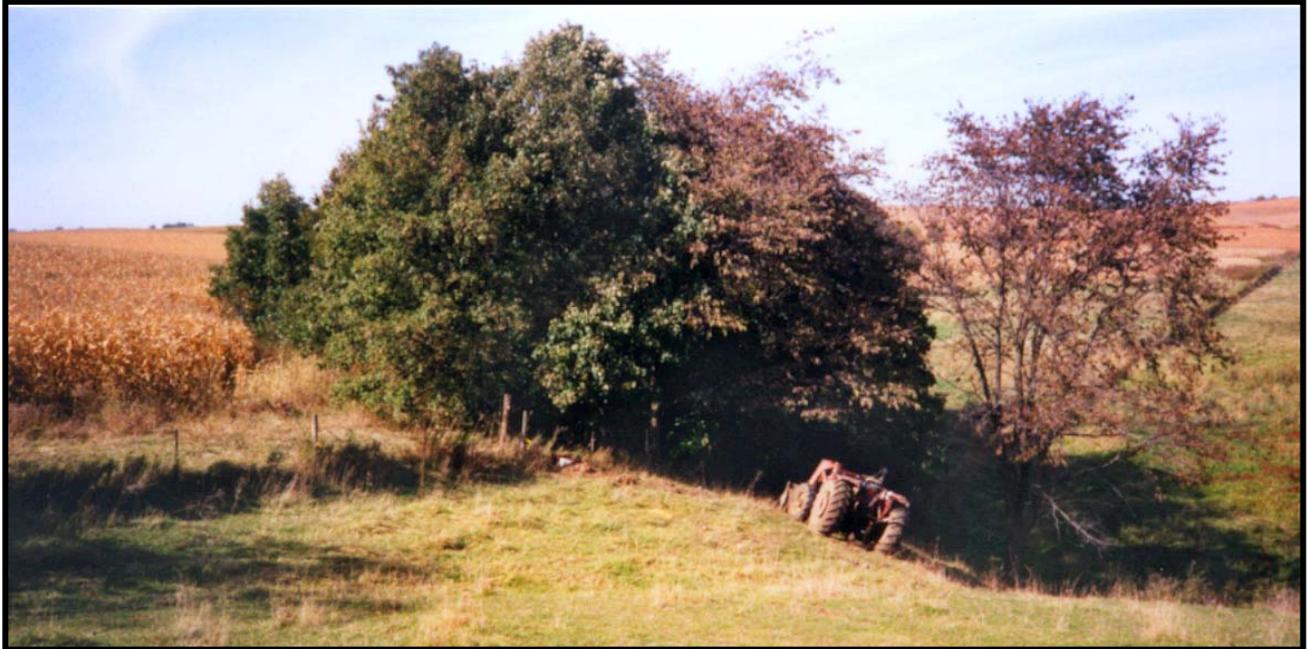
Photo 2 – Long shot of the entire scene, showing the slope of the pasture and the up-righted tractor.
