**FROM: Iowa FACE Program      Case No. 31A45      Report Date: 8-4-2004**

**SUBJECT: Auto Mechanic Dies from Explosion While Welding a Barrel in His Shop**

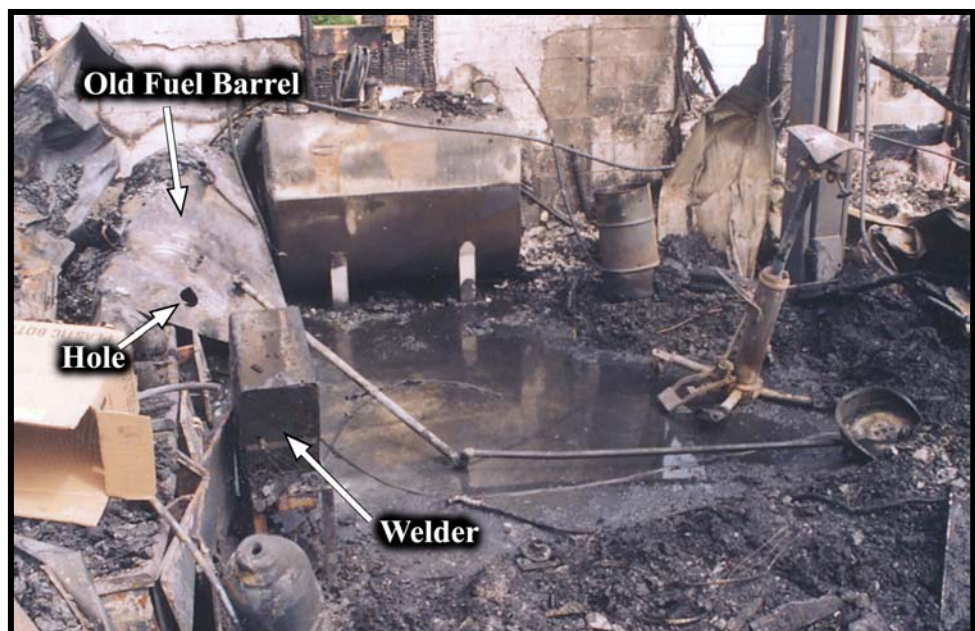
Photo 1 – View of the burned out shop area, showing the old fuel barrel and welder.

This auto repair shop had built a system for collecting used engine oil from vehicles. The oil was stored in an old 250 gallon fuel barrel, as seen in Photograph 1. This barrel had a bung hole on the top side and a welded pipe fitting connected to an articulated arm made of one-inch steel pipe. The other end of the pipe had a welded oil pan for collecting used oil (see Photo 2). When a vehicle needed its oil changed, it was raised off the ground with a hydraulic lift, and the oil pan was positioned under the engine oil drain plug. The oil pan and articulated arm were held in place under the vehicle with a simple bungee cord.

**Discussion:** 29CFR1910.252 describes specific safety procedures for welding. These procedures include removing and taking all movable fire hazards in the vicinity to a safe place, protecting all combustible materials from sparks, having fire extinguishers readily available, using fire watchers if there are combustible materials close to the point of operation, and inspecting the area and authorizing the work before welding. Welding is prohibited in the presence of explosive atmospheres (mixtures of flammable gases, vapors, liquids, or dusts with air) or atmospheres that may develop inside un-cleaned or improperly prepared tanks, which have previously contained such materials. Specific regulations for welding or cutting containers state that no welding or cutting or other hot work shall be performed on used drums, barrels, tanks, or other containers until they have been cleaned so thoroughly as to make absolutely certain that there are no flammable materials present. The containers must be vented, and purging with inert gas is recommended.

There have been many similar reports of explosions from welding on used oil drums, fuel tanks, gas barrels, etc. Even when empty, these containers may retain an explosive mixture, which can explode from welding sparks. Any containers must be thoroughly drained, cleaned, and vented (and preferably purged with inert gas) before welding or cutting.

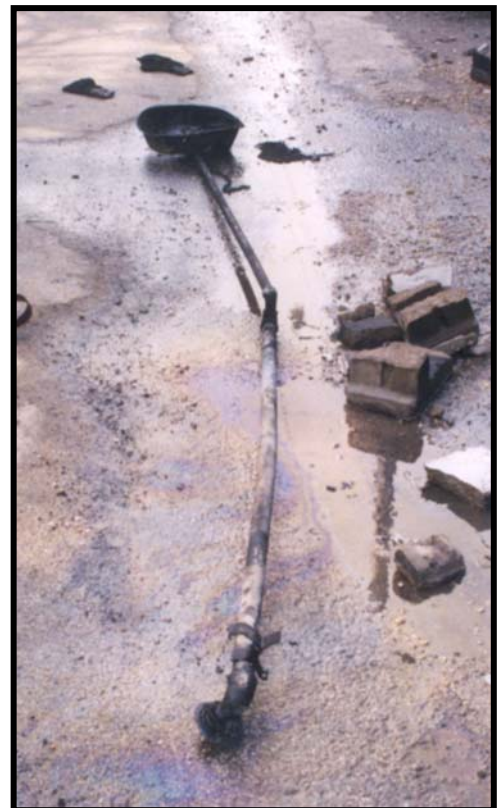
Recently, one employee did not use the bungee cord, and the weight of the articulated arm cracked the weld around the hole on the oil tank. The employee was told to repair the tank, and his plan was to drain the barrel of oil and fill it with water before he began welding. Apparently, at this time the employee had a vacation already scheduled, and he didn't have time to repair the barrel before he left, but was planning to do so when he returned to work. The victim, however, was unwilling to wait until that time, and being the owner of the shop, chose to repair the used oil barrel himself. The barrel had broken once before in the same location, and the victim had successfully repaired it at that time without any problems.

Photo 2 – Articulated pipe with oil pan on one end, and broken fitting for the oil barrel on the other.

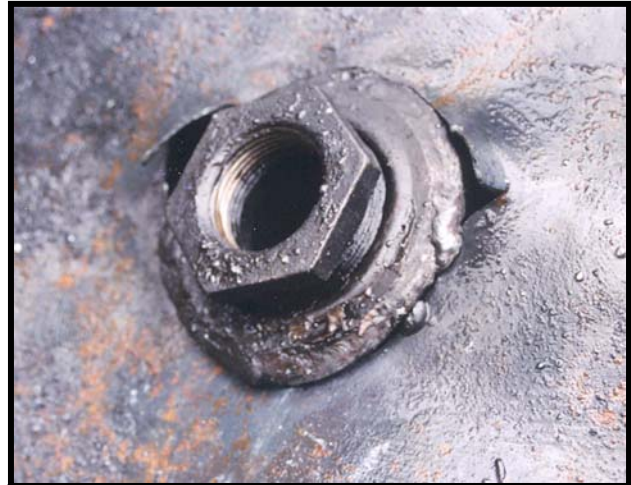
Fire investigators learned that the man had changed oil on a vehicle that morning, and that the barrel contained fresh used oil, which usually contains dissolved volatile components. It is assumed that fresh gasoline vapors in the oil tank ignited, causing the explosion. Over time, these vapors will dissipate if the container has access to open air. This may explain why the victim was able to weld the barrel at one point previously without incident.

Photo 3 – Close-up of bung hole showing broken welds that were being repaired.
