Case No. 3IA35

Report Date: March 9, 2004

SUBJECT: Tractor Operator Run Over and Killed While Making Repairs

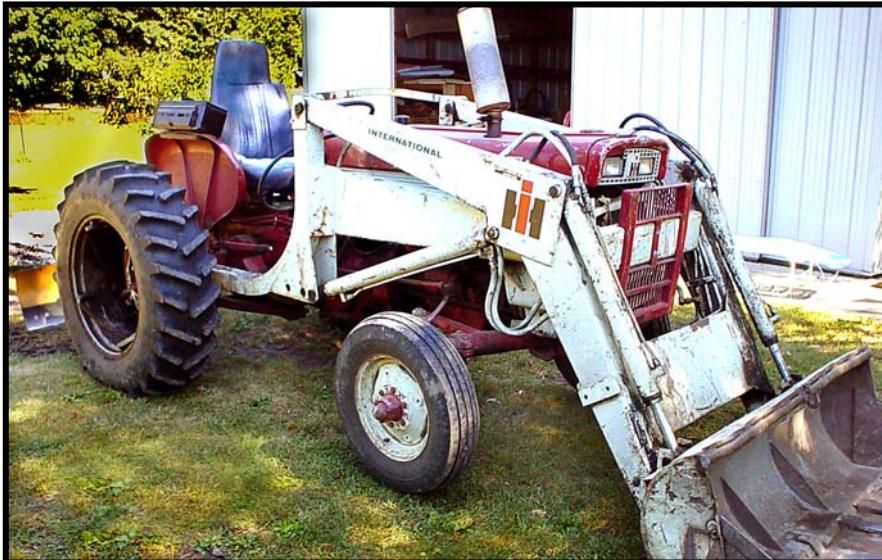
Photo 1 – Front / right side view of tractor involved in runover incident.

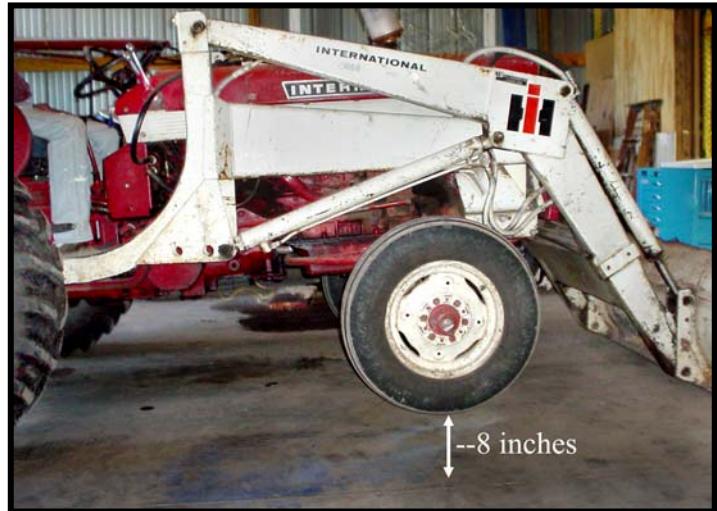
The victim had replaced two of the wishbone bolts, but could not insert the last bolt because the hole was not aligned properly. To relieve pressure on the attachment members and align the bolt holes, the victim was apparently trying to raise the front wheels of the tractor off the floor by powering down with the front bucket (see Photo 3). Without tilting the bucket, the loader would raise the front wheels about 8 inches, and allow free movement of the axle and front wheels. There were no jacks or jack stands used to support the front axle at the time.

Photo 3 – Right side view of tractor with front bucket powered down to raise the front wheels off the floor.

Recommendation #3 -- Hydraulic jacks and jack stands should be used to raise and support the tractor during repair, rather than using the front-end loader.

Discussion: Front-end loaders may provide a quick way for raising tractor front wheels off the ground during repair or maintenance. However, hydraulic leaks, inadvertent movement of hydraulic controls, or losing hydraulic pressure for any reason can cause the front-end loader to fail. It is not safe to rely on front-end loader to support the front end of the tractor during maintenance. Jacks and jack stands are designed for that purpose, and should be used instead of the front-end loader. In this case, using the front-end loader for this purpose likely introduced another hazard. It is assumed from the circumstances in this case that using the front end loader was the reason to start the tractor, which was done in an unsafe manner, leading to the death of the operator.

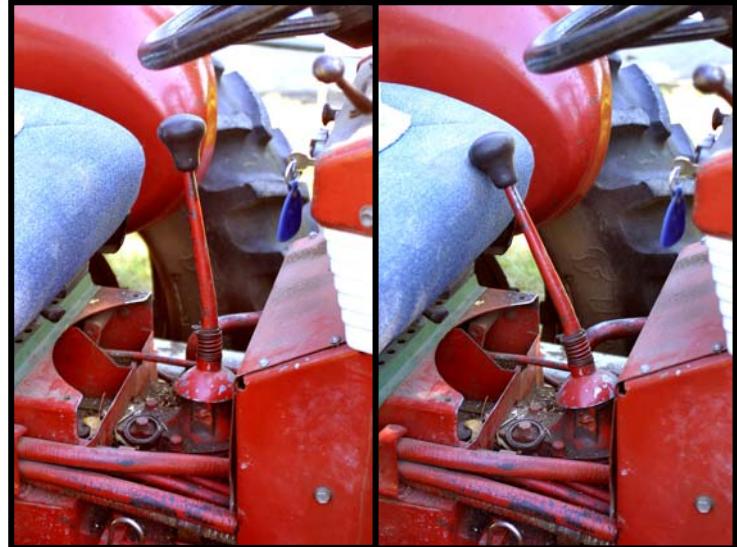
Apparently, the victim did not notice that the transmission was in gear. In first gear, the lever is nearly touching the newer retrofit seat of this tractor, while in neutral, the lever is a few inches away from the seat (see Photo 5). This would surely have been visible from where the man was standing, although not a very obvious sign that the transmission was in gear. When the tractor started, it immediately drove forward and ran over him causing severe internal injuries. The machine continued to move into the next room where it stalled against the exterior wall of the building. The tractor owner was also working in the next room at this time, but was not injured. He immediately ran to aid his friend; then called 911. Rescuers were on-site within ten minutes, however, the victim soon became unconscious, and died later that day from internal injuries.

Photo 5 – Right side view of gear shift lever, in neutral position (left image) and first gear position (right image).

Recommendation #1 -- *Tractor operators should be seated at the controls when starting a tractor.*

Discussion: Run-over is the second most common type of tractor fatality after overturn.¹ Many run-overs occur when the tractor is started while standing on the ground next to the tractor. In some situations it is more convenient to start a machine from the ground, rather than from the operator's seat. Examples might include connecting, disconnecting, repairing, maintaining, oiling/greasing, or adjusting implements, or anything that requires frequent mounting and dismounting of the tractor. Newer tractors have interlock mechanisms that prevent them from starting unless an operator is seated at the controls. But whether they are present or not, the operator should never attempt to start the tractor while standing on the ground.
