**Case No. 3IA21**

**Report Date: Aug 25, 2004**

**SUBJECT: Welder Falls from Boom Forklift Platform When Boom Shifts Laterally**

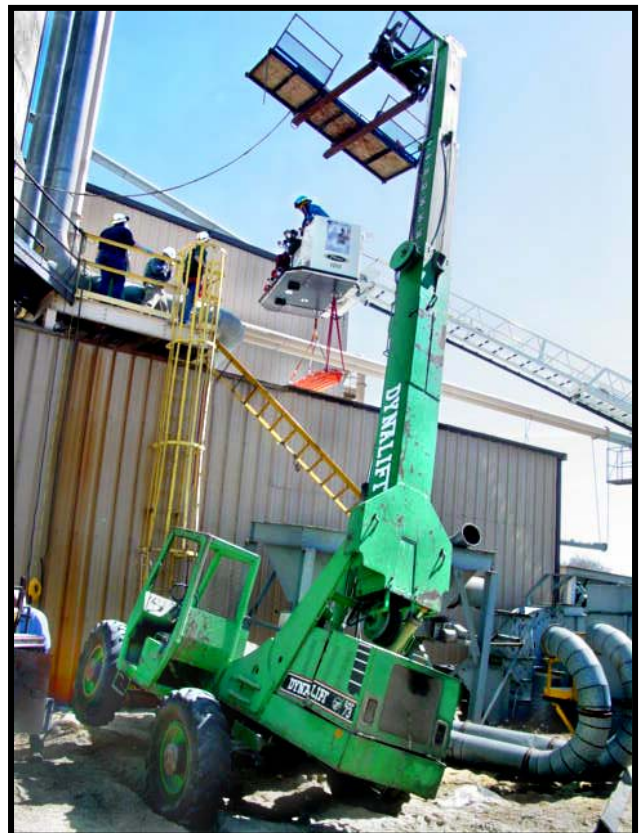
At one point, the men were adjusting the lateral position of the raised platform using the frame-tilt function (sway control) of the forklift. While moving the platform to the right, the victim yelled, "Stop", however the boom and the platform kept moving to the far right position and the victim fell off the unprotected left end of the platform, landing on the metal catwalk 20 ft. below him. The man was not wearing any sort of harness or safety line, nor was he wearing a hard hat. He sustained fatal head injuries and was dead at the scene when firefighters arrived. At that time the boom for the forklift was situated to the far right position with the left front wheel of the machine raised two feet off the ground (see Photo 1).

Photo 1 – Police photo of the scene showing the new catwalk, and the boom forklift, leaning to the right.

The left front wheel of the forklift raised two feet off the ground when the boom shifted to the far right position. It is unknown if the boom was stuck in this position, or why the boom was left in this position when firefighters arrived.

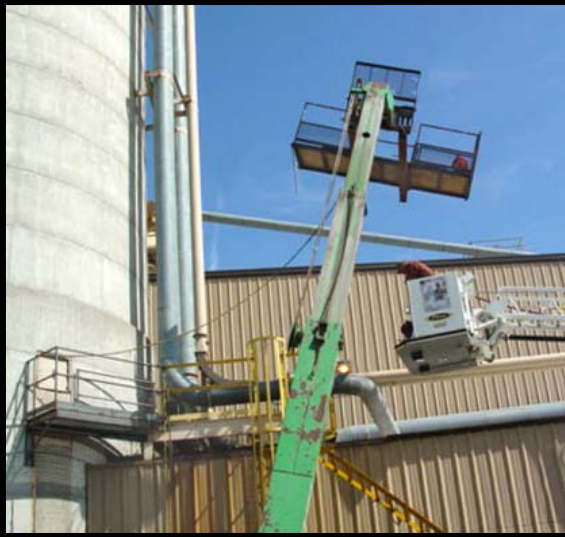
Photo 2 – Shot from the rear of the machine, showing the platform tilted far to the right.

In this case, the personnel platform was a few feet too wide. The ANSI standard for lift trucks (ANSI B56.6-2002 [8.24.1(b)])<sup>1</sup> states the platform floor can't exceed the overall width of a lift truck measured across the load-bearing tires *plus 10 inches on either side*. For this machine the maximum platform width would then be  $96'' + 20'' = 116''$  total inches. In addition, personnel platforms must be securely anchored to the forks of the machine. In this case it appears the platform was welded to extended steel channels, which were then attached to the forks. (see Photos 2, 4).

All forklift loads should be leveled before the lift is initiated, or before the boom is extended, and this especially applies to personnel platforms. It is never a good idea to use the sway control to make lateral adjustments while workers are on an extended and raised work platform. Small adjustments in the hydraulics of the sway control cylinders produce exaggerated movements of the forks if the boom is extended. If the sway control lever is rapidly pushed to one side, it will cause violent and jerky movements of the personnel platform if it is raised high off the ground.

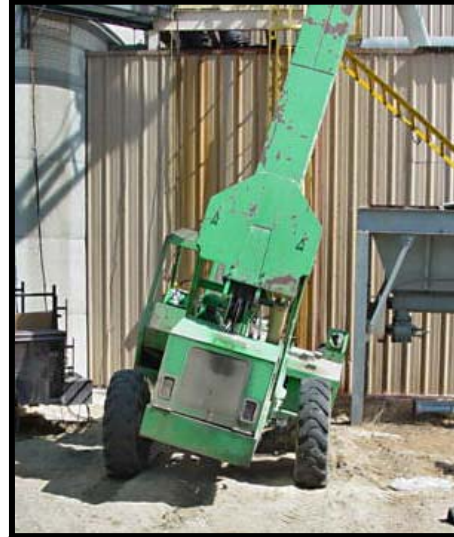
Photo 3 – View from the rear of the machine, tilted to the extreme right.

**Discussion:** The approved use of the boom on this machine was strictly in an up and down motion, and there was no provision for lateral movements or rotation, which are possible on many larger truck-mounted cranes. One must back up and reposition the forklift if a lateral position is desired, even for a few inches. Normally, the frame-tilt (sway control) function of the forklift is used only for leveling the machine while traveling along sloping ground or making a lift on terrain that is slightly sloped to the right or left. The operator's manual for this machine forbids traveling on slopes of greater than 16.5 degrees (left or right), and forbids placing or retrieving a load on slopes greater than 4.5 degrees (left or right). With the boom in a full vertical position, *it is possible* to make minor left and right shifts of the boom and the forks using the sway control feature. The owner's manual for the forklift specifically warns against this practice, for obvious reasons of creating an off-balance load, losing the load, or tipping over of the machine. However, while using a relatively light-weight work platform, workers are tempted to make minor left and right adjustments with the hydraulic frame-tilt control. In this case, the platform was moved to the far right position when the sway control was used, causing the victim to lose his balance on the platform and fall off.

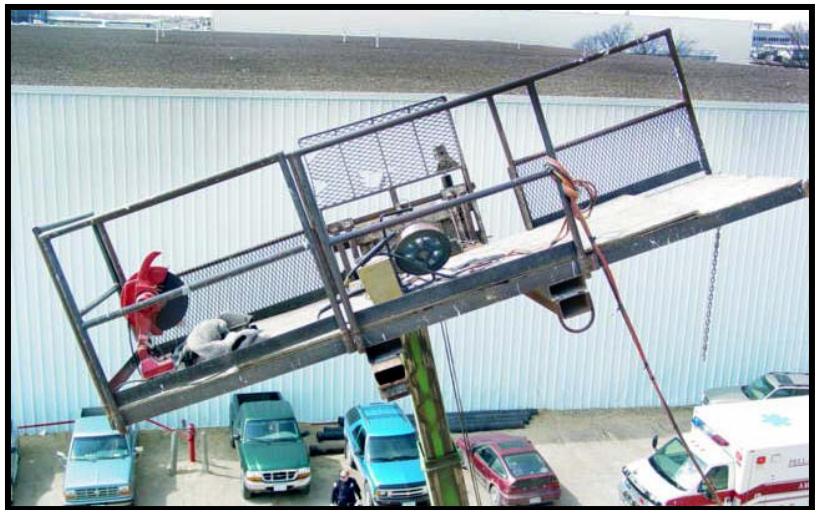
The 3-man work crew was building a new catwalk and ladder assembly on the side of a cement silo, and the victim was working on a personnel platform as a welder. Also on the platform were a wire welder, a metal chop saw, some welding hand tools, and a welding mask. The work platform was made of steel with a plywood base, and was approximately 4 x 12 ft. in size. It was constructed with seven removable metal guardrail sections, two of which were missing from the corner adjacent to the

silo where the victim was working (see Photo 4). Welded to the bottom of the platform were two 8-ft. long steel channels, which were made to receive the forks of the boom forklift truck (see Photo 5). It is not known how the extended channels were attached to the original forks of the machine. The boom forklift was routinely used in this manner for fabrication and assembly of various outdoor metal projects.

Photo 4 – View from the firefighter's ladder, showing details of the personnel platform, the tools onboard, the unprotected end, and the welded steel channels for the forks.

**Discussion:** ASME standards do allow a company to construct and attach a personnel platform to an extended-reach rough terrain boom forklift. There are rigorous guidelines for this, and it is therefore, preferred that individuals consult with the forklift manufacturer for assistance, or better, purchase a factory-made and approved personnel platform designed for their particular machine. Requirements for an approved personnel platform include proper size, approved guard rails, rated anchor points for attachment of lifelines, and a secure method to secure the platform to the forklift. OSHA frequently writes citations for inadequate / home-made personnel platforms, deferring to the restrictions written into machine operator's manuals, which usually forbid using a personnel platform on the forklift. Manufacturers differ in their treatment of this issue, therefore companies desiring a personnel platform for a boom forklift should be diligent to study their options carefully.

**Discussion:** Approved equipment in this case would be use of a full body harness, and lifeline which does not permit a fall of more than six feet. This ruling applies to all extended boom machines, for they have the potential of *bouncing a worker up* and off the platform, even if the platform is equipped with permanently-mounted guard rails. Exceptions to this rule are for scissor lifts, which have permanently attached guard rails. These machines use hydraulic-powered mechanical linkages to slowly raise and lower the work platform, minimizing the potential to bounce a worker up and off of the platform. In this case, the victim was not wearing any type of fall protection, and was working near an unprotected edge of the personnel platform. When the sway control was activated, the hydraulic controls shifted the frame of the forklift to the right, and the extended work platform was also shifted further and faster to the right causing the victim to lose his balance and fall. Had the victim been wearing a body harness and lifeline properly anchored to the platform, it is likely he would have survived this fall.

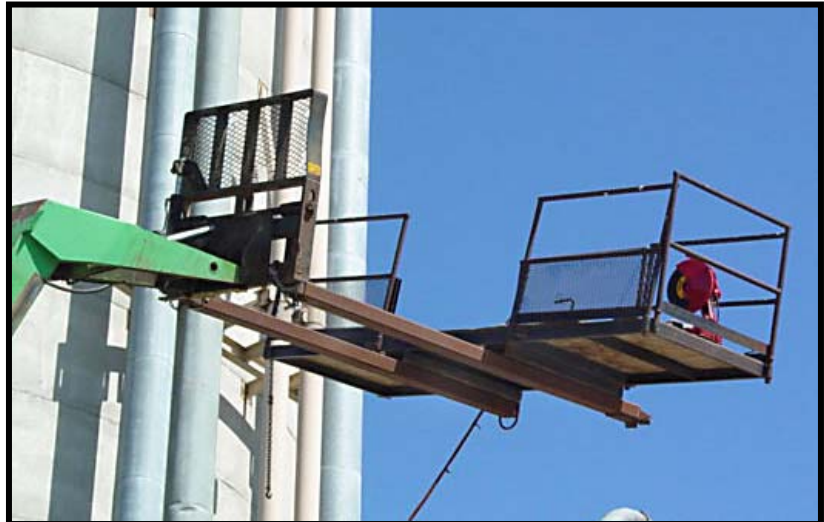
Photo 5 – Shot from underneath the platform showing the extended steel channels attached to the forks of the machine.
