FROM: Iowa FACE Program

Case No. 2IA57

Report Date: Aug. 29, 2003

SUBJECT: Man Crushed Between Skid-Steer Loader and Dump Truck

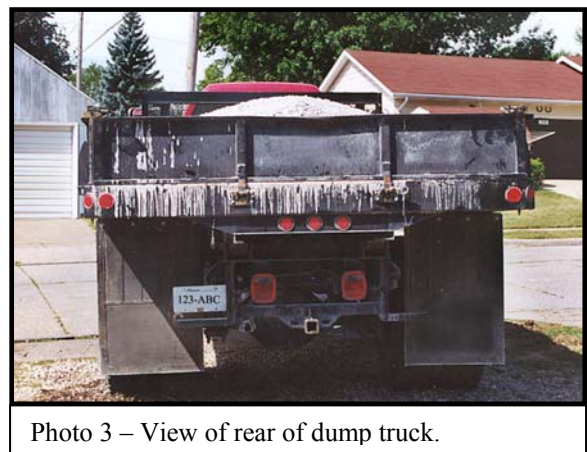
The truck had a back-up alarm, which was functioning, but the skid-loader operator apparently did not hear the alarm, and kept working. The dump truck was backed into position from the street and the victim and a co-worker were in process of locking down the tailgate to dump the gravel in a pile adjacent to the driveway area. The loader operator did not know the truck had returned or was in position to dump, for he was facing away from the dump truck. He continued to move gravel and dirt preparing the foundation on the opposite side of the construction site, assisted by another employee.

The victim, with his back to the loader, had just finished locking down the tailgate. His co-worker had finished doing the same on his side of the truck and had stepped to the side of the truck. At that time, while backing up, the skid-steer loader pinned the victim against the rear end of the dump truck causing fatal internal injuries. Only when he heard cries for help did the skid-steer loader operator realize he had backed into the victim, because the skid steer had not come into contact (collided) with the dump truck.

Photo 3 – View of rear of dump truck.

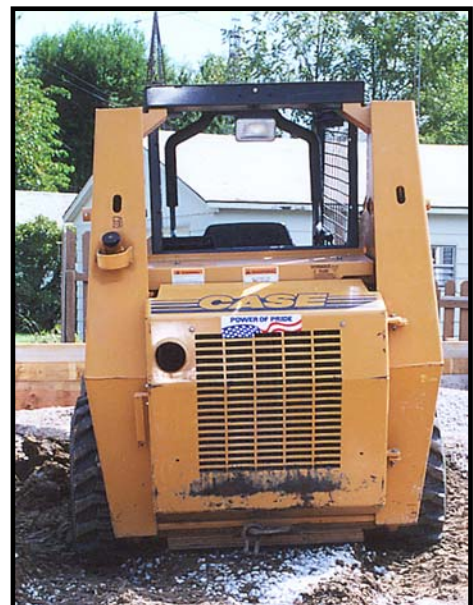
The skid-steer loader was a Case Model 1840 diesel, about 4-5 years old. It was in normal operating condition and did not have a backup alarm or rear view mirror. In the future, workers with this company agreed to never work directly behind an operating skid-steer loader. Further, all of these workers showed an increased awareness of the potential danger these machines present, and now give such equipment a much larger operating area.

Virtually all skid-steer loaders have inherent blind-spots to their rear due to their design and configuration. This makes the area to the rear of these machines an extremely hazardous place for workers. Backup alarms on loaders should be directed towards the rear of the machines to provide optimal reception by workers in these areas. Further, backup alarms should not produce pure tone sounds. Instead, the backup alarm should be at several different frequencies to prevent them from being canceled out by (indistinguishable from)

Photo 4 – View of rear of skid-steer.

Recommendation #3 *Backup alarms with variable intensity and frequency should be installed on all skid-steer loaders, and owner / operators should ensure that mufflers are working properly to reduce machine noise*

Discussion: The use of a backup alarm is an obvious recommendation, however, alarms can easily become ineffective if they are ignored by workers or if their intensity is below that of the background noise level at a jobsite. As mentioned earlier, skid-steer loaders change directions very quickly, and an alarm which is constantly going on and off will soon become an annoyance, which may lead to its removal by workers.

other noise sources. Also, the intensity of backup alarms should be 10-15 dB above the surrounding background noise level.⁽¹⁾

In this particular case, the noise levels emitted from this loader may have been a contributing factor. Workers reported that this loader was loud, which may indicate a faulty or worn-out muffler was present on the machine. Although this was a smaller skid-steer loader, its noise level may have been sufficient to drown out, or cancel, the backup alarm from the dump truck. Clearly, if noise levels are elevated to the point that workers cannot hear each other, safety is reduced.
