FROM: Iowa FACE Program Case No. 2IA51 Report Date: 7/23/2003

SUBJECT: Farmer Falls to His Death from Grain Bin Ladder

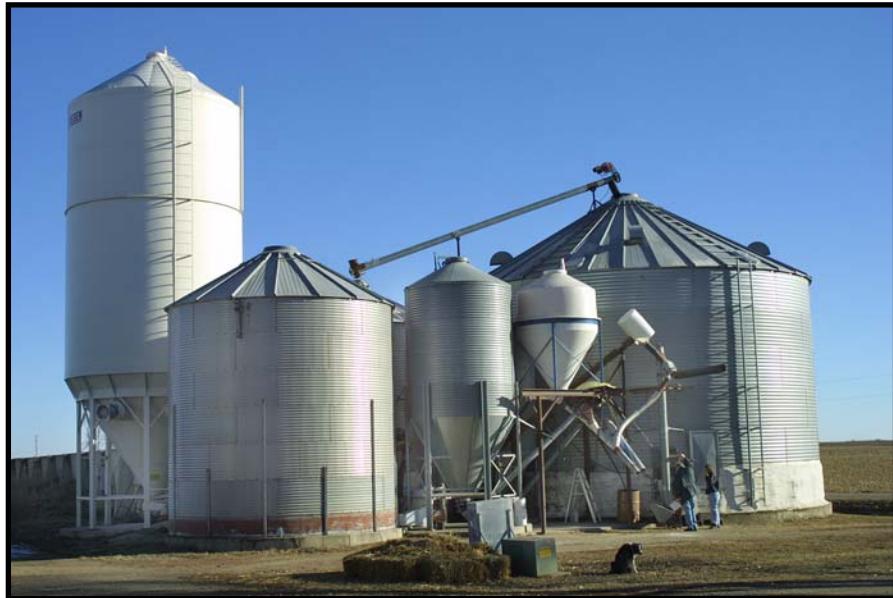
Photo 1 – Group of grain bins at the farm, facing Southeast.

The grain bin involved in this injury (to the right in Photograph 1) was built in 1986. Other bins were added to this facility in 1988-89. The facility had four corn bins and additional smaller bins for feeds and supplements. Each bin had an auger connecting to the central auger, which was used to feed the grinder mixer to mix corn, soy meal, alfalfa, minerals, and other supplements for livestock feed.

After this incident, new grain bin ladders (outside and inside the bin) were added to the west side of the bin (see Photo 1). These new ladders are similar to the old ones, but have no obstructions and no concrete pad underneath. A new access door and ladder/walkway to the central opening was also added.

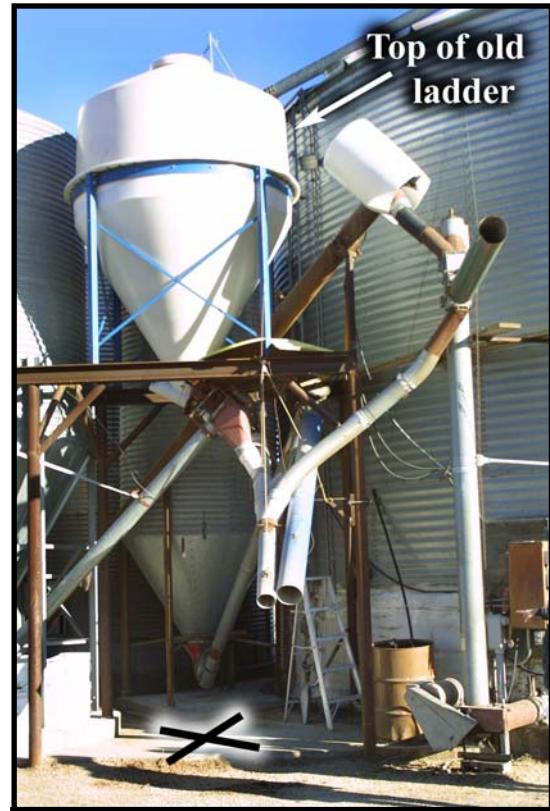
The original ladder for the large bin was located on the north side, the top barely visible in Photograph 2. The ladder was about 24 foot (7.2 m) tall. A smaller bin had been constructed very close to this ladder, so that one had to climb the ladder at a slight angle (see Photograph 3). The ladder was used frequently to reach the access door on top of the bin. There was no cage around the ladder, nor were there other means to prevent or arrest falls from the ladder.

Photo 2 – Side view of old grain bin ladder and concrete pad where the victim fell.

auger, hitting his head on the concrete pad below (location marked with an X). He was stunned, but conscious, and walked to a nearby lawn to lie down.

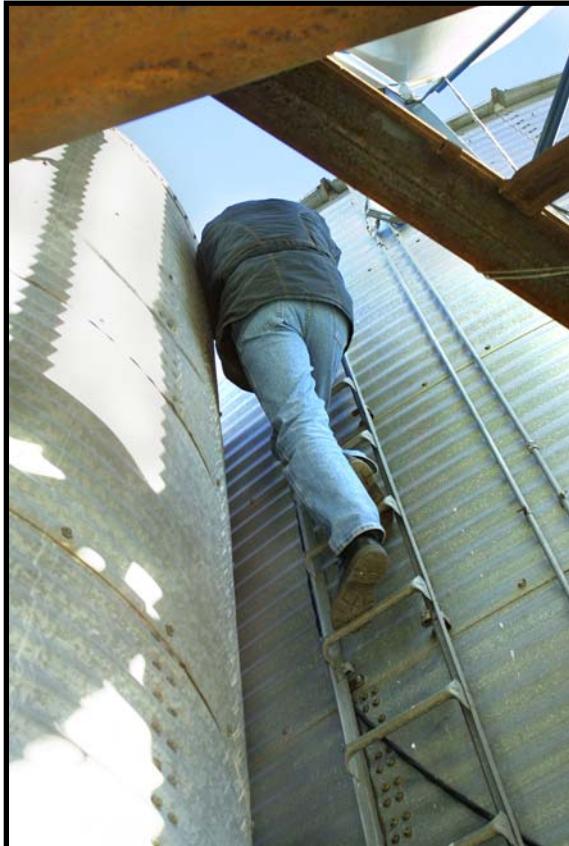
bin, leaving less than adequate clearance for the ladder, which made it somewhat difficult to climb the ladder in a normal fashion. When using this ladder, one would need to lean slightly to the right (See Photo 3). While grinding feed with his son, the farmer was climbing down the ladder after checking the grain bin. He fell approximately 10-12 feet (3-3.6 m) and hit his head on the concrete slab (See Photo 4). He was able to get up, and went to lie down on the lawn and his son called 911, against his father's wishes. The man was taken to a local hospital, then, transferred to a regional hospital by helicopter. He lost consciousness and rapidly deteriorated and died the next day from his head injuries.

Photo 3 – View from the ground looking up the old grain bin ladder.

Discussion: In this case the ladder did not have adequate clearance to climb the ladder in a normal fashion. The newer grain bin added next to the original grain bin was too close to the ladder, and forced the worker to lean to his/her right side when climbing. This may compromise the worker's ability to hold on to the ladder and have secure footing at all times. 29 CFR 1910.27 also specifies how much clearance is needed around the ladder, and these specifications should be followed regardless whether the standards are enforced on farms or not.

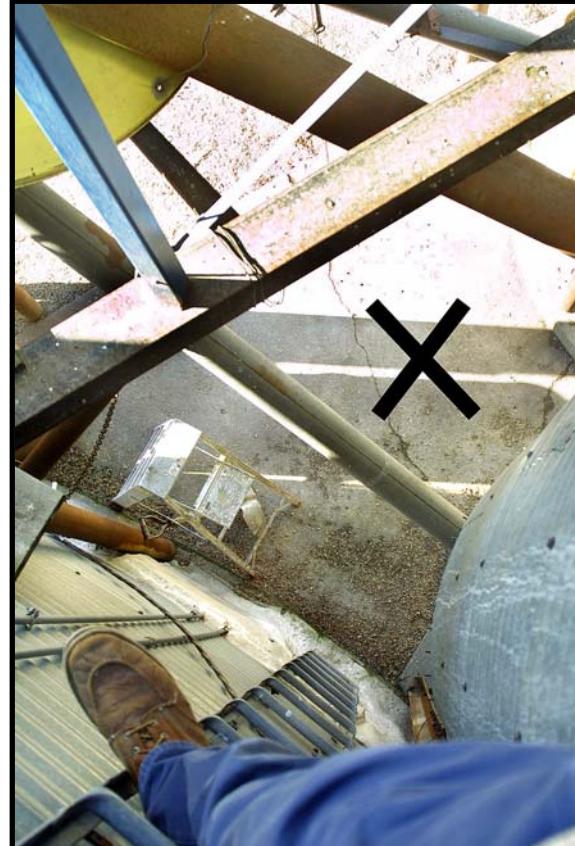
On the day of the incident, the victim was working with his 17-year-old son, mixing and grinding feed as they had done many times in the past. The large bin was about 2/3 full of corn, and contained some clumps of out-of-condition corn. Both the farmer and his son had been up in the bin that morning, apparently checking the level and condition of corn and breaking up any clumps that could clog up the auger. The son came down the ladder first, followed by his father. About half way down, the farmer apparently slipped and lost his grip, and fell backwards off the ladder. He may have hit an auger first (visible in Photograph 4) as he fell over to the other side of the

Photo 4 – View from the top of the ladder, showing area where the farmer fell.
