FROM: Iowa FACE Program

Case No. 01IA005

SUBJECT: Farmer Caught and Killed by Input Shaft of Roller Mill.

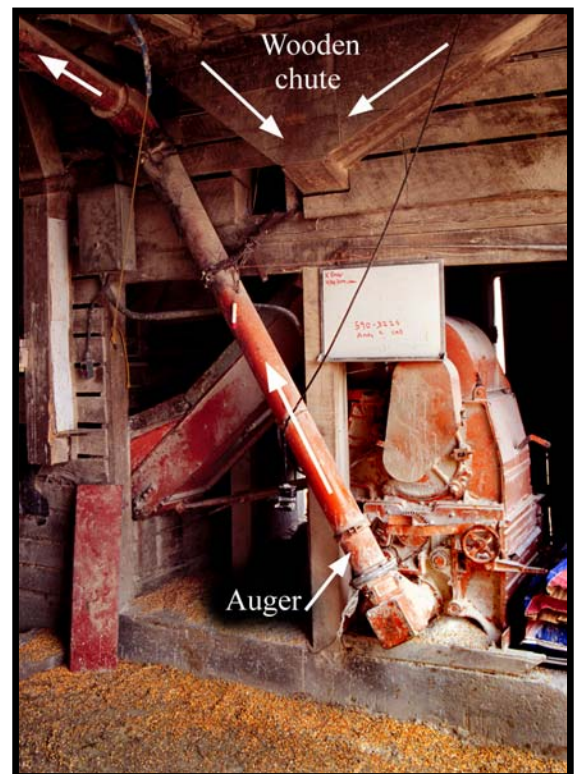
Photo 1 -- View of roller mill from inside the corncrib showing gravity-fed chute and auger.

The roller mill was installed as a stationary machine on the ground level of a wooden old corn crib where shelled corn was stored (see photo). Four times each day the roller mill would be started to grind about 0.75 m^3 (1 cubic yard) of corn to feed cattle. Shelled corn was gravity-fed from storage on the second level through a wooden chute directly to the top of the roller mill. Then ground corn was sent through an auger to a grain wagon parked next to the mill inside the corn crib.

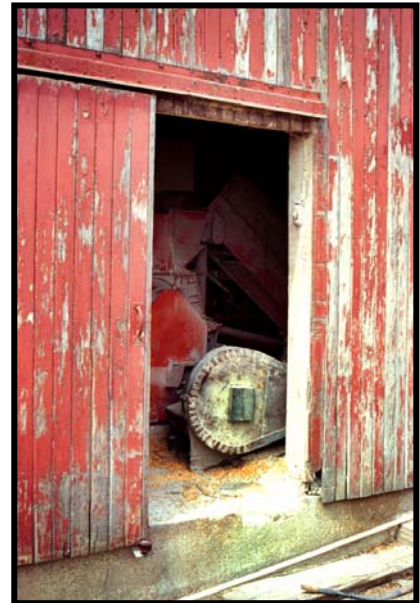
Photo 2 -- View of corner door with mill immediately inside.

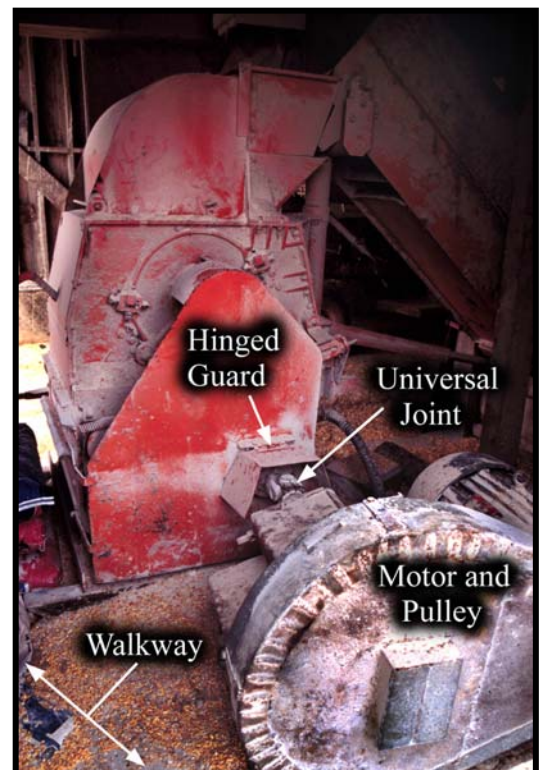
The roller mill was purchased new 20 years earlier, and was always in its present location. It was powered by a 15 kW (20 hp), 3-phase electric motor through a V-belt transmission; a smaller pulley on the motor and a larger pulley on the power shaft driving the mill (see photo). The ~50 mm (2") diameter shaft was covered by a guard but the U-joint and shear bolts section attached to the mill power intake shaft was exposed for about 250 mm

Photo 3 -- Mill as seen from side doorway.

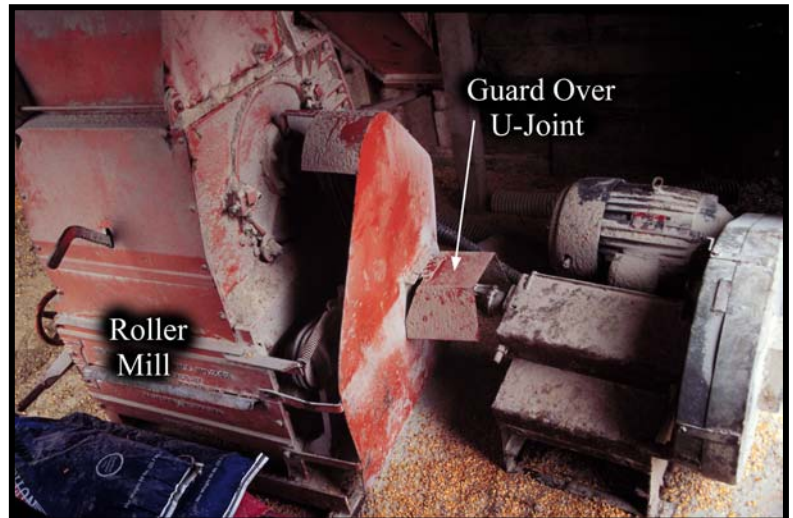
Photo 4 -- View of roller mill from inside corner of corncrib.

An oilcan was found buried in the corn, and it was suggested that the farmer may have been servicing the machine prior to the accident. This is possible, for there are many chains and moving parts on the opposite side of the roller mill. However there are no serviceable parts on the side of the mill where he became entangled. The mill did not appear to malfunction, and the V-belts did not appear to be slipping, which could have possibly caused maintenance work on this side of the mill. There would be no obvious reason for his head or neck to be close to the exposed and spinning shaft. There were various objects on the floor and 9 sacks near the door opening and the mill. It is possible that the man may have stepped on an object or slipped, tripped, or bumped against an object between the doorways, next to the machine, causing him to lose balance and fall.

Discussion: The mill was located inside a corncrib building near a door opening where the feed wagon was parked during grinding and loading. On the other side of the mill, there was another door opening. There was adequate room to walk around the mill, and conduct maintenance and control of the mill, however, there were feed sacks, objects, corn, and dust around the floor and the area, making it more hazardous for the workers. This mill was used four times every day to grind feed for cattle. It was therefore a very frequently used work area, and such areas require frequent cleanup and housekeeping. It is possible that some objects on the floor or around the mill contributed to the worker losing his balance and falling into the power shaft of the mill. Housekeeping is a basic requirement for safe working conditions in all work areas.

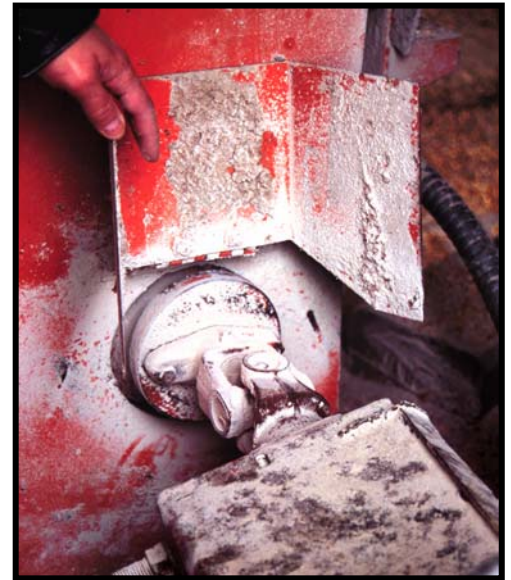
(10") on the side of the mill. During the investigation visit, this U-joint section of the shaft had a metal master guard hinged above it, to shield the joint from debris, and protect from accidental contact with the spinning U-joint. At the time of the injury, the photographs suggested that the cover was missing.

Discussion: The hinged guard over the universal joint appeared (from photographs) to be out of place at time of the incident. The guard was in place during the investigation. The metal guard (see photo) was light duty and hinged on the top, with no other attachment points. This guard, if down in the operating position, would likely be adequate to help protect workers

Photo 5 -- Close-up of universal joint and flimsy guard hinged above it.

Recommendation #1 *Moving machinery parts such as belts, pulleys, chains, gears, and shafts, must be guarded to protect workers.*

from getting entangled in the rotating shaft. As this was a stationary machine, this shaft and the U-joint could have a more permanent guard, covering all sides of the shaft and the U-joint, and not only the top and the sides, as did the existing guard. This case underscores the fact that machine guards should always be left in place. Even if rotating machine parts are in an area unfrequented by workers, there is always the possibility of a worker slipping and/or falling into a dangerous area.
