**FROM: Iowa FACE Program      FACE No. 01IA00401      Report Date: March 2002**

**SUBJECT: Farmer Was Killed When Pinned by Old Skid-Steer Loader.**

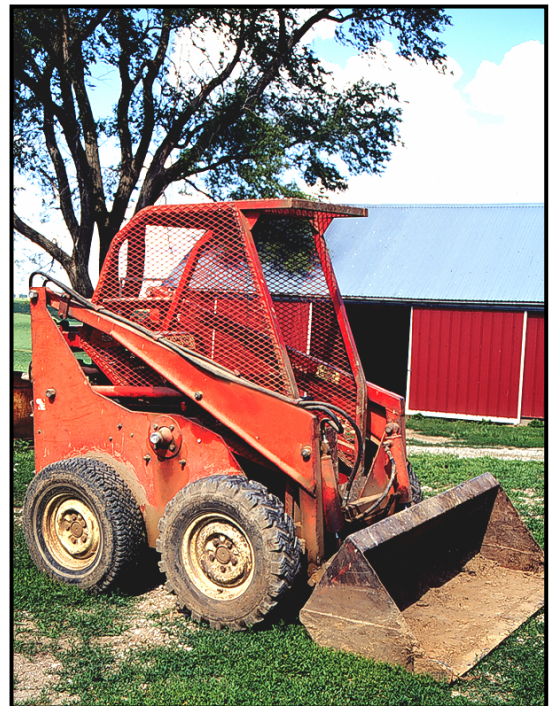
Photo 1 -- Old skid-steer loader with ROPS cage re-attached by new owner.

The height of the loader with the cage attached was 70" (1.8 m) tall. This protective cage was too tall to accommodate an older hog house at the farm, and the farmer had removed the cage several years earlier to facilitate cleaning of manure from this building. The protective cage did not have machine controls or other mounted connections, and was therefore very easy to remove. The small loader had 28" (71 cm) between the right and left hydraulic lift arms and only 21½" (55 cm) of space left to right inside the cage. The victim was taller and heavier than average, which likely made mounting and dismounting the narrow loader quite cumbersome, especially in the winter with heavy clothing.

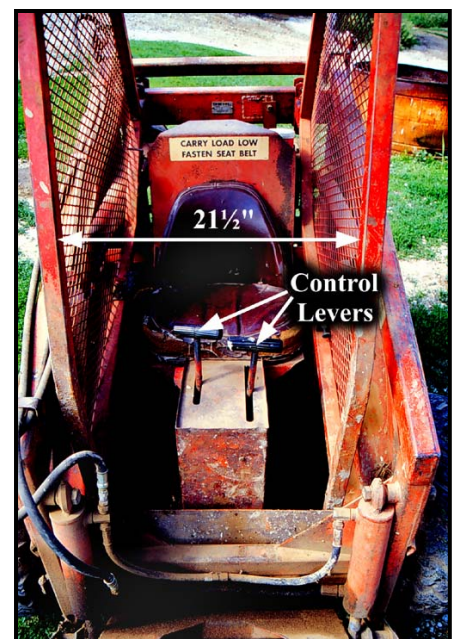
Photo 2 -- Front of skid loader showing narrow ROPS cage.

The victim was found dead in the seat of the skid-steer loader, leaning to his left, with the left lift arm crushing his chest against the frame of the loader. The loader bucket was empty, and the loader was backed in position in a corner of the hog lot, as if getting ready to scoop more snow. There were no obvious gates or other objects in the vicinity that the man could have been reaching for. He may have leaned and looked to the side, or been distracted, and inadvertently grabbed one of the control levers. These circumstances are not known.

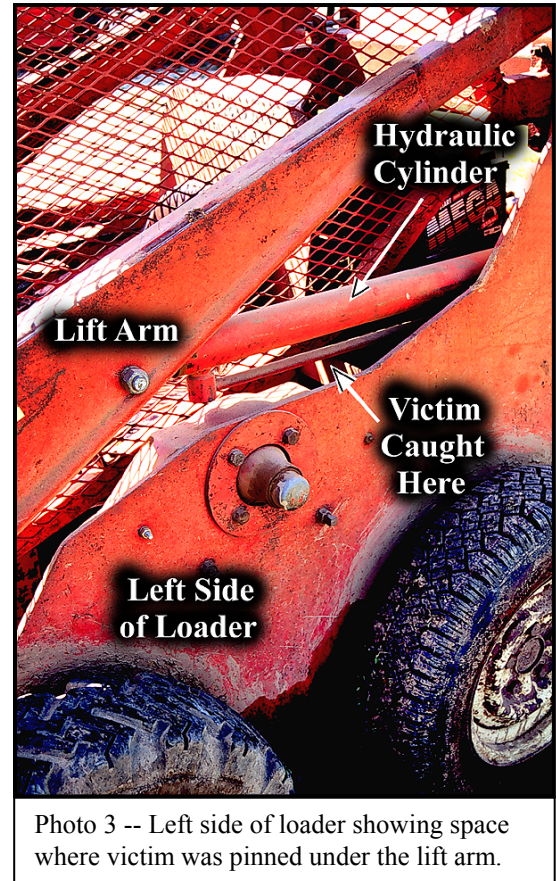
**Discussion:** The protective structure is an essential safety feature of all new skid-steer loaders. Due to close proximity to the loader bucket and lift arms, the operator is in great danger if the protective structure is removed or modified, especially on this machine, which had a very narrow distance between the lift arms. This protective cage was removed to provide easier access to an old, low farm building. Other safety features are commonly built into newer original protective cages, such as lift arm safety stops and ignition safety interlocks. This older loader had none of these features. Removal of the cage provided easier access to the machine, and to certain low worksites at the farm, but seriously compromised safety of the machine. Using the machine with the original cage would have prevented this fatality.
