**FROM: Iowa FACE Program**

**Case No. 01IA00201**

**SUBJECT: Towman Crushed To Death While Hooking Up Disabled Propane Truck**

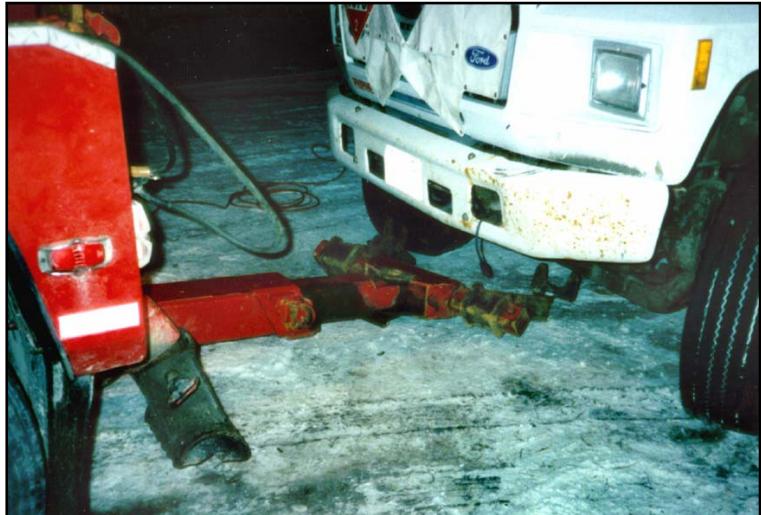
Photo 1 --- Shows red tow truck in position with T-bar extended under front of disabled propane truck.

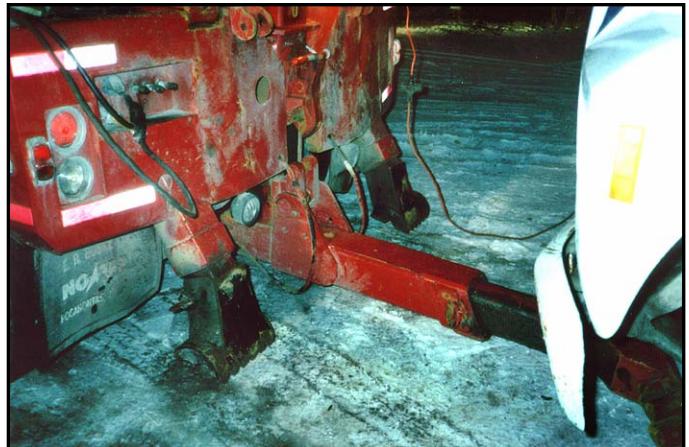
Photo 2 --- View of rear of tow truck.

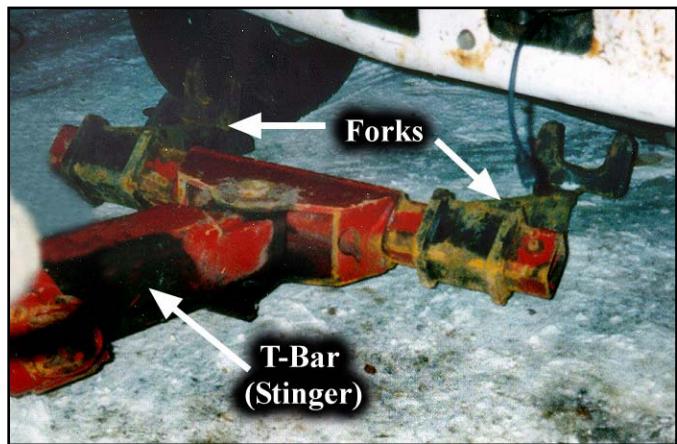
Photo 3 -- Close-up of extended T-bar with forks attached.

The Sheriff's department investigated the scene that night taking several photographs, and again the next day before the propane truck was removed. Photographs show the tow truck in position, with the stinger extended, with both forks in the ends of the T-bar (see Photo 3). From marks made in the snow, it was evident the propane truck had slid forward on the ice about 1.2 meters (four feet). The wooden block in front of the left rear tires had slid forward about 0.3 meters (one foot), then dug into the snow, and shot backwards as the tires moved over it. There were no other blocks or tire chocks used for other wheels.
