FROM: Iowa FACE Program

Submission Date: 3/23/2000

SUBJECT: Sewer maintenance worker killed by nozzle tip on jet/vac hose (99IA038)

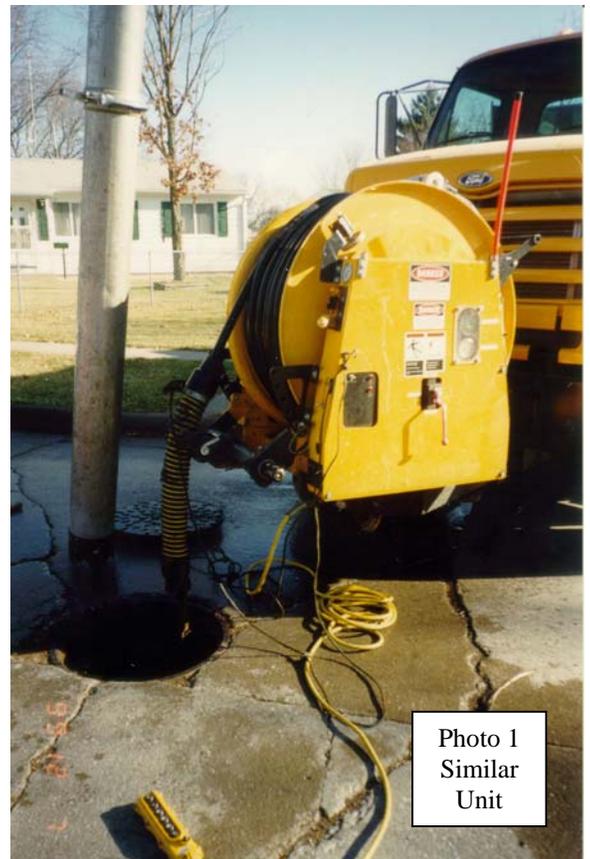
On August 6, 1999, a 29 year old male public works employee died when he was struck by the nozzle of a high pressure water hose. Two employees were doing routine cleaning of the sanitary sewer line using a combination jet/vac truck equipped with a water-powered hose and nozzle. The nozzle somehow came back up through the manhole and struck the victim in the head. His co-worker was at the next manhole some distance away, and not in visible sight due to a ravine and landscape between the two positions. His co-worker stated that as the sewer cleaning was in process, he heard the nozzle approaching his end of the sewer line, indicating there were no obstructions in the line, and radioed the victim. The victim started reeling the hose back to the truck. The co-worker heard the truck idle down and knew that the hose was back at the start of the sewer line. The victim radioed the co-worker to confirm that he was shutting the unit down. The co-worker started fastening down the manhole cover following normal procedures, when he heard the truck idle back up to operating speed. He then heard boys screaming and knew something had happened. It took him some time to get through the ravine and back to the truck. Upon arriving at the truck, he found the victim lying by the manhole with massive head injuries. The nozzle had somehow come back up through the manhole and struck the victim in the head. Bystanders reported that they heard something explode from the back of the truck. They saw the hose spraying water into the air and the victim lying on the street, and immediately called 911. The city police and fire department responded, and the victim was unconscious when they arrived. Life Flight helicopter was notified and transported the victim to a local hospital. The victim remained unconscious and died two days later.

RECOMMENDATIONS based on our investigation are as follows:

- 1. Employees must follow manufacturer's instructions when using equipment.*
- 2. Safety issues should be re-emphasized periodically during staff meetings.*

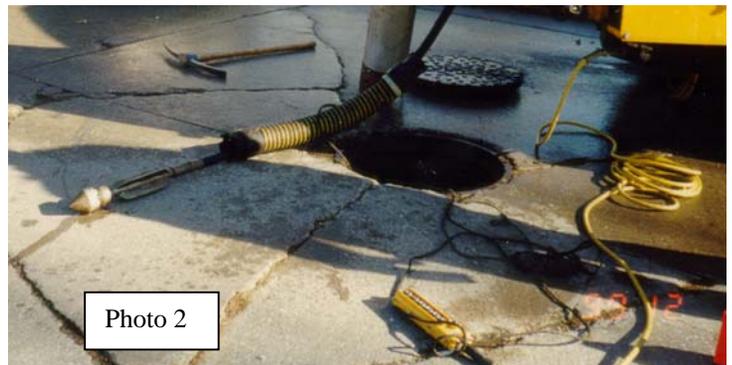
The combination jet/vac process consists of a hose and nozzle that is propelled forward in the sanitary sewer line by high water pressure. Depending on the size and type of sewer line, a steel nozzle weighing 10-12 pounds, is placed on the end of the hose. The steel nozzle controls the rotation to clean the sewer walls. In this incident a 1-inch steel nozzle was used. The water pressure is usually 1100-1200 psi. at the nozzle, which corresponds to 80 gallons of water per minute delivered at the nozzle. This high water pressure allows the nozzle to propel the hose forward in a rotating manner to clear obstructions in the sewer line.

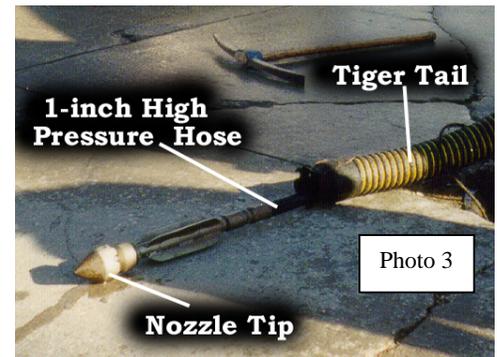
Before the hose is placed in the manhole, a section of thicker hose, called a 'tiger tail' (see Photo 3) is placed on the outside of the hose/nozzle assembly, using a split ring, in such a manner that the tiger tail can not slide off the end of the hose. The tiger tail section stays in the sewer opening to direct the hose assembly and protect the hose from friction and wear. The tiger tail is connected separately with a cord to the truck. The employee can view the tiger tail / hose assembly, using a halogen floodlight, by looking down through the manhole.
