FACE INVESTIGATION # 04WI06701

SUBJECT: Farmer Dies when he is Pinned under his Tractor that rolled over on an Incline

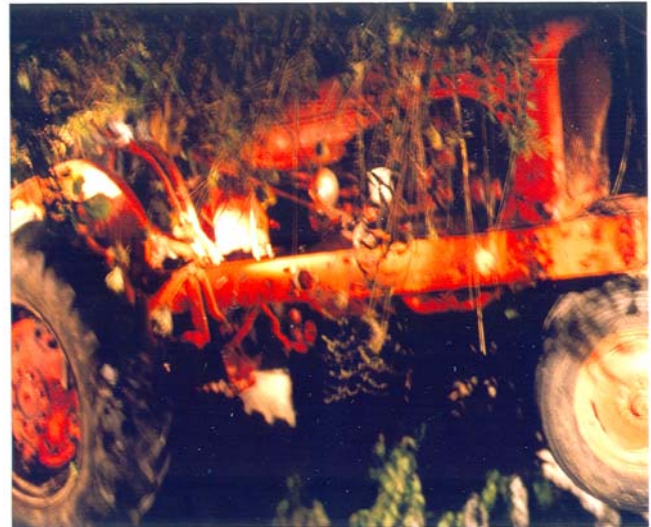
On September 10, 2004, a 62 year-old farmer died after his tractor rolled over on an incline and pinned him underneath. He was spraying weeds along the edge of his field, at approximately a 25-degree angle on a hill with an Allis Chalmers WD45, tricycle-front-end tractor. (Figure 1) The container of weed spray was attached to the back of the seat of the tractor. The tractor was not equipped with a cab or rollover protection structure (ROPS). When her husband did not return home, the victim's wife became worried and contacted neighbors and then the sheriff's department. Having no success in locating the victim, the helicopter from a nearby hospital was contacted. The emergency personnel arrived in the helicopter equipped with spotlights to join the search. The tractor was located upside-down in tall weeds down the incline of a hill. The victim was found pinned underneath the tractor. Emergency medical persons were present when the victim was located and they examined the victim. No signs of life were found. The medical examiner was contacted and pronounced the victim dead at the scene. The FACE investigator concluded that to help prevent similar occurrences, farmers should:

Figure 1. Side view of Allis Chalmers WD45 after the incident.

The area where the victim was found was on the side of a hill less than 25 feet from the edge of the field. The field was on a flat terrain with the edge of it near an area where trees had been cut. This area was not cultivated. This area had a hill that was about a 25-degree angle sloping down. A fence was approximately 25-30 yards from the edge of the field. The victim had been spraying weeds along the uncultivated area of the edge of the field. He was using the Allis Chalmers tractor and a tank with a sprayer on it attached behind the seat on the tractor. The tractor rolled down the hill toward the fence that was located partway down the hill, but did not roll into the fence. The victim ended up face down with his legs under the fenders and his back under the tractor seat. The tractor was a narrow tricycle front-end Allis Chalmers that was not equipped with a cab or ROPS.

Discussion: The tractor in this incident was not equipped with a seatbelt or ROPS when it was manufactured. The model, an Allis Chalmers WD45 tractor, was no longer made after 1952 and no ROPS are made to retrofit this model tractor. It is very important to use only the ROPS recommended by the manufacturer or tractor dealer. ROPS are engineered specifically for each tractor and must pass a series of dynamic and static tests. They must also meet the test and performance requirements of OSHA 1928.52 CFR. According to the National Farm Medicine Center in Marshfield, WI, "Due to dynamic forces which act upon a ROPS during a tractor rollover, it is imperative that a ROPS be properly designed, manufactured and installed. Proper materials and mounting hardware as well as engineering design, are necessary to ensure safe performance. A ROPS is not something to be fabricated in the farm shop."

Discussion: The position of the tractor's center of gravity with respect to its tires can influence the stability of the tractor. In this case, the narrow front of the tractor, the incline of the terrain and the weight of the chemicals in the container may have all affected the overturn of the tractor.
