## FACE INVESTIGATION # 03WI080

### **SUBJECT: Farmer Dies When Skid Steer Loader Rolls Over Him After it Plunged Over Edge of Bluff**

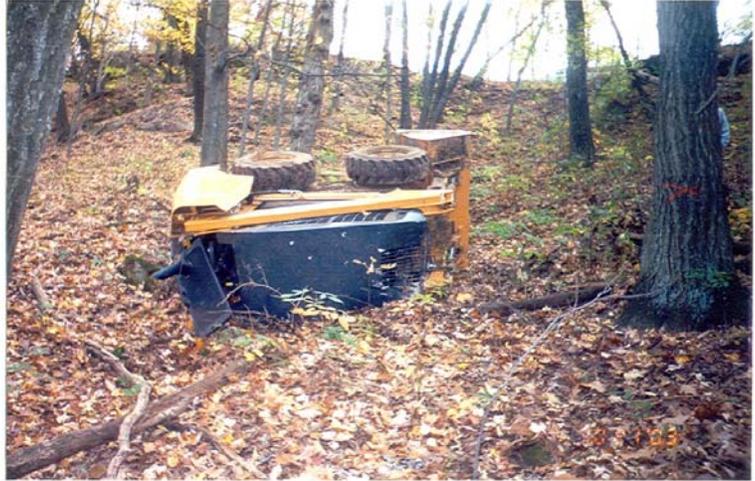
On October 22, 2003, a 43 year-old farmer died after his skid steer loader plunged over the edge of a bluff and rolled over him. He was filling in ruts on a dirt road close to the edge of a bluff by his field and planned to cut up a tree that had fallen across the road. He was using a new Case Model 40XT skid steer loader that he had owned about two months. The victim's father came to the farm and realized the victim had not returned home. He took the tractor up to the field to check on the victim and found the skid steer loader lying on its side over the embankment. (Figure 1) The victim was

**Figure 1. Skid steer loader on its side, after rolling over the embankment**

The skid steer loader went over the edge of the bluff from the road. There were divots and broken tree limbs in the path the skid steer loader had taken. The chainsaw was lying about 15 yards from the top of the hill and was in the path that the skid steer loader had taken. Tire tracks indicated the skid steer loader went over the edge of the bluff backwards and rolled about three times to a point about 30 yards down the hill. The skid steer loader was lying on its left side facing west. The victim was lying on his right side facing north beside the south side of the skid steer loader. The victim was thrown out of the skid steer loader and it rolled over him as he and the skid steer loader went down the hill. The seatbelt on the skid steer loader was not fastened and the safety restraint bar was up. The lift arms on the loader were not raised.

### **Recommendation #1: Always fasten the seat belt and keep the operator's restraint bar down at all times when operating a skid steer loader.**

Discussion: The seat belt protects the operator in several ways. The seat belt can protect the operator from being jostled and thrown against cab structures, out of the cab or into the operating zone of the lift arms and bucket. During rollovers, the seat belt maintains the operator within the protective envelope of the cab. Operators should not take their seat belt off or move the operator's restraint bar up until after the equipment has been properly shut down.

### **Recommendation #2: Walk around the work area before starting to work and look for hazards. Use extreme caution when operating machinery on or near sloped terrain or embankments and consider doing work by hand where machine use may be too hazardous.**

Discussion: Inspect all surfaces over which the skid steer loader is to travel. Pay attention to drop-offs, banks, steep slopes, hidden obstacles, etc. that may cause a collision or loss of control. In situations where machine use may be too dangerous due to the terrain, use of hand tools, such as shovels and rakes may be a more safe alternative method for filling in potholes.
