## FACE INVESTIGATION

### SUBJECT: Hispanic Painter Dies after Falling from a New House Roof

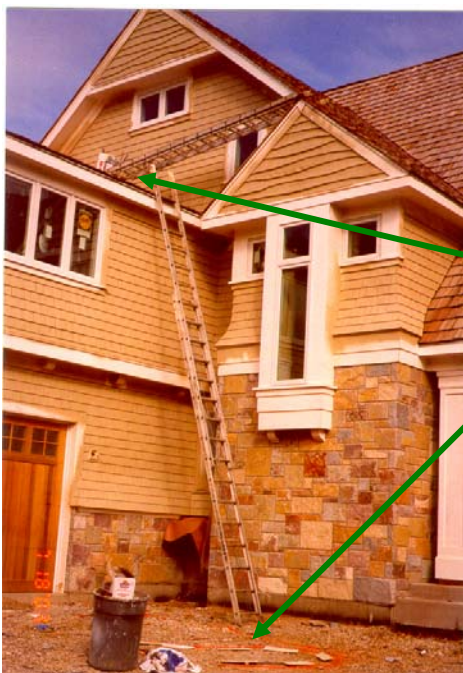
**Figure 1. View of Scene**

**SUMMARY:** A 43 year-old Hispanic painter (the victim) fell from a roof while painting the exterior of a two-story home under construction. The victim was employed by a painting company that was contracted to paint the house. The company had worked at the site for two days prior to the incident, but the victim was not scheduled to work there on that day. When the victim showed up at the jobsite, the employee in charge allowed him to begin work. He was assigned to do ground-level painting and cleanup, while co-workers were painting the second story portions. The victim apparently climbed a ladder to a first story rooftop to paint the lower part of a second-story dormer. The victim was wearing worn, smooth-soled athletic shoes and was not wearing any fall protection equipment. He either slipped or tripped and fell from the roof, landing on the ground (Figure 1).

**Area where Victim Fell from Roof**

**Location of Victim**

A 25-foot extension ladder extended from the ground to the edge of a sloping roof, about 20 feet above the ground. The painters used this ladder to access the wood shingle rooftop, where they could stand to paint the lower portion of a second story dormer.

The victim apparently climbed the ladder and went onto the rooftop to paint the lower part of the dormer. At the time of the incident, co-workers # 1 and 2 were working on another side of the building and worker #3 was working on the ground on the same side of the building as the victim. The victim was wearing worn, smooth-soled athletic shoes and was not wearing any fall protection equipment. He either slipped or tripped and fell from the roof, landing on the ground. Worker # 3 heard a yell, then turned to see the victim falling and hit the ground. Worker #3 called for help, then called for EMS services. EMS responders transported the victim to the hospital, where he was pronounced dead.

**Recommendation #1: Employers should develop, implement, and enforce a fall protection plan that protects workers against potential fall hazards and, at minimum, meets OSHA standards for fall protection.**

Discussion: In this case, the work location was a residential construction site and a sloping

rooftop was used as a working surface to paint a second-story dormer. The employer did not have a written safety and health program and did not require employees to use a fall protection system when working at elevations.

Employers should develop, implement and enforce a written safety and health program that contains a fall protection plan that meets OSHA requirements for fall protection in residential and/or commercial construction. OSHA's fall protection standard requires employees engaged in residential construction activity at elevations to be protected by fall protection. Subpart M, Section 1926.501(b)(1) states:

*Unprotected sides and edges.* Each employee on a walking/working surface (horizontal and vertical surface) with an unprotected side or edge which is 6 feet or more above a lower level shall be protected from falling by the use of guardrail systems, safety net systems, or personal fall arrest systems.
