WISCONSIN FACE INVESTIGATION # 03WI001

SUBJECT: Farmer Fell into Auger of Manure Spreader while Scraping the Tank

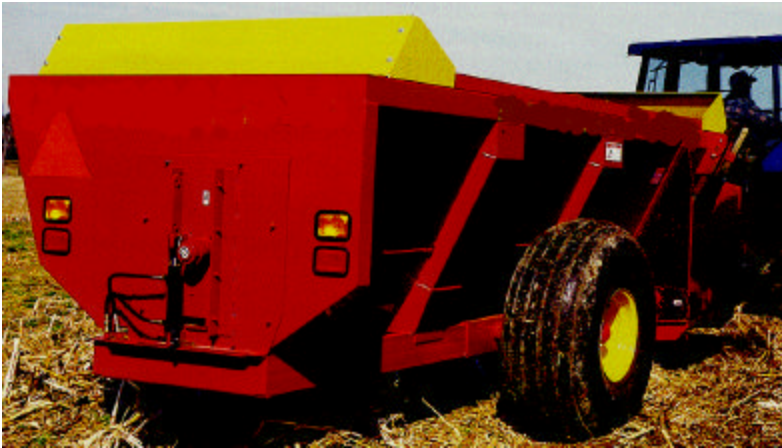
Figure 1. V-tank design side-delivery spreader

On February 27, 2003 a 38 year-old farmer died when he fell into a manure spreader and was pulled into the auger. The victim was working by himself cleaning the sides of the spreader tank with a scraper, while standing on the front tire of the spreader (Figure 1). He didn't return to the farm at the usual time so a co-worker went out to the field and found the victim under the auger at approximately 7:30 AM. The co-worker called for emergency services located about 14 miles away. The victim was pronounced dead at the scene. The spreader was transported to a facility where the body could be extricated.

Height from ground to top of tank: 5 feet

Victim stood on a tire to scrape the inside of the tank on a similar spreader.

Recommendation #1: Remain seated on the tractor while the spreader is in operation.

Discussion: One of the safety precautions the operators manual recommends is: “Do not get off the tractor while the spreader is in operation.” The power to the PTO will be off when the engine of the tractor is shut off, preventing the auger from rotating.

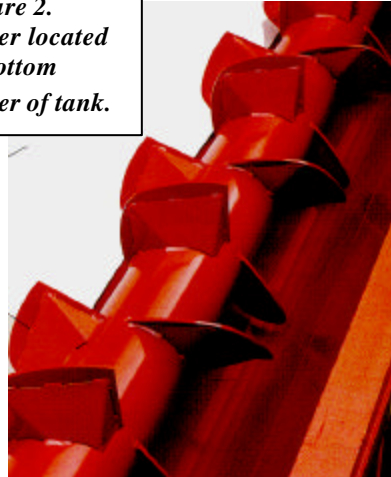
*Figure 2.
Auger located
in bottom
center of tank.*

On the day of the incident, the victim went to the neighbor's farm and cleaned the barn. The victim had planned to bring a calf to his home farm later that morning. He talked with his co-worker at the neighbor's farm before he left to take a load of manure out to the field. When the co-worker thought he had been gone longer than usual, he went to the field to check on him. At that time the co-worker found the victim in the spreader under the auger. The victim had been working by himself cleaning the sides of the spreader tank with the scraper, while standing on the front tire of the spreader. He apparently fell into the spreader and was caught under the auger (Figure 2). In freezing

While it appeared that the victim slowed the power take off on the tractor, he did not turn it off when he went back to clean the manure spreader. When the power take off is running at full speed, the auger which is located in the center of the machine pushes the manure up front and then beaters at the door of the chute kick the manure out the side up to a distance of 20 feet. At the time of the incident, the manure had been kicked out approximately a distance of 8-10 feet, demonstrating that the tractor was running slowly. When the victim was caught in the auger, the tractor lost power and shut off; however, the key was turned on and the ignition red light on the dashboard of the tractor was activated at the time the victim was discovered. The sides of the spreader had about 3 feet of manure left to clean when the victim fell into the spreader.

*Auger Dimensions:
Diameter: 24 in.
Length: Approx: 16 ft.*

Recommendation #2: Stop all augers and shut off the power source before operators attempt to clean, maintain or work close to the auger.

Discussion: Because many manure spreader augers are not shielded, augers should be stopped prior to operators performing any activities in the vicinity of the auger. This

includes cleaning the sides of the spreader and any other activities that place an individual close enough to an auger that entanglement might occur. If the auger involved in this incident had been shut off, this fatality would have been prevented. The operator's manual states "Do not clean, lubricate, or make any adjustments to the spreader while it is in motion or operation."
