## FACE INVESTIGATION

### SUBJECT: Youth Camp Counselor Dies of Carbon Monoxide Poisoning

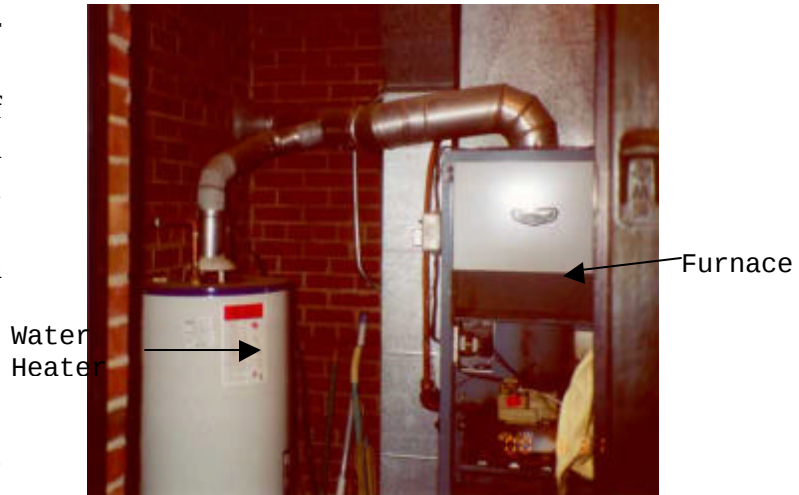
Figure 1. View of  
Furnace Room

This incident occurred in a 50-year-old health services building which was located about one-fourth mile from the central lodge. It contained an office, a treatment room, sleeping quarters for four people, and a utility room. Throughout the summer, health services staff and ill or injured campers slept in the building on a regular basis. The wood frame building had an interior furnace room which housed a 25-year-old LP gas fueled furnace and an LP gas water heater. Neither appliance had a source of outside air for combustion purposes, nor was there a source of outside air for air exchange to the occupied areas. The furnace thermostat would not shut off the furnace when the desired temperature was reached, so camp staff routinely used a toggle switch on the office wall to turn the furnace on and off as needed. There were no records to indicate when the furnace and water heater had been inspected or repaired. The building lacked carbon monoxide detectors.

Discussion: Gas fueled appliances produce carbon monoxide (CO) as a waste product of incomplete combustion of organic material. The concentration of the odorless, colorless and tasteless gas can reach hazardous levels if it accumulates in an area lacking sufficient ventilation. In this case, the gas fueled furnace and water heater were installed without provision for outside combustion air and the building lacked ventilation for make-up air whenever the doors and windows were closed. On the night of the incident, the victim kept the windows and doors closed, allowing the CO to accumulate to a deadly level while he slept.

Discussion: There was no set schedule for inspection of the furnace and water heater at the camp, nor were records available to indicate when the appliances were last inspected. Inspection of the heating systems by a heating and ventilation specialist would have detected the lack of design for combustion and make-up air, and the wiring design that used a wall switch to turn the furnace on and off. If these situations had been corrected, the incident might have been prevented.

### **Recommendation #1: Employers should ensure that gas fueled appliances are installed and maintained to prevent production and buildup of carbon monoxide.**

### **Recommendation #2: Employers should ensure gas fueled appliances are inspected on a schedule recommended by the manufacturers by knowledgeable technicians with authority to make changes.**

### **Recommendation #3: Employers should install carbon monoxide detectors in buildings with gas fueled appliances.**
