## FACE INVESTIGATION

### SUBJECT: Youth Farm Worker Pinned Under Overturned Horse-Drawn Manure Sled

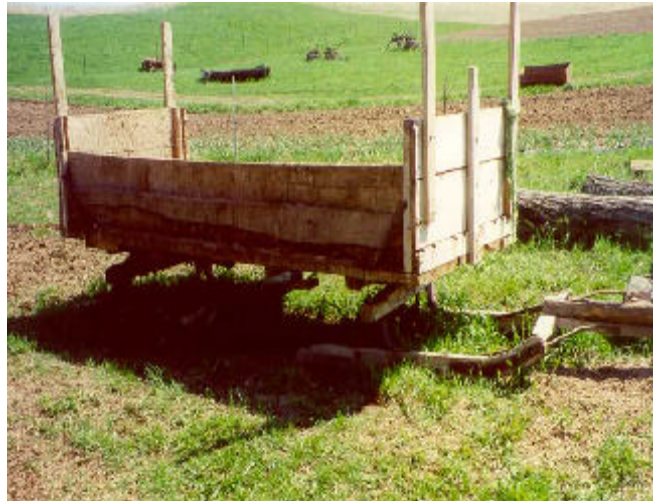
Figure 1. Sled Box

**SUMMARY:** A 16-year-old male farm worker (the victim) died when a horse-drawn sled loaded with manure overturned on him. The victim had driven the horses with the sled to a snow-covered hillside about a half-mile from the farmstead to spread the load of cow and horse manure. He was in the wooden box that was piled high with manure, using a pitchfork to throw it out the back of the box. The long rectangular box sat on the cross braces attached to the sled runners. (Figure 1) Wooden dowels projected up from the cross braces and through the bottom of the box to prevent the box from shifting side-to-side.

Apparently, the box tipped sideways off the runners, trapping the victim under the load and the box. When the horses returned to the farmstead pulling the sled runners, the victim's family went to the field and found him under the box.

! **design and build the sled box with secure attachments to the runners**

**Recommendation #1: Farmers who use box sleds should design and build the box with secure attachments to the runners.**

Discussion: The sled box in this incident was secured to the runners with wooden dowels that prevented the box from shifting sideways. However, the dowels did not prevent the box from tipping off the runners. The box could be secured to the runner braces by bolts or by inserting a pin through an extension of the dowel above the bottom surface of the box.

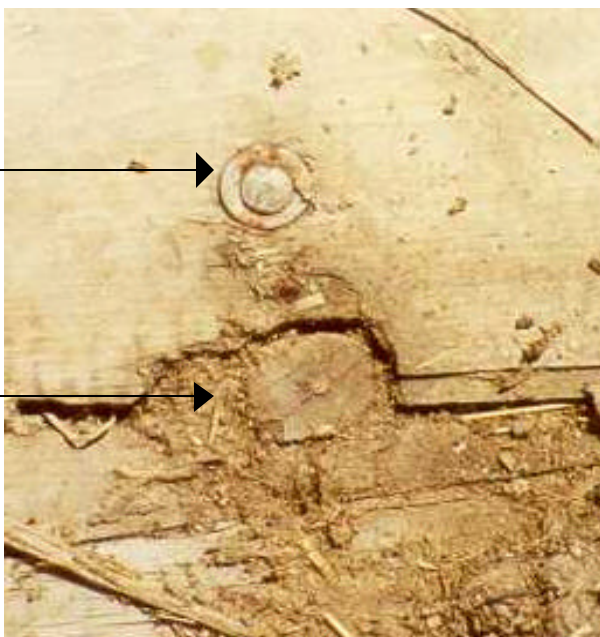
Bolt Added After Incident

Original Wooden Dowel

Note: At the time of the site visit, the box had been secured to the runner braces with bolts.
