## FACE INVESTIGATION

### **SUBJECT: Farm Worker Dies after Being Struck by a Flywheel of a Haybaler**

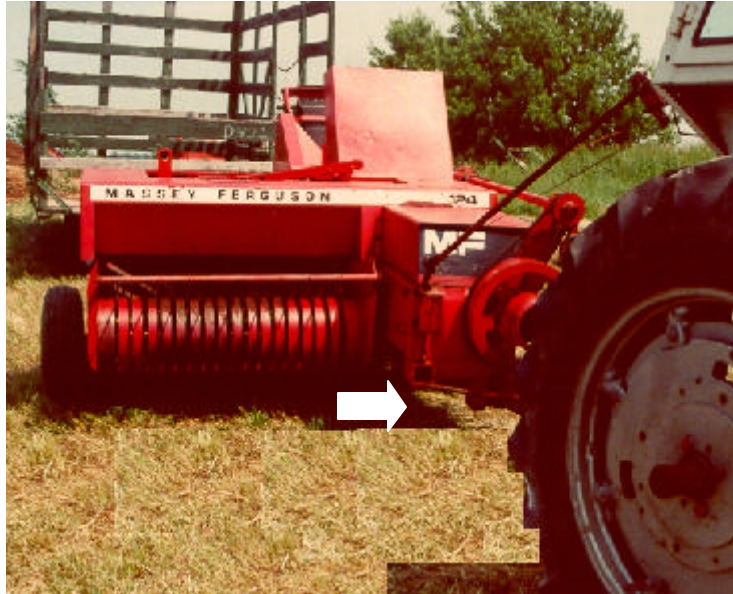
Figure 1. The arrow indicates the victim's location.

**Recommendation #1:**        **Farm equipment operators should observe and follow all applicable safety precautions when operating machinery driven by tractor power take-off equipment, including disengaging the PTO and stopping the tractor engine before approaching the machinery to make repairs, adjustments or perform maintenance.**

Discussion: The chains on the hay baler in this case could be safely oiled from above while the machine was not operating. After the victim finished oiling it in the recommended manner, he apparently turned on the tractor, engaged the PTO, and went under the baler to oil another location. The incident would have been prevented if the victim or a standby helper had observed the machine for the location of squeaking parts from a safe distance while it was operating, then disengaged the PTO and turned off the tractor before going under the baler.
