FACE INVESTIGATION

SUBJECT: Farmer Dies After Being Pinned Between the Bucket and Frame of a Skid steer Loader

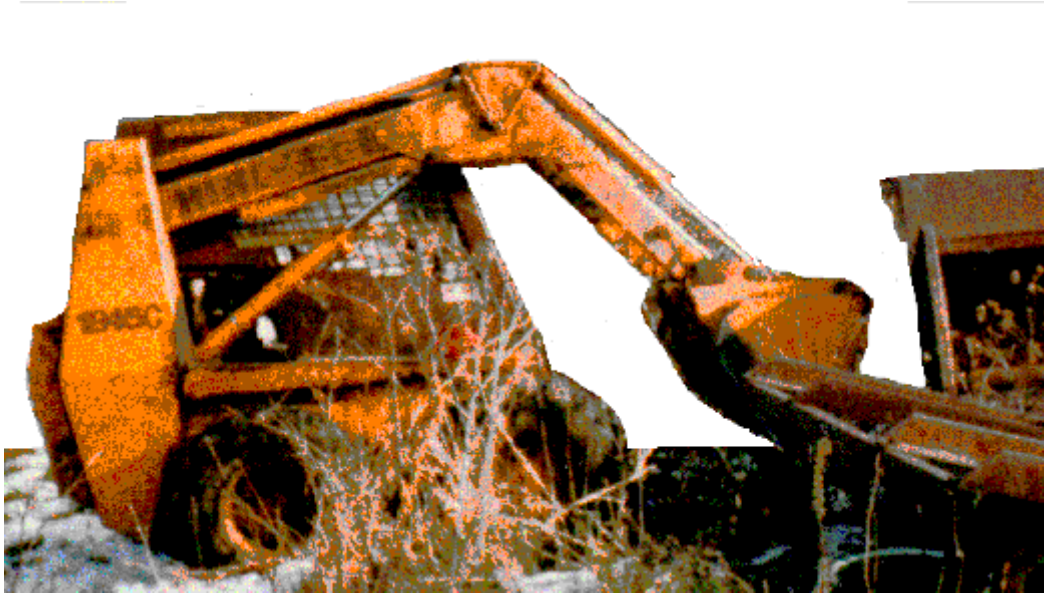
Figure 1. Skidsteer loader at incident scene

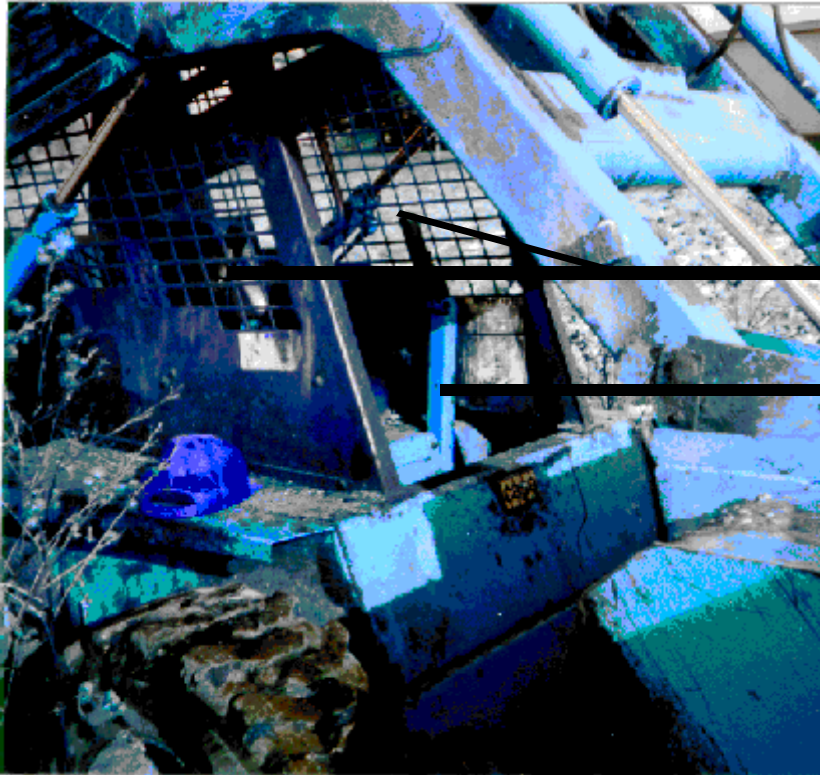
Safety Bars

Bucket Control Handle

Figure 2. Skidsteer loader cab and bucket lift arm

The farmer bought the Case Uni Loader skid steer loader new from an equipment dealer eight years before the incident. It was equipped with a seatbelt, and an interlock system which required two restraint bars to be brought down over the seat area and the engine running before the hydraulic lift system would operate the bucket. The farmer selected this model in part because the interlock system did not require the operator to sit on the seat for the hydraulic system to work. Although the victim occasionally reported discomfort in his knee and ankle, he could enter and exit the loader without assistance. At the time of the incident, the victim was wearing a brace on his right knee. His son reported the victim usually wore the seatbelt when operating the loader.

Discussion: Seat belts and interlocked restraint bars are intended to protect skid steer loader operators from serious injury caused by jolts, overturns and being pinned by the equipment. The victim in this incident defeated the restraint bar system by exiting the cab after the restraint bars had been lowered, allowing the hydraulic arm controls to be operated. When the machine was purchased eight years before the incident, loaders were available with seat sensor systems that locked the lift arm and tilt functions when the operator left the seat. Correct use of a seat belt, restraint bars, and a safety interlock seat sensor system would have prevented this incident.

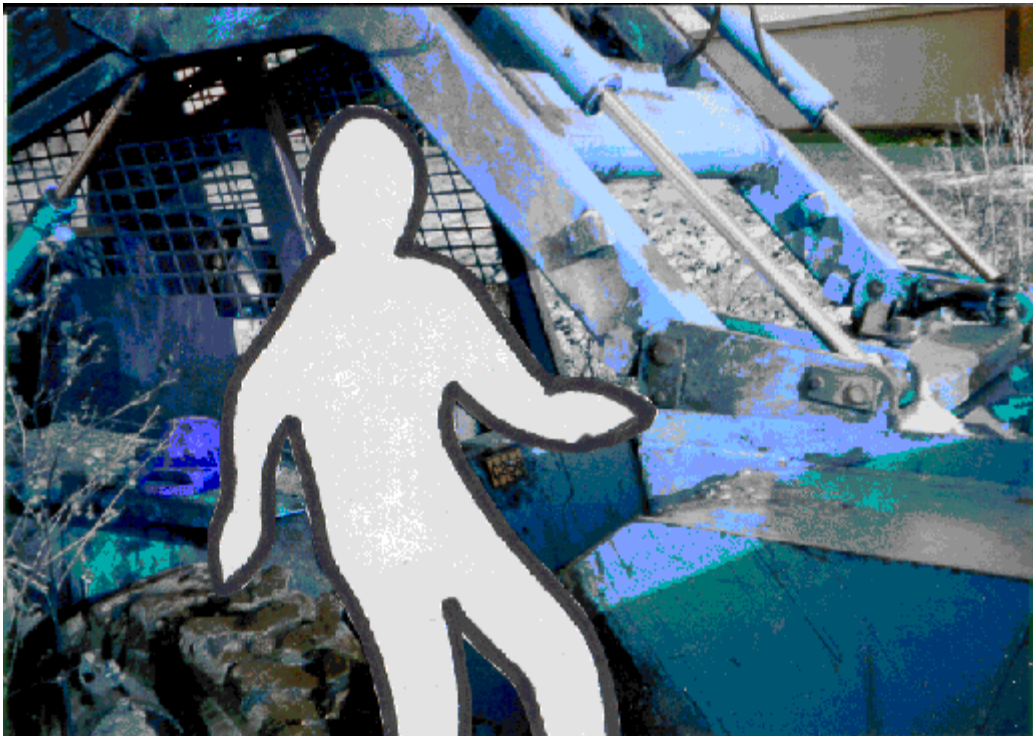
Figure 3. Simulated location and position of victim

On the day of the incident, the victim and his son completed most of their usual morning farm chores by 11:15. The victim had been using the skidsteer to clean the barn, while the son spread fresh bedding in the cleaned areas. After cleaning the barn, the victim drove the loader behind a machine shed in the farmyard and was using the bucket to lift an edge of an old manure spreader. The event was unwitnessed, but it appears that the victim started the loader after lowering the seat bars, then exited the loader with the bucket in the raised position. He stood in front of the skidsteer frame on the right side to operate the control handle. The bucket came down and pinned the victim against the frame of the loader (See figures). Meanwhile, the victim's son completed the morning barn chores and waited about 15 minutes for his father to return to the barn. When the victim did not return to the barn soon after the last trip with the loader, his son stepped outside to find him. He heard the loader motor idling, and followed the sound around the back of the machine shed. He saw the victim pinned by the bucket, and climbed into the cab to raise the bucket. The son ran to the house and yelled to his mother to call 911. After running back to the incident scene, he positioned the victim on the ground. His mother arrived at the scene, followed by sheriff's deputy and emergency responders within two minutes. The responders initiated CPR and continued until the ambulance arrived a few minutes later. The victim was transported to the hospital, where he was

Discussion: Skid steer loaders are designed and manufactured to be operated from the operator's cab. Safety devices, such as safety bars, seat belts, metal cage sides and rollover protection structures (ROPS) are all intended to protect the operator from injury while seated in the cab. In this case, the victim exited the cab and operated the hydraulic arm controls from outside. The bucket came down and pinned the victim against the frame. The incident would have been prevented if he had remained in the loader cab.
