**SUBJECT:** Hispanic heavy equipment operator was killed while jump-starting a pad-foot drum compactor.

## SUMMARY

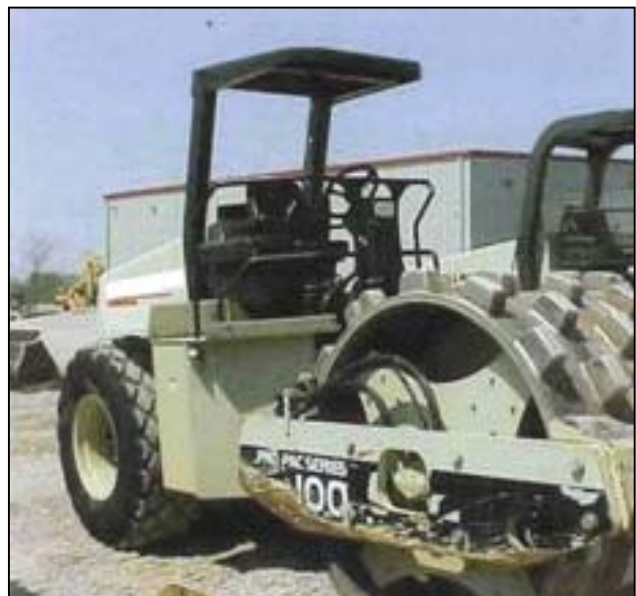
On April 1, 2004, an equipment operator was crushed by a pad-foot drum compactor (Figure 1) while attempting to start the machine manually. OKFACE investigators

Figure 1. Pad-foot drum compactor similar to the one involved in the incident

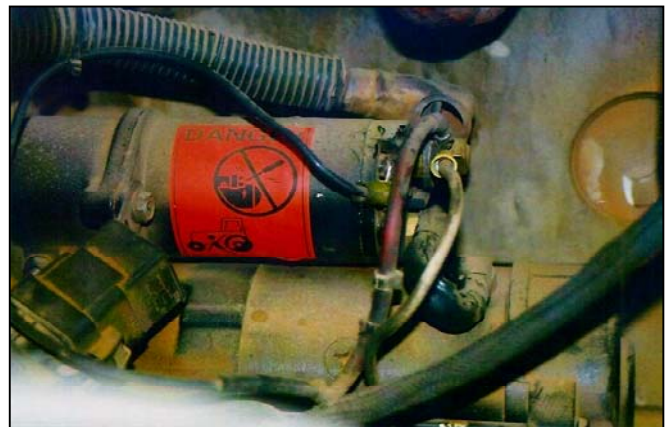
The compactor was used throughout the workday, although the malfunctioning starter system had to be bypassed several times. Whenever the machine traveled over a rough or rocky surface, the engine would stall. To restart the engine, the decedent stood on the rim of the left rear wheel assembly, leaned across the tire to reach the starter solenoid, and then jumped across the terminals with a 7/16"-3/8" offset open end wrench. A guard over the side of the engine where the solenoid was located was missing, in addition to the operator's manual, which had clear recommendations pertaining to the situation. For example, the operator's manual required a daily pre-start inspection in which broken or missing parts had to be corrected or replaced prior to use: "INSPECT your compactor daily. Ensure the routine maintenance and lubrication are being dutifully performed. Have any malfunctioning, broken or missing parts corrected or replaced before use. DO NOT operate a damaged or poorly maintained compactor. You risk lives when operating faulty equipment, INCLUDING your own." Additionally, the solenoid had an orange and black pictorial decal warning (Figure 2) against the startup procedure used by the decedent, and the manual outlined the following guidelines: (1) "READ and FOLLOW ALL instruction decals"; (2) "START the engine from the operator's position only"; (3) "Jump starting the engine is NOT RECOMMENDED. If you do jump start, use EXTREME CAUTION. Prior to jump starting, ENSURE propulsion (travel) control lever is in 'Neutral', a TRAINED OPERATOR is at the controls when the engine starts, and the parking brake is 'Applied'."

Figure 2. Compactor warning decal

Discussion: Although the compactor's malfunctioning starter system had been identified, the danger posed by that deficiency was underestimated and the equipment was used anyway. Because the inoperative starter system necessitated an alternate method for starting the machine, other safety features were bypassed, posing additional hazards to the workers. Employers should follow the manufacturer's recommendations for inspecting equipment daily and correct any malfunctions prior to use. This inspection should be performed on all equipment whether it is company-owned, borrowed, or rented. Managers and supervisors should be provided with risk management training, which would give them tools for making difficult decisions that balance production demands with worker safety and health. In addition, the employer should consider developing and implementing procedures and policies regarding rented or borrowed equipment, including the steps for inspecting the equipment and what to do if it is found to be defective, as well as procedures for reporting hazards at multi-employer worksites. Even if the operator's manual is not available on the machine, as in this incident, the signage and decals located on the equipment itself indicate dangers and warnings that should be heeded.

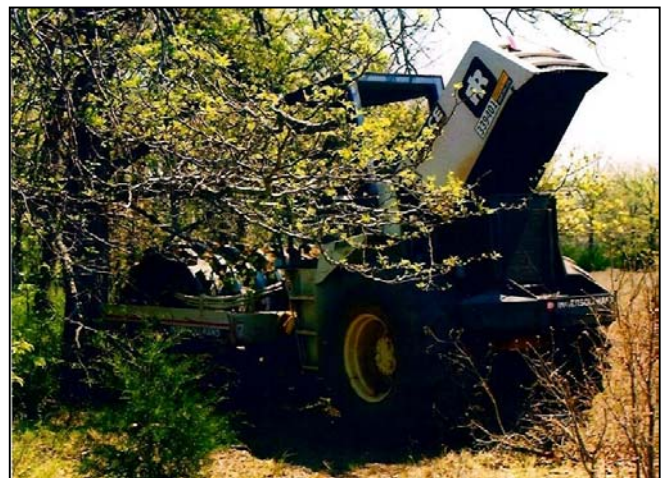
The decedent had finished working for the day and was driving the compactor to the parking area when he ran over a rock, causing the engine to die. The machine was in high gear and the propulsion lever full forward. The decedent dismounted from the operator's position and stepped onto the wheel assembly as he had done several times earlier in the day. The machine was left

Figure 3. Compactor after the crash

in gear and the parking brake was not applied as he performed the jump-start. In addition, the neutral safety switch, which prevented the engine from starting while in gear, was bypassed as a result of the jump-start, thereby increasing the safety hazards present. As the engine engaged and the machine moved forward, the decedent was caught between the tire and the fender assembly and crushed. Co-workers did not witness the incident, but did notice the compactor run off the roadway and crash into a tree ¼ mile away (Figure 3). Upon seeing the machine without an operator, the crew noticed the decedent lying unresponsive at the point where he had attempted the jump-start and immediately called 911. The decedent was pronounced dead at the scene.

### **Recommendation #1: Employers should ensure that all defective equipment is removed from service until repaired.**
