SUBJECT: Three workers died following a propane gas explosion on a quail/pheasant farm.

SUMMARY

The Oklahoma Fatality Assessment and Control Evaluation (OKFACE) is an occupational fatality surveillance project to determine the epidemiology of all fatal work-related injuries and identify and recommend prevention strategies. FACE is a research program of the National Institute for Occupational Safety and Health (NIOSH), Division of Safety Research.

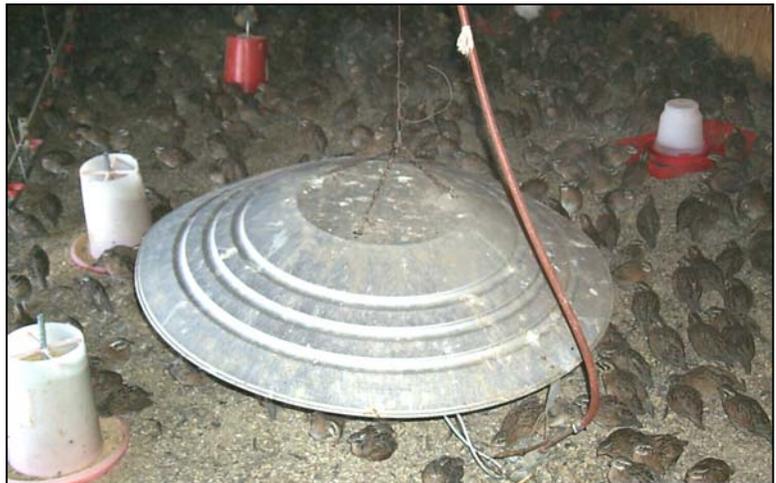
Figure 1. Brooder and feeders

*A hooded device used to control air temperature for poult and chicks during the first several weeks of age.

The farm housed quail and pheasant in approximately 20-25 buildings. The buildings were made of plywood and were approximately 1500 square feet. There were window openings at the top of the buildings and plywood panels on the sides of the buildings, which could be opened. Each building had three or four brooders. The owner of the farm and his wife were the only full time employees on the farm. The two workers, who were friends of the owner, had helped on the quail and pheasant farm from time to time for a couple of years. Their primary occupation was construction, and they had moved to the United States from Mexico a couple of years earlier. Spanish was their primary language, but they were able to speak broken English.

Discussion: Occupational Safety and Health Administration (OSHA) standards and manufacturer operating manuals provide guidelines for the safe operation of gas powered heating units. Employers should utilize these resources in the development of a formal procedure for lighting, servicing, and maintaining all natural gas powered heaters. In addition, warning signs should be prominently posted and signs or labels placed on gas controls, circuit breakers, thermostats, and/or controllers to caution workers to turn controls off when brooders are not actually in use. Portable fire extinguishers should also be available.

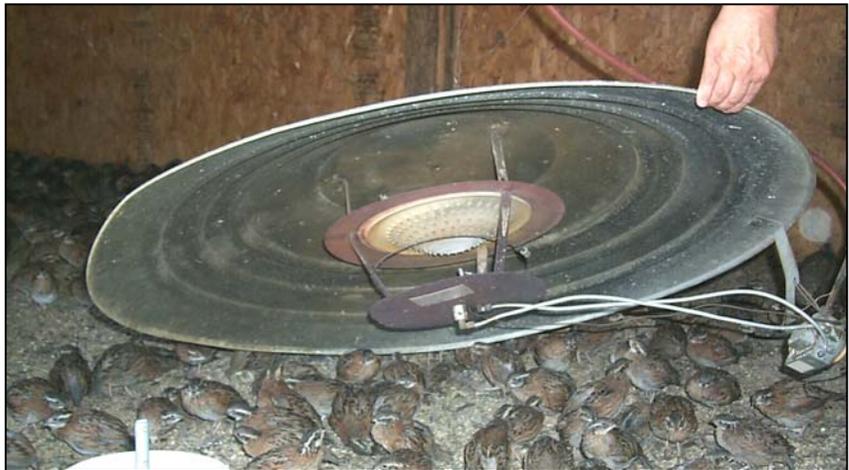
Figure 2. Inside of brooder

As the owner began lighting the brooder, an explosion occurred engulfing the entire building in flames. Apparently the brooder had been left on unlighted, or the supply line had a leak. (The Fire Marshal could not conclusively determine the cause of the fire.) In either case,

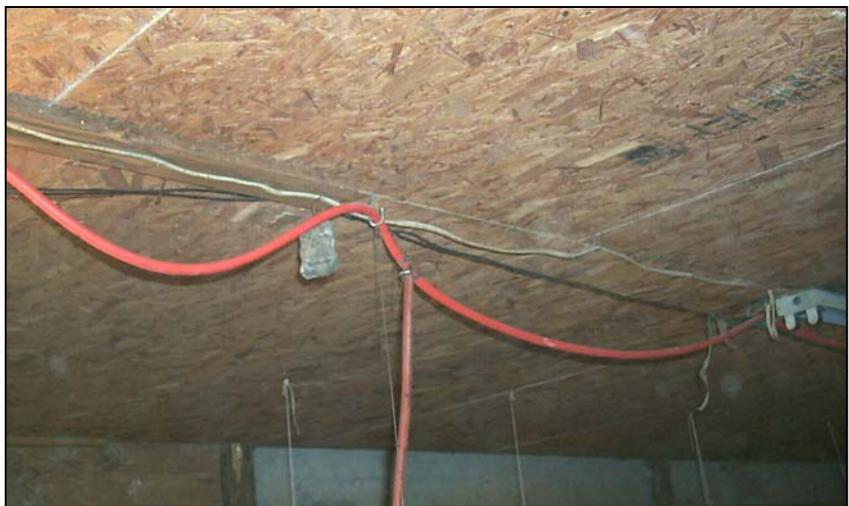
Figure 3. Supply lines

On the day of the incident, the weather was clear and cool, and the working surfaces were dry. Very early in the morning, about 1:45 a.m., the owner and two workers were attempting to move quail from a delivery truck into a building where quail were kept. While the two workers started moving the quail cages from the truck, the owner entered the building and began lighting one of the brooders. The brooder had a metal deflector with a propane burner underneath and was used to keep the quail warm (Figures 1 and 2). The brooder's gas supply line appeared to be a regular pneumatic hose, which ran from the brooder, up to the ceiling, and outside to a 20 pound capacity portable propane tank (Figure 3). The propane tank was on a grassy area just outside the building wall (Figure 4). The hoses were

attached and fitted with hose clamps similar to those used in automobile cooling systems.

To prevent the high risk of fire, it is absolutely essential that supply line hoses be gas-rated hoses, not ordinary air or automotive hoses. OSHA and National Fire Protection Association guidelines mandate the use of approved lines and hoses for transporting liquefied petroleum gases. In this incident, it appeared that regular pneumatic hoses were used to move the gas from the tank, through the building rafters, and down to the brooder burner. Only wrought iron or steel, brass, copper, or aluminum alloy pipes may be used for moving this type of gas. The pipes must be labeled appropriately. In addition, pipe joints should meet standards.
