SUBJECT: Waste disposal worker was crushed between a waste disposal truck and a dumpster.

SUMMARY

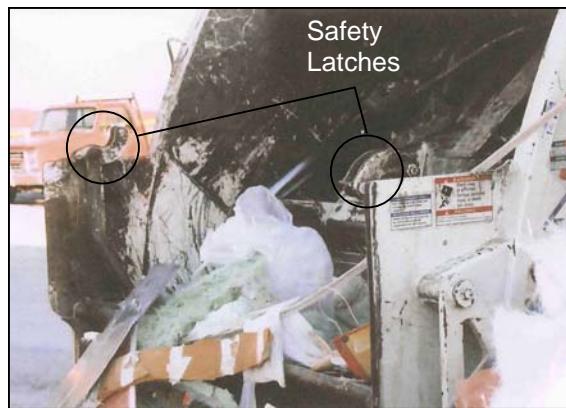
Figure 1. Rear of waste disposal truck

The victim was attempting to empty a 6-yard commercial dumpster into the rear loading waste disposal truck on which he was the operator. The normal procedure for emptying the dumpster involved the operator backing the truck up to the dumpster and attaching a wench cable-lifting hoist to the far end of the dumpster. The operator must also lock the two safety latches (one on each side) on the dumpster's trunnion bar to stabilize the dumpster as it is lifted and tilted forward (Figure 1).

Both locks must be used to properly secure the dumpster to the truck. When the wench cable is engaged, it causes the dumpster to pivot up on the trunnion bars, dumping the contents into the back of the waste disposal truck.

Recommendation #1: Employers should ensure that all waste disposal truck operators attach disposal containers in the proper manner.

Discussion: Employees should be made aware of the mandatory procedure of using the safety latches to secure the dumpster's trunnion bar to the truck. In this case, safety training had been completed and documented. Training should include information on the potential consequences of lifting a dumpster if the safety latches are not engaged. The manufacturer's signage on the side of the truck, located by the controls, depicts what could happen if the dumpster is not attached properly. Wire hoisting cables should also be inspected regularly to ensure that they are in good condition. A Safety and Health Information Bulletin, *Crushing Hazards Associated with Dumpsters and Rear-loading Trash Trucks*, is available on the Occupational Safety and Health Administration website <http://www.osha.gov/dts/shib/shib120903.html>.

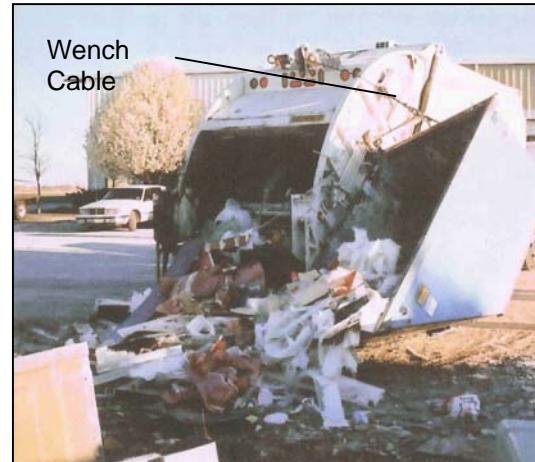
Figure 2. Truck with dumpster on side

During the lifting procedure, the suspended dumpster dislodged and swung around to the side of the truck where the decedent was standing to operate the controls. The dumpster pinned the victim against the right side of the truck and the controls (Figures 2 and 3).

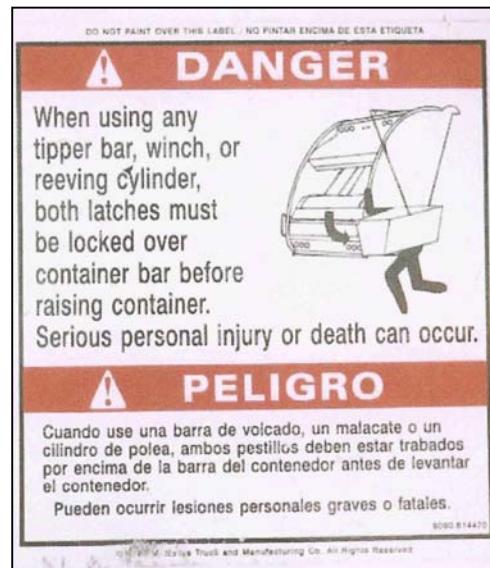
Figure 4. Signage located on side of waste disposal truck

Warning signage was posted on the vehicle in all locations of danger, including one directly relating to this type of hazard, positioned where the victim was found (Figure 4).
